**AIRCRAFT ACCIDENT REPORT AND EXECUTIVE SUMMARY**

<b>Reference:</b>		CA18/2/3/10550	
<b>Aircraft Registration</b>	ZS-MKY	<b>Date of Accident</b>	4 February 2025		<b>Time of Accident</b>	1300Z	
<b>Type of Aircraft</b>	Piper PA28-180			<b>Type of Operation</b>	Training (Part 141)		
<b>Pilot-in-command Licence Type</b>	Commercial Pilot Licence (CPL)		<b>Age</b>	24	<b>Licence Valid</b>	Yes	
<b>Pilot-in-command Flying Experience</b>	<b>Total Flying Hours</b>		490.9		<b>Hours on Type</b>	469.6	
<b>Last Point of Departure</b>	Wonderboom Aerodrome (FAWB), Gauteng Province						
<b>Next Point of Intended Landing</b>	Wonderboom Aerodrome (FAWB), Gauteng Province						
<b>Damage to Aircraft</b>	Substantial						
<b>Location of the accident site with reference to easily defined geographical points (GPS readings if possible)</b>							
Approximately 3.7 nautical miles west of Runway 29 (GPS co-ordinates: 25°38'51.99" South 028°10'17.78" East) at an elevation of 3 999 feet (ft)

<b>Probable Cause</b>							
The engine lost power during the climb phase and the reasons were undetermined. This necessitated a forced landing on an unsuitable terrain.							
<b>SRP Date</b>	9 September 2025		<b>Publ

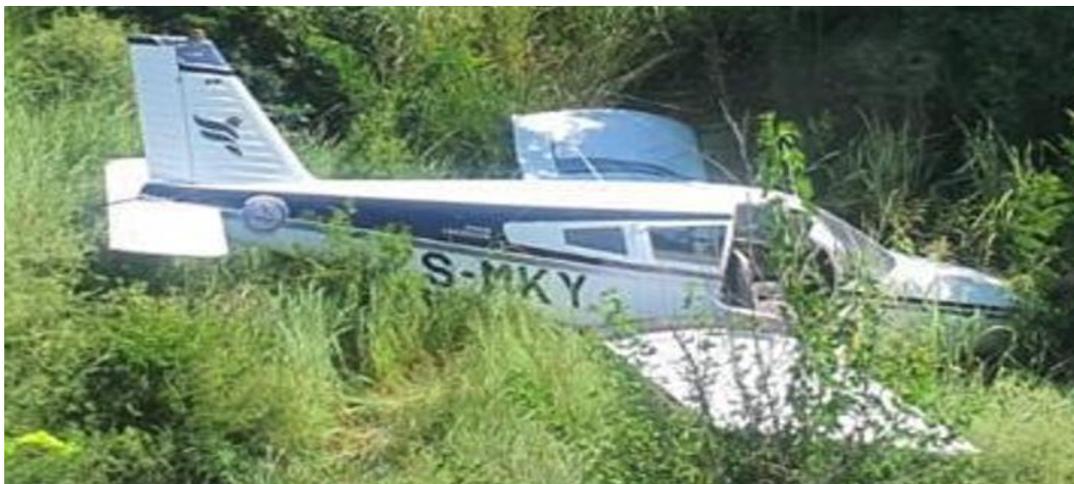
1.3.1. The left wing and the propeller blade sustained damage during the forced landing.

**Figure 2:** The aircraft at the accident site. (Source: Operator)

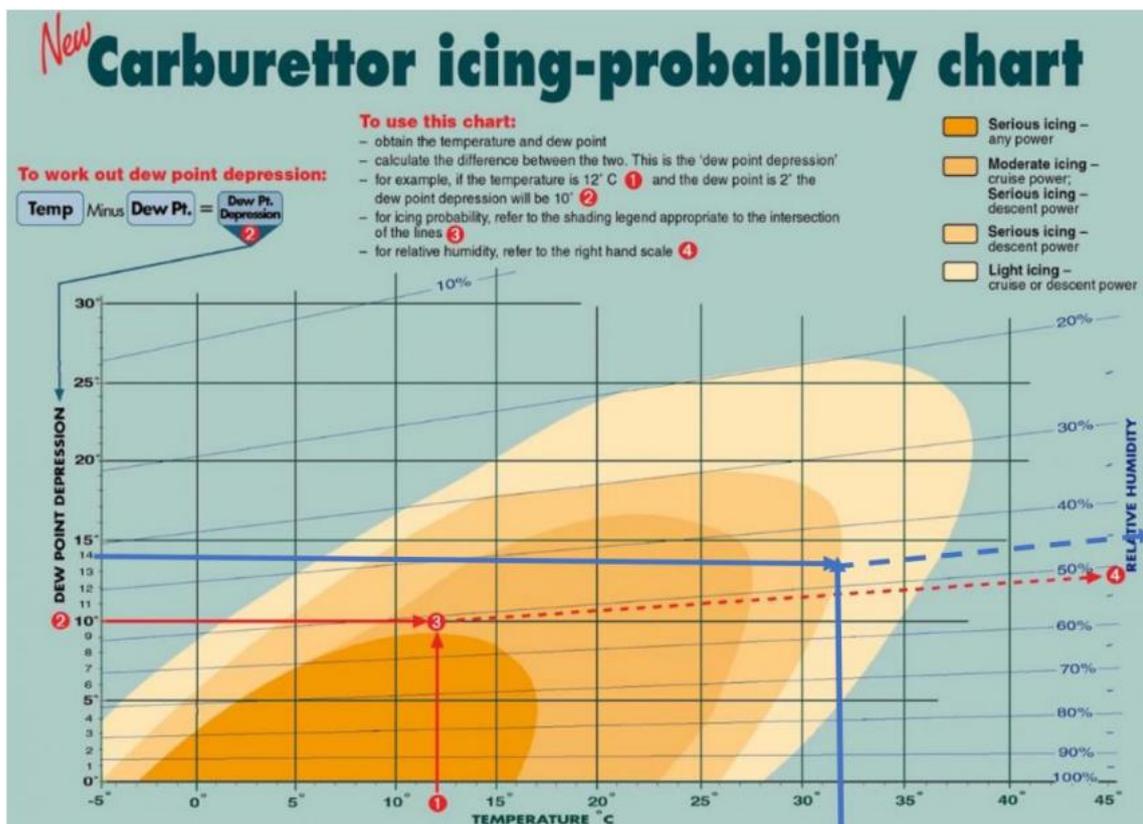
**Figure 5: Icing-probability Chart.**

1.7.2. According to the carburettor icing probability chart, the meteorological conditions at the time of the flight indicated a dew point depression of 14°C, with an ambient air temperature of 32°C and a dew point of 18°C. These values corresponded to a relative humidity of approximately 45%. Based on these parameters, the probability of carburettor icing was

assessed as low to negligible. The aircraft was in the climb phase when these environmental conditions were recorded. A climb phase is generally associated with high engine power settings, which reduces the likelihood of carburettor ice formation. No indications of carburettor icing were reported by the flight crew during this phase.

- 2.2.10. Weather conditions at the time of the flight were fine and stable; the weather had no bearing on the outcome of the accident. While the carburettor icing charts indicated potential for icing at descent power, the aircraft was operated at take-off power in which the likelihood of carburettor ice was significantly reduced. Even if the carburettor ice had formed during ground operations, the ambient temperature of 32°C and the 20-minute ground time would likely have dissipated any accumulated ice. Therefore, carburettor icing was not considered a contributing factor to this accident.
- 2.2.11. The aircraft took off normally within the prescribed power and performance parameters, and density altitude was within limits, playing no role in the event.

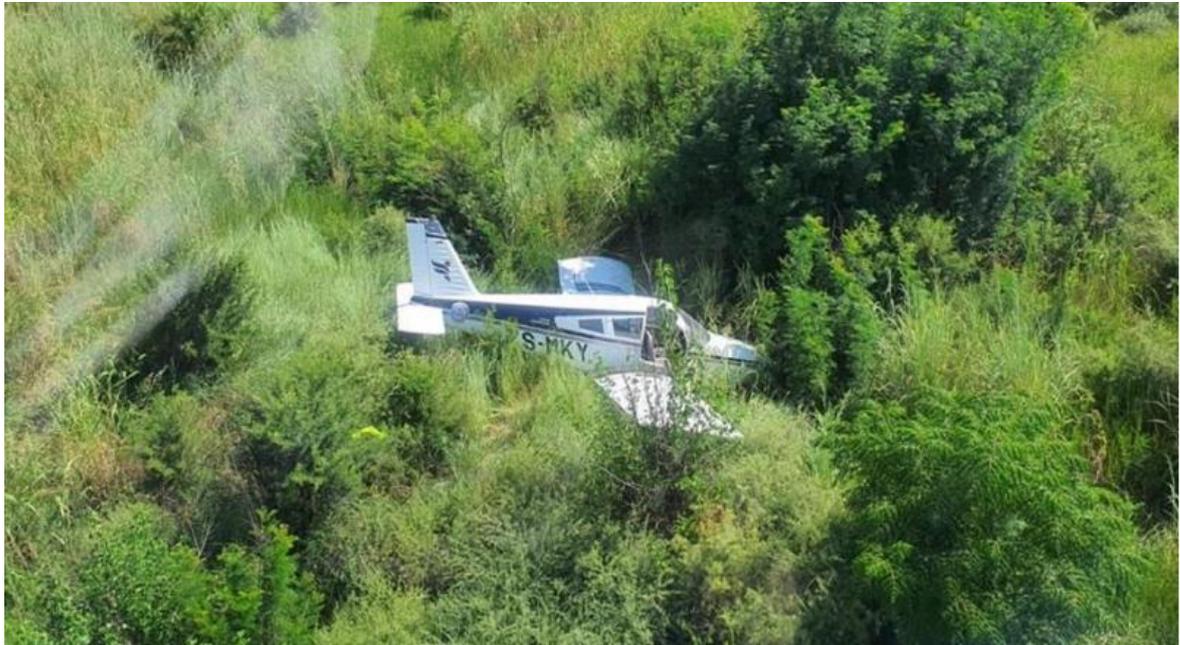
**Figure 6:** The aircraft at the accident site. (Source: Operator)

1.12.2. The left and the right wings, as well as the landing gears and the propeller were damaged during the forced landing. The aircraft was recovered in its entirety without it being disassembled. It remained structurally intact as it was found which ensured that all components were preserved in their original condition for examination.

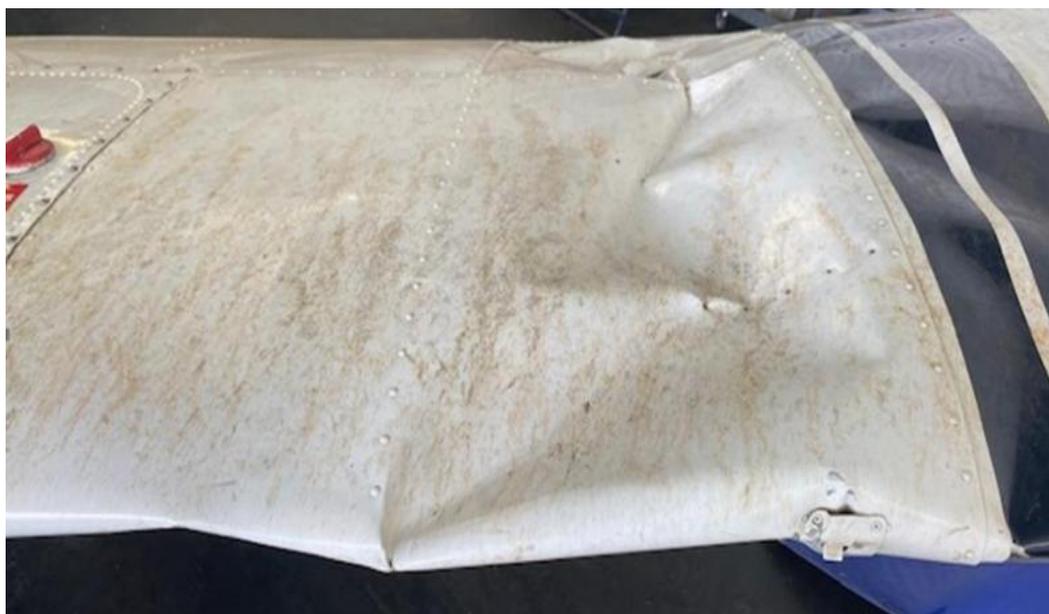
**Figure 7:** The damaged left wing.

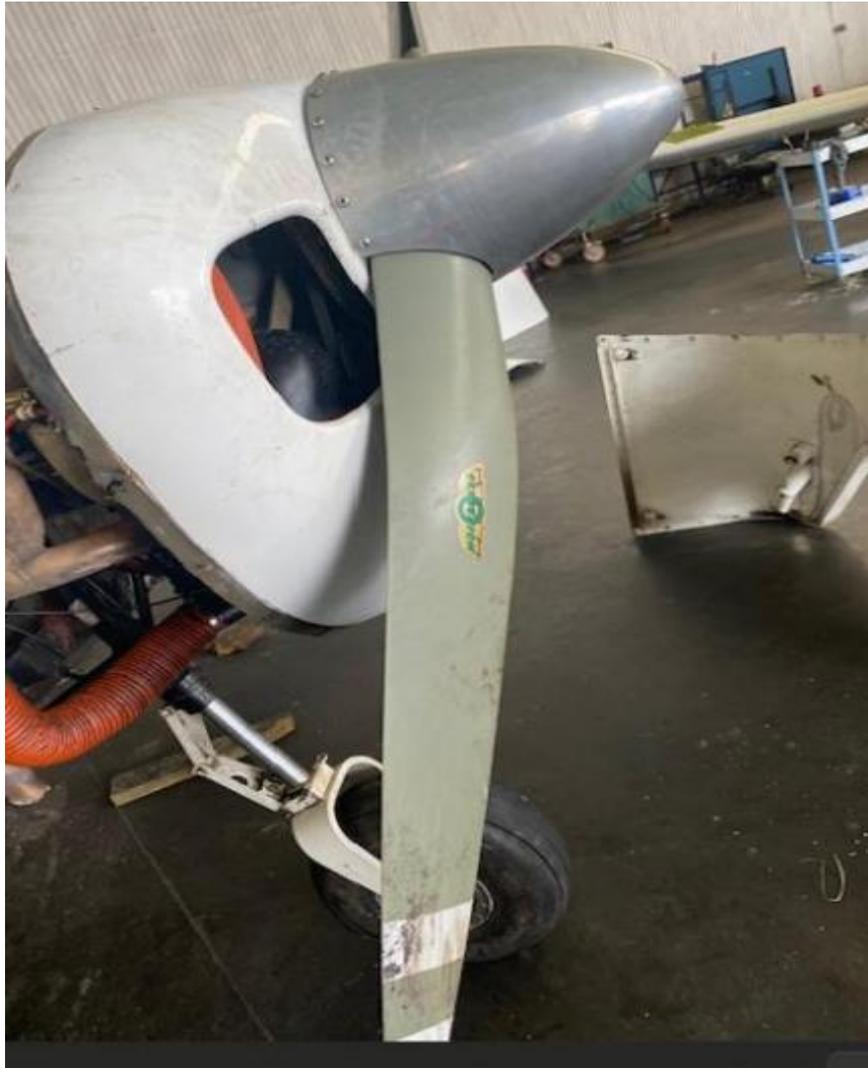
**Figure 8:** The bent propeller blade.

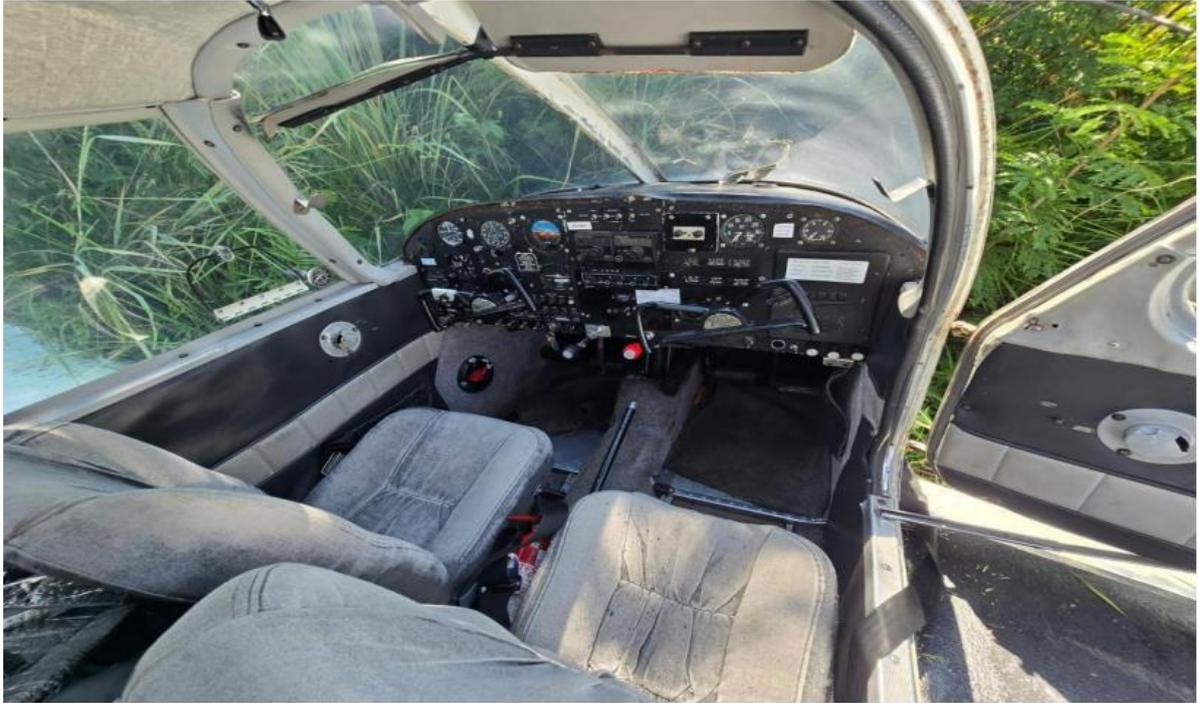
1.15.1. The accident was considered survivable as there was no damage to the cockpit and cabin areas that would have caused serious injury to the crew. The crew had their safety harnesses on during the flight, and they did not fail during the accident sequence.

**Figure 9:** A view of the cockpit after the accident. (Source: Operator)

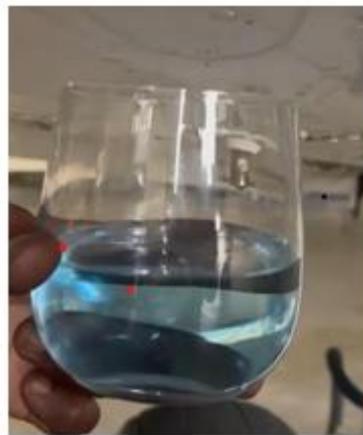
1.16.5. On 6 February 2025, a detailed inspection of the aircraft's fuel system was conducted as part of the investigation. Fuel was drained from both the left and right tanks in accordance with standard maintenance and safety procedures. The drained fuel was visually and physically inspected for quality and contamination.

The inspection confirmed that the fuel in both tanks matched the correct grade and specification as outlined in the aircraft Pilot's Operating Handbook (POH). No evidence of water, sediment, microbial growth or foreign particulate matter was found during the examination. The fuel was determined to be clean, uncontaminated and suitable for operational use at the time of inspection.

**Figure 10:** A sample of fuel drained for inspection.

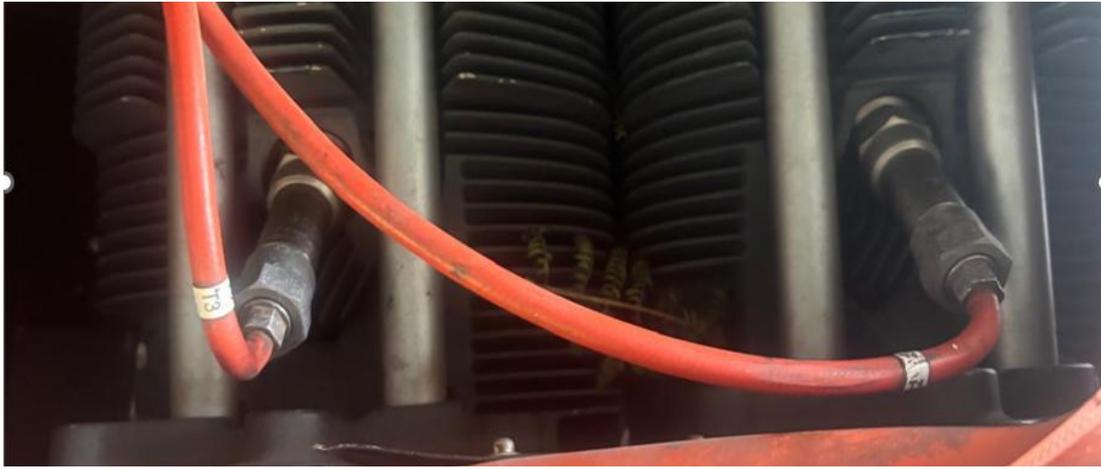
- The magnetos were bench-tested, and no faults were found.
- The spark plugs high-tension (HT) leads were bench-tested, and no faults were found with the spark plugs.

**Figure 11:** Inspected ignition system.

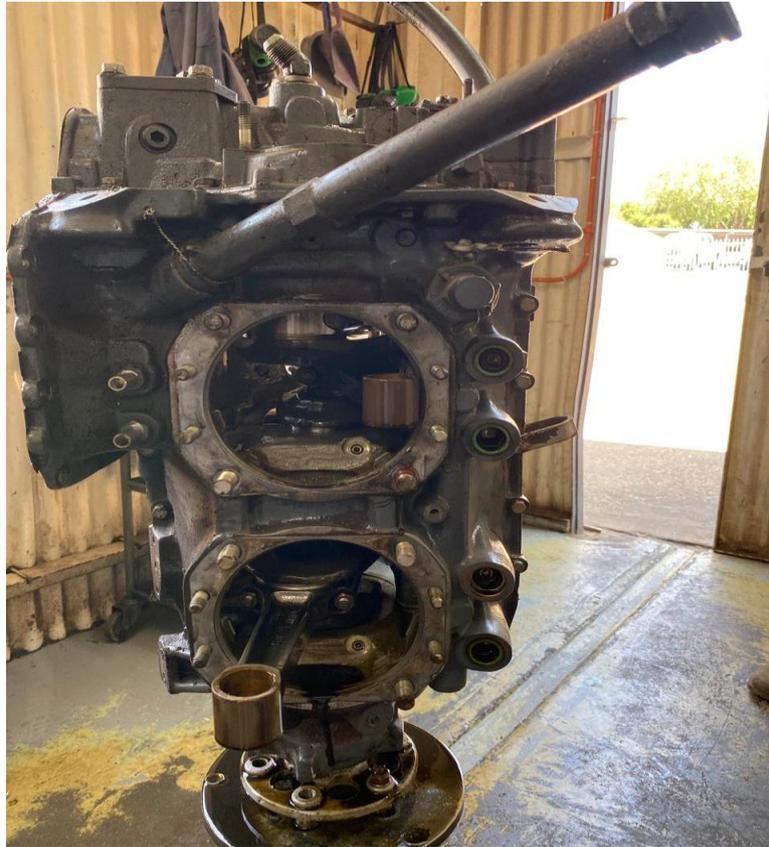
- 1.16.8. The crankcase, crankshaft connecting rods, camshaft and assessor gears were all inspected and showed no mechanical anomalies.
- 1.16.9. The propeller and its governing system were examined and did not exhibit any pre-impact damage. Therefore, the governing system was ruled out as a possible cause of loss of engine power.

- 1.16.10. The engine drive train was rotated by turning the propeller by hand; compression was evident on all four cylinders and all rockers/valves moved normally. Both magnetos remained secured to the engine. Examination showed that the magneto to engine timing was set according to the manufacturer's specification and was tested for functionality. The propeller and its governing system were examined and did not exhibit any pre-impact damage. The propeller was rotating when the aircraft struck the ground. Approximately 7 quarts of oil was found in the oil tank; the minimum safe quantity was 2 quarts, according to the POH. Examination of the aircraft revealed that fuel was present in the tanks and in the fuel lines that led to the injectors.

**Figure 12:** The aircraft's engine.
