AIRCRAFT ACCIDENT REPORT AND EXECUTIVE SUMMARY

Reference:		CA18/2/3/10551		
Helicopter Registration		ZS-RAC	Date of Accident		5 February 2025		Time of Accident	0705Z
Type of Helicopter		Bell 206L-4 Long Ranger IV		Type of Operation		Private (Part 91)		
Pilot-in-command Licence Type		Commercial Pilot Licence (CPL) Helicopter		Age	34	Licence Valid	Yes	
Pilot-in-command Flying Experience		Total Flying Hours		1 675.5		Hours on Type	230.9	
Last Point of Departure		Rand Airport (FAGM), Gauteng Province						
Next Point of Intended Landing		Polokwane Civil Airport (FAPI), Limpopo Province						
Damage to the Helicopter		Destroyed						
Location of the accident site with reference to easily defined geographical points (GPS readings if possible)								
On the border of Polokwane Game Reserve at Global Positioning System (GPS) co-ordinates determined to be 23°56'54"South 029°27'23"East, at an elevation of 4 265 feet (ft)								
Meteorological Information		Wind velocity: 020° at 3KT; Temperature: 26°C; Dew Point: 18°C; Visibility: ≥10000m; Cloud ceiling: FEW020; QNH: 1021 hPa

The engine failed due to loss of lubrication which resulted in a rapid loss of engine power, subsequently followed

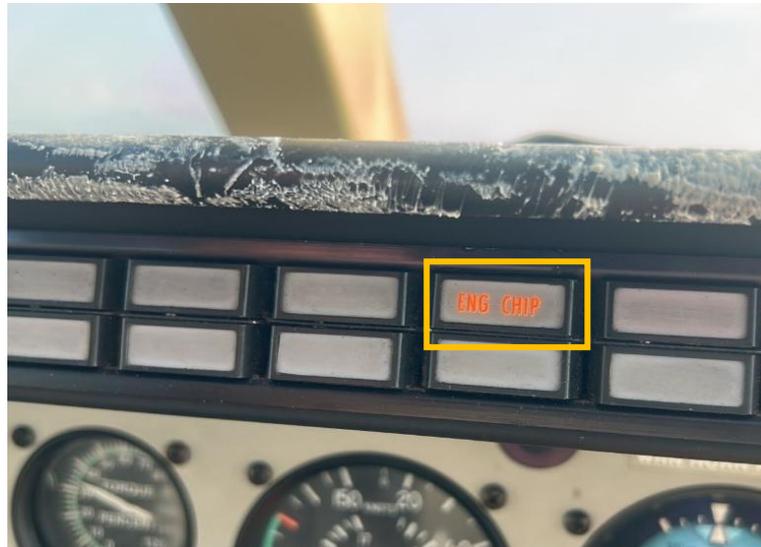
- 1.1.3. Whilst en route to the first planned stop at FAPI and in the vicinity of Wonderboom Airport (FAWB), the pilot reportedly noticed warning indications of low oil pressure and engine metal chip detection, as relayed by the pilot's father. According to communication records via WhatsApp (a messages application) that were obtained from the pilot's mobile phone (from the pilot's father), there were several warning indications on the caution and warning panel (CWP) in the cockpit during the flight.

Figure 1: Engine chip warning in-flight on the caution and warning panel (CWP). (Source: Pilot's phone)

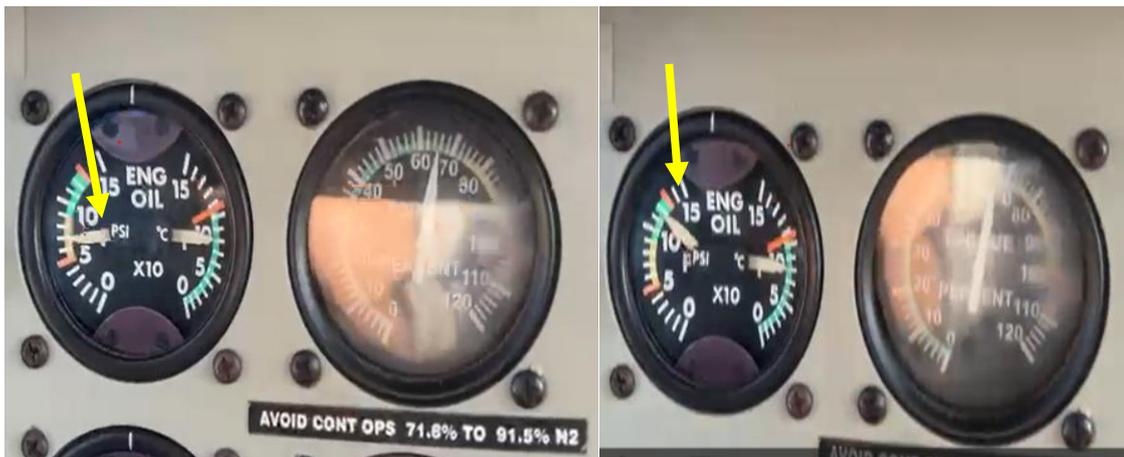
- 1.1.5. The pilot sent a video message to the AME at 0551Z shortly after lift-off which showed oil pressure indication fluctuations to which the AME responded: '*could be some air in the system*'. The next phone message records showed that at 0606Z, the oil pressure warning indicator fluctuated; and at 0611Z, a torque fluctuation indication was noted. At 0639Z, there was an oil temperature decay indication which was followed by the activation of a metal chip light (ENG CHIP) at 0640Z. The engine metal chip warning indicated a detection of metal particles in the oil lubrication system. The pilot made a voice call to the AME which lasted approximately 57 seconds. The engine failed at 0703Z, and the helicopter crash-landed shortly afterwards.

Figures 2 and 3: Unstable (erratic) engine oil pressure warning indication (yellow arrows) which is low on the left picture and high on the right picture. (Source: Pilot's phone)

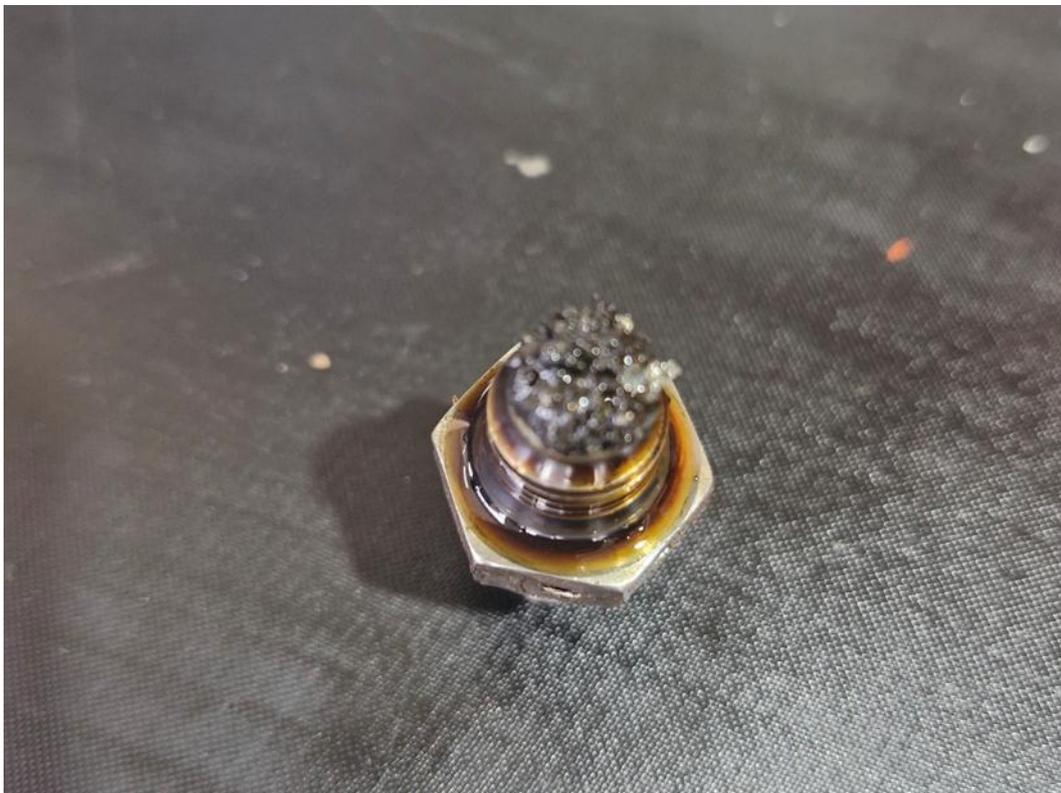
1.6.4. However, during landing at FAPI, the engine metal chip indication warning light illuminated. The pilot inspected and removed metal particles from the metal chip detector; the oil level was below optimal, which the pilot topped up. He then consulted with the AME at the base in FAGM who deemed it acceptable to continue with the flight. The operator stated that an additional landing between FAPI and FAGM was added to the route to re-check the chip detector; this was planned for Bela-Bela area. A vehicle was positioned at the planned Bela-Bela Landing Zone (LZ). The helicopter landed at Bela-Bela, and the chip detector was examined for any metal particles; none was found.

Figure 7: The Bell 206 chip detector with metal chips.

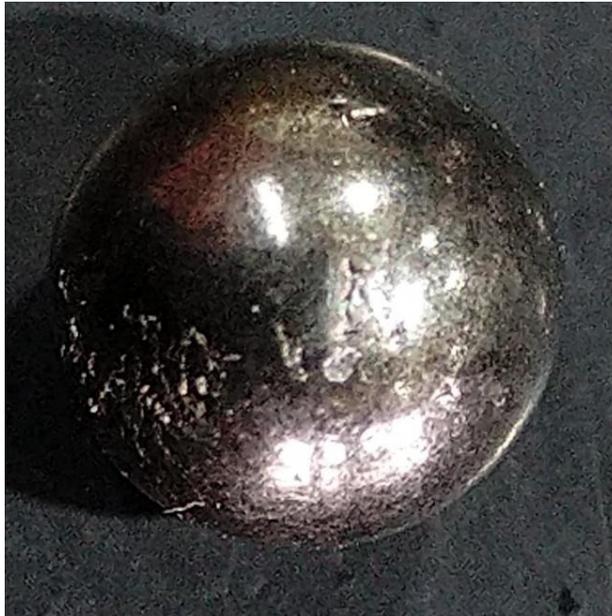
1.6.6. During maintenance, the engine compressor and turbine modules were removed and sent to a Rolls-Royce approved engine shop for Metal in Oil Inspection (MIO). According to the Rolls Royce maintenance manuals, the MIO inspection should be conducted on the entire engine stages including the compressor, turbine and gearbox stages. The Number 2 bearing (Illustration 1) on the compressor was inspected by the engine shop as this was believed to be the reason for metal particle detection warning light illuminating. Further teardown of the compressor revealed that the labyrinth seal had failed. This was given by the engine shop as the reason for the higher-than-normal oil consumption. The engine shop stripped the turbine assembly to determine any other sources of metal chips, and the Number 8 bearing (Illustration 1) was found to have spalling. The decision was made to replace all the bearings in the turbine.

Figure 8: One of the spalled balls from bearing Number 8. (Source: Engine shop)

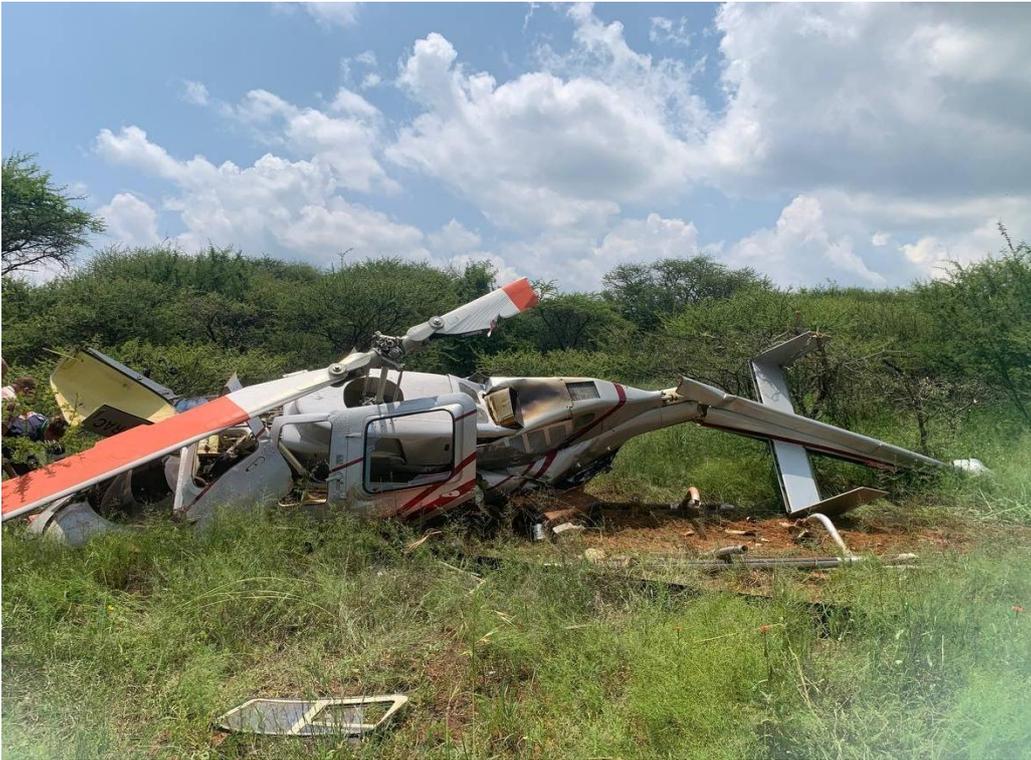
1.12.1 The accident occurred in a bush-type terrain within the Polokwane Game Reserve situated approximately 1.4 nm west of FAPI. The damage pattern was indicative of a helicopter that had descended in a steep angle before it crashed on the ground in a nose-high attitude and left roll. The tail rotor and vertical fin impacted a tall tree and, subsequently, separated from the tail assembly. The helicopter sustained significant damage to the skid landing gear, fuselage, main rotor and tail boom.

1.12.2 There was no evidence of a significant engine power during impact with the ground. All airframe components and controls were accounted for post-accident. There was evidence of fuel at the accident site although the quantity could not be determined. There were no noted pre-impact anomalies; all fractures were consistent with impact forces.

Figure 9: The helicopter as it rested after the crash. (Source: EMS)

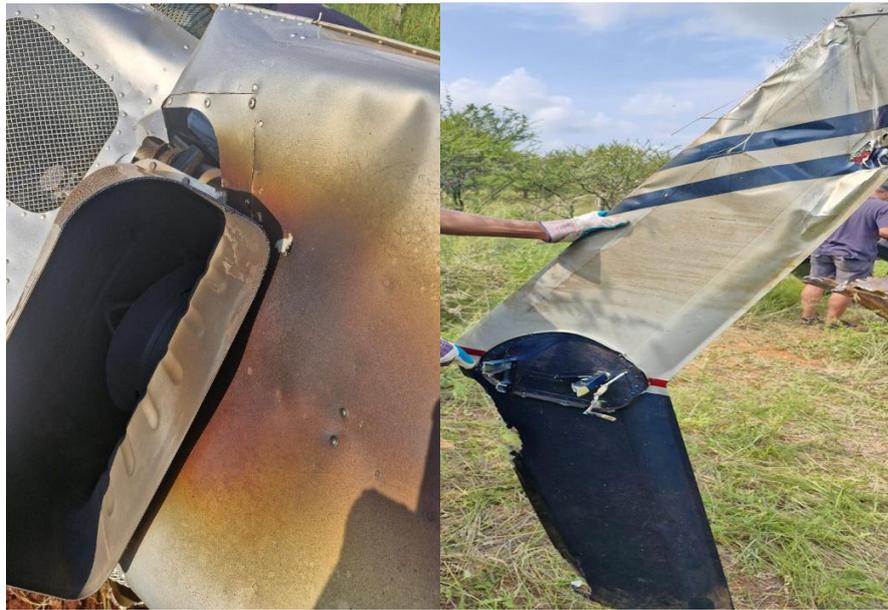
1.12.3 The separated vertical tail fin displayed a sheen oil residue, indicative of oil discharge rearwards during flight prior to impact. There was a concentrated area of dark coked oil residue on the upper engine cowling aft of the exhaust stack which was consistent with prolonged exposure to overheated or burnt lubricant. The examination of the exhaust pipe revealed molten metal particles which suggested internal engine component distress and localised overheating. The outer oil reservoir was found completely empty at the accident site, corroborating significant in-flight oil loss. Additionally, two full 946ml cans of AeroShell 555 and Mobile Jet Oil 254 were recovered from the wreckage, confirming that no oil replenishment had been performed before the occurrence.

Figures 11 and 12: The coked oil residue on the upper engine cowling and oil sheen on the vertical separated fin.

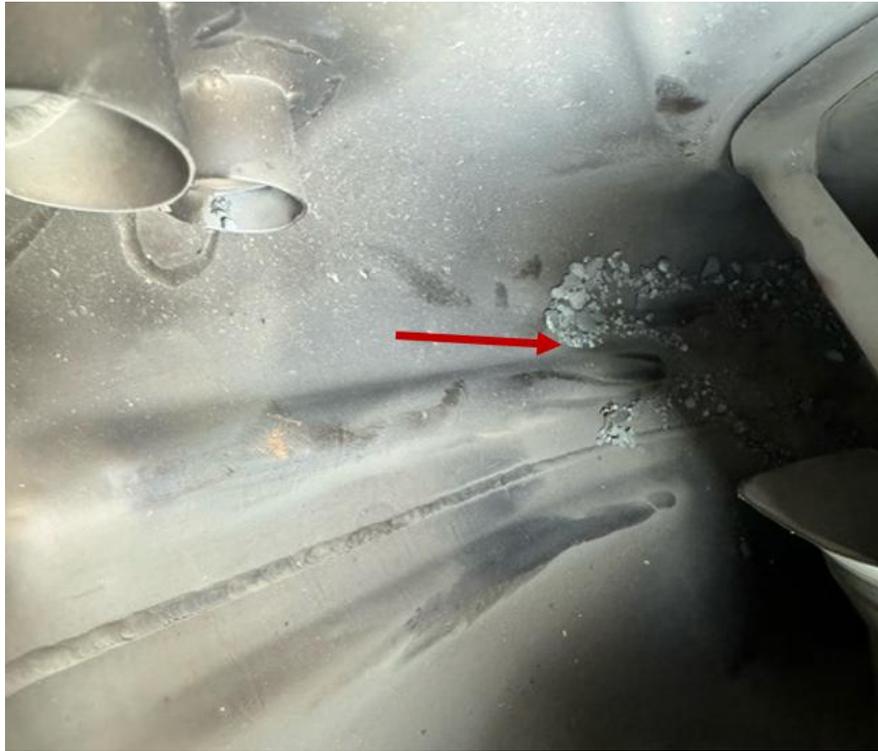
1.12.4 The exhaust stack contained numerous molten metal particles, indicating that internal engine components had experienced severe overheating and localised thermal breakdown. These particles were fused and irregularly shaped, consistent with high-temperature distress within the turbine section where metallic fragments are expelled through the exhaust flow path after component degradation.

Figure 13: The molten metal particles inside the exhaust stack.

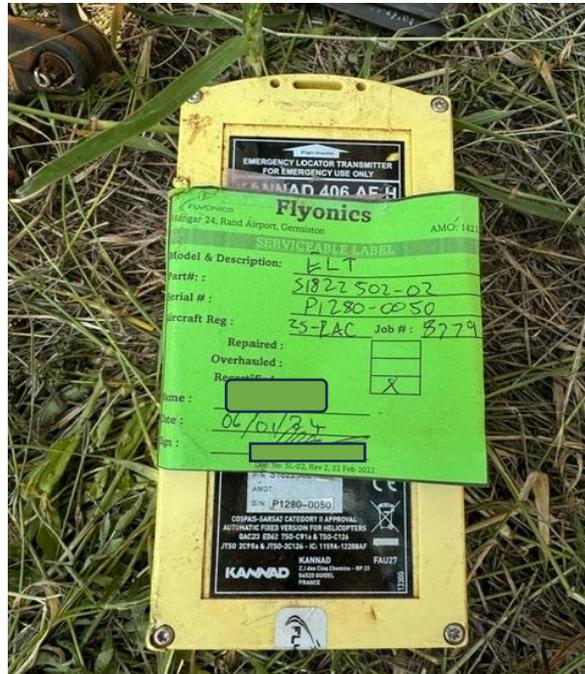
1.15.2 The helicopter was equipped with a Kannad 406 emergency locator transmitter (ELT). The Aeronautical Rescue Coordination Centre (ARCC) did not receive a signal from the ELT. The ELT was removed from the helicopter at the accident site, and the switch was found in “ARM” position.

Figure 14: The Kannad 406 ELT at the scene.

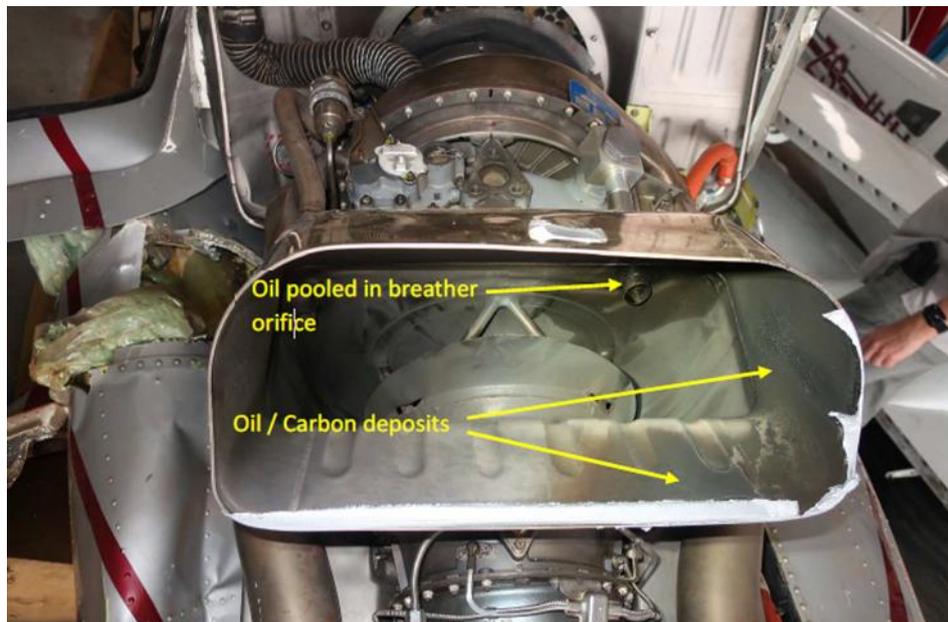
The No. 5 bearing was dark in colour and oil drenched. The bearing spun with some resistance and roughness. Oil was noted within the gearbox breather orifice (located within the exhaust collector) and on the exhaust collector surface around the orifice. The airframe supplied exhaust stack displayed a dark, carbon-like coating which was concentrated on the right side, aft of the gearbox breather orifice (Figure 15).

Figure 15. Oil in exhaust collector and stack.

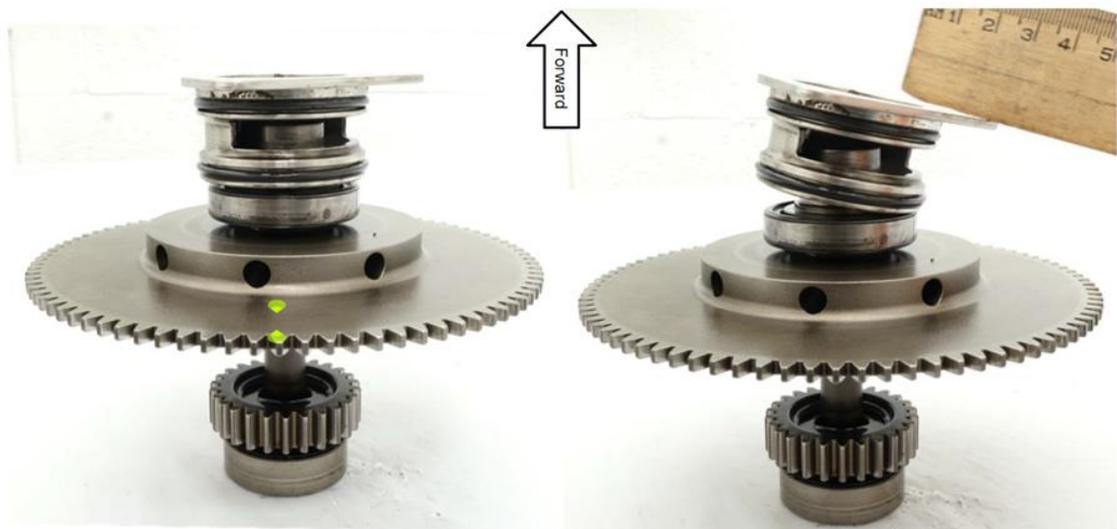
The centrifugal breather gearshaft support seal was not tightly fitted to the centrifugal breather gearshaft. The seal was dark in colour and the inner diameter did not retain the same stiffness as an exemplar seal. The seal mating surface on the centrifugal breather gearshaft felt normal with no obvious nicks or damage.

The centrifugal breather gearshaft support seal inner diameter exceeded the component definition requirement. The inner diameter of the support seal exceeded the outer diameter of the gearshaft sealing surface.

surface (Figure 16) to demonstrate the fit of the seal onto the gearshaft. The support seal exhibited a loose fit on the gearshaft sealing surface. The support seal inner diameter was measured optically and with callipers. The seal inner diameter measured approximately 0.885 inch with each method, which exceeded the component definition requirement of 0.790 – 0.830 inch.

Figure 16. Re-assembled seal and gearshaft demonstrating the amount of looseness between the seal and shaft.

The resultant fit between the seal and gearshaft surface presented a gap of 0.009 inch. The assembly is designed to have an interference (or tight fit) of the seal to the seal land of 0.040 inch to 0.087 inch tight. This gap presented an escape path for the engine oil out of the engine. The subsequent loss of oil resulted in oil starvation to several bearings within the engine, including the No. 8 bearing. The failure of the No. 8 bearing allowed the turbine gas producer rotor to shift axially forward. Which caused the first stage turbine wheel to contact the second stage turbine nozzle and ultimately burst.

4.2.1. It is recommended to the Director of the South African Civil Aviation Authority that a strengthened oversight be established to provide a clearer mechanism for assessing and, where necessary, designating manufacturer service bulletins as mandatory when they have
