LIMITED OCCURRENCE INVESTIGATION REPORT – FINAL

Reference Number		CA18/2/3/10553						
Classification	Accident			Date	25 February 2025		Time	0935Z
Type of Operation	Training (Part 141)							
Location								
Place of Departure	Lanseria International Airport (FALA), Gauteng Province			Place of Intended Landing	Lanseria International Airport (FALA), Gauteng Province			
Place of Occurrence	On Runway 07 at Lanseria International Airport, Gauteng Province							
GPS Co-ordinates	Latitude	25° 56'22.89" S	Longitude	027° 55'32.07" E	Elevation	4521ft		
Aircraft Information								
Registration	ZS-TDI							
Make; Model; S/N	Diamond, DA-42 (Serial Number: 42-200)							
Damage to Aircraft	Substantial			Total Aircraft Hours	2632.5			
Pilot-in-command								
Licence Type	Commercial Pilot Licence		Gender	Male		Age	34	
Licence Valid	Yes	Total Hours	1130		Total Hours on Type	35.2		
Total Hours 30 Days	2.8		Total Flying on Type Past 90 Days	18.1				
Pilot in Training

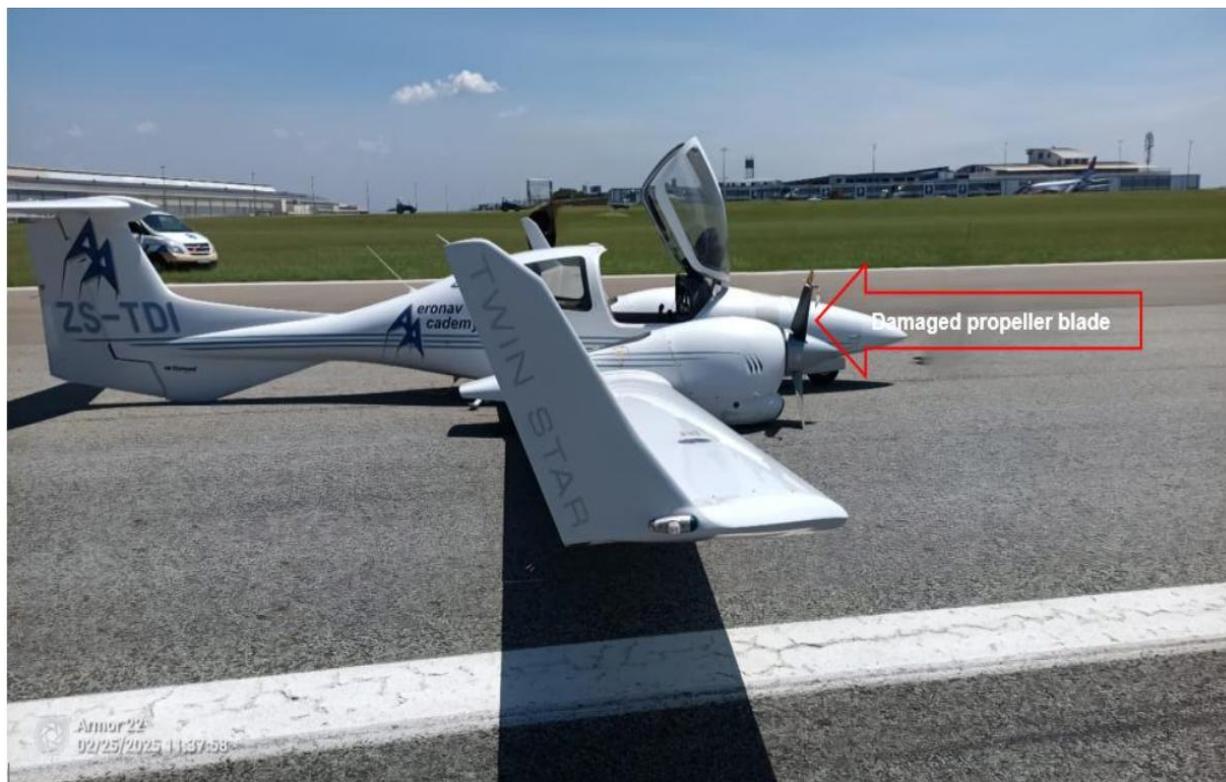
Whilst the aircraft was in the flare with the low-power warning horn still audible, the crew realised that the landing gear had not been lowered. The FI called for gear extension, but it was too late. The aircraft landed on the runway with the landing gear retracted; as a result, both propellers struck the ground. The aircraft slid on the runway for approximately 800 metres (m) before it stopped on the left side of the runway's centreline. The aircraft sustained damage to both propellers, engine cowlings and the underside of the fuselage. The crew disembarked from the aircraft unassisted and without injury.

Figure 1: The aircraft after it had come to a stop. (Source: Pilot)

The pilots omitted to extend the landing gear during the landing phase.
