LIMITED OCCURRENCE INVESTIGATION REPORT – FINAL

Reference Number	CA18/3/2/10554					
Classification	Serious Incident	Date	25 February 2025	Time	0900Z	
Type of Operation	Private (Part 91)					
Location						
Place of Departure	New Castle Aerodrome, (FANC), KwaZulu-Natal Province		Place of Intended Landing	Swiss Valley Private Airstrip, Harrismith, Free State Province		
Place of Occurrence	Runway 18 at Swiss Valley Private Airstrip, Harrismith, Free State Province					
GPS Co-ordinates	Latitude	28°16'58" S	Longitude	029°04'43" E	Elevation	5 350ft
Aircraft Information						
Registration	ZS-MNW					
Make; Model; S/N	Maule M-7-235 (Serial Number: 4093C)					
Damage to Aircraft	Substantial		Total Aircraft Hours	4 876.4		
Pilot-in-command						
Licence Type	Private Pilot Licence (PPL)		Gender	Male	Age	33
Licence Valid	Yes	Total Hours	1 042		Total Hours on Type	762
Total Hours 30 Days	4.6		Total Flying on Type Past 90 Days	9.4		
People On-board	1+ 0	Injuries	0	Fatalities	0	Other (on the ground) 0

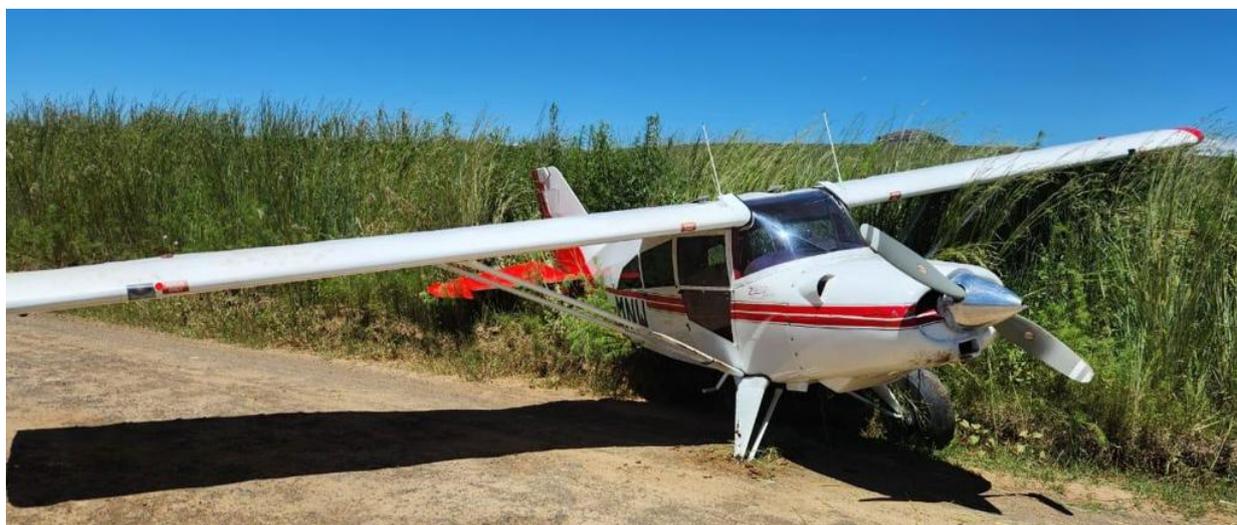
Subsequently, the aircraft rotated 180 degrees before it stopped. The aircraft sustained substantial damage to the right main gear strut and propeller blades; the pilot was not injured.

Figure 2: The aircraft at the accident site. (Source: Pilot)

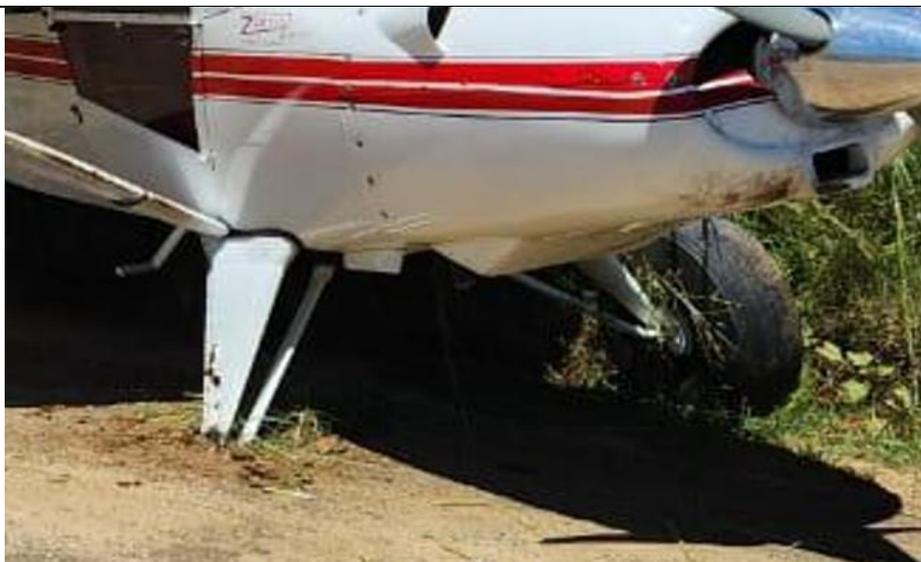
The right main landing gear wheel assembly detached from the strut and (the strut) dug into the ground.

Figure 3: The failed right main gear strut. (Pilot)

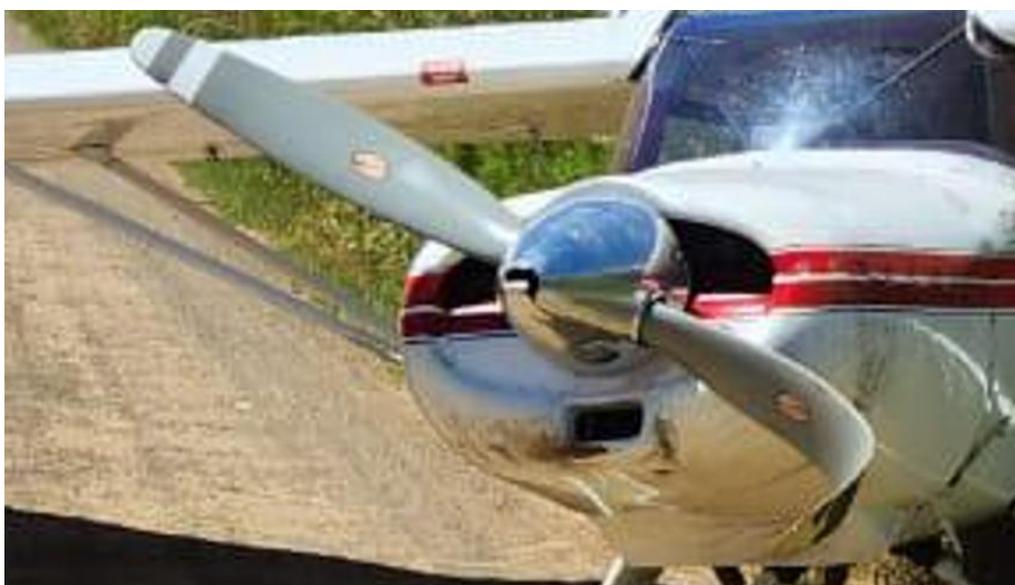
Figure 4: The bent propeller blade. (Pilot)

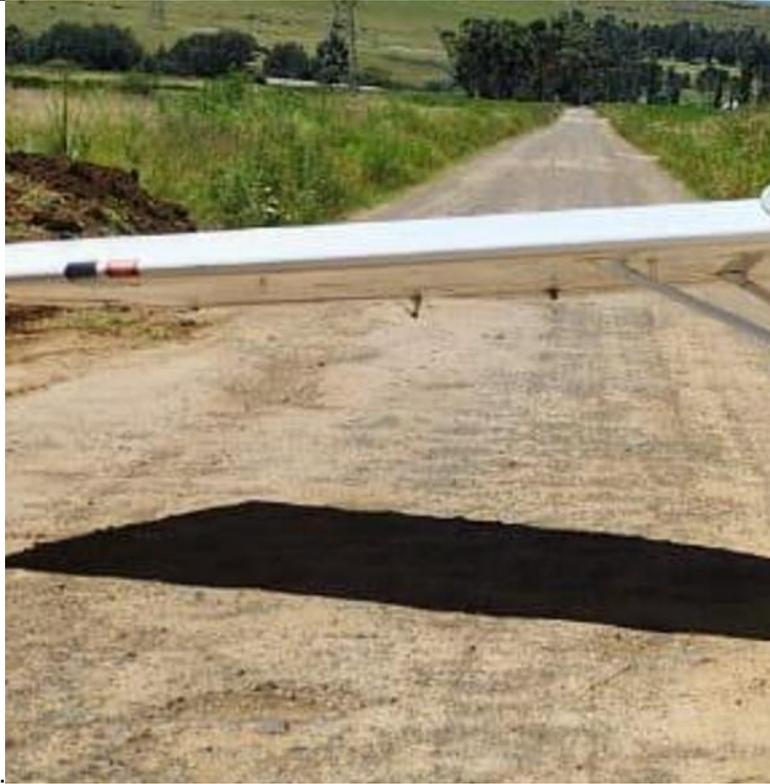
A 4m high grass grew along the edges of the runway. The overall runway surface was flat and even, which provided a suitable runway surface that would not pose challenges to the aircraft during landing or take-off under normal circumstances.

Figure 5: The runway surface. (Source: Pilot)

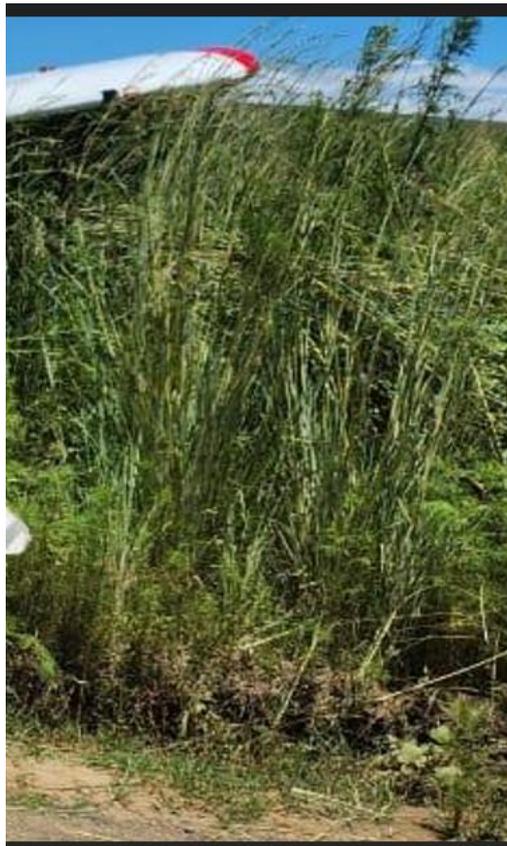
Figure 6: The overgrown grass on the sides of the runway. (Source: Pilot)

The pilot lost control of the aircraft due to the right wing contacting the tall grass on the edges of the runway during an attempted go-around.

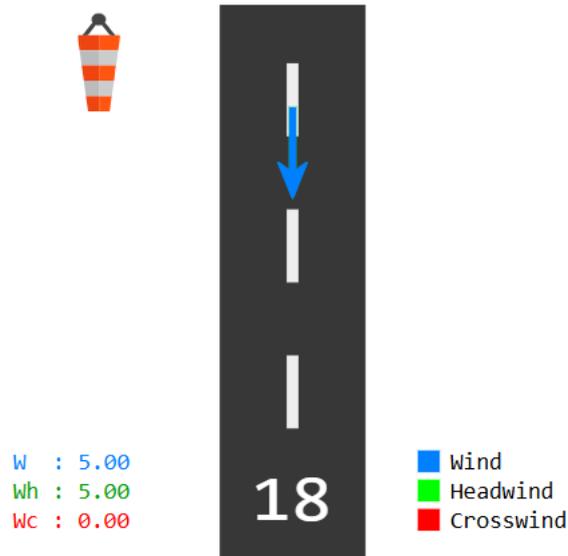
Figure 7: The wind component during landing. (Source: <https://e6bx.com/wind-components/>)

The wind analysis (above) illustrates the wind conditions on Runway 18, oriented 180°, at the time of the serious incident. The windsock indicates that the wind was blowing down the runway (the blue arrow indicates the wind direction). The wind analysis shows a wind speed (W) of 5.00 with a headwind component (Wh) of 5.00, and with no crosswind component (Wc = 0.00).
