AIRCRAFT ACCIDENT REPORT AND EXECUTIVE SUMMARY

Reference:		CA18/2/3/10556	
Aircraft Registration	ZU-SIG	Date of Accident	1 March 2025		Time of Accident	0715Z	
Type of Aircraft	Sling 2			Type of Operation	Private (Part 94)		
Pilot-in-command Licence Type	Commercial Pilot Licence (CPL)		Age	37	Licence Valid	Yes	
Pilot-in-command Flying Experience	Total Flying Hours		3 500	Hours on Type	37		
Last Point of Departure	Worcester Airfield, Western Cape Province						
Next Point of Intended Landing	Worcester Airfield, Western Cape Province						
Damage to Aircraft	Substantial						
Location of the accident site with reference to easily defined geographical points (GPS readings if possible)							
On a bush-type terrain approximately 400 metres (m) short of Runway 15, at Global Positioning System position: 33° 39' 06.7" South 019° 24' 16.1" East, at an elevation of 672 feet (ft)							
Meteorological Information	Surface wind:170°/ 07 kt; temperature: 20°C; dew point: 15°C; Visibility: CAVOK

Reference Number : CA18/2/3/10556
Occurrence Category : Accident (Category 2)
Type of Operation : Private (Part 94)
Name of Operator : Maria Susanna Potgieter
Aircraft Registration : ZU-SIG
Aircraft Mak

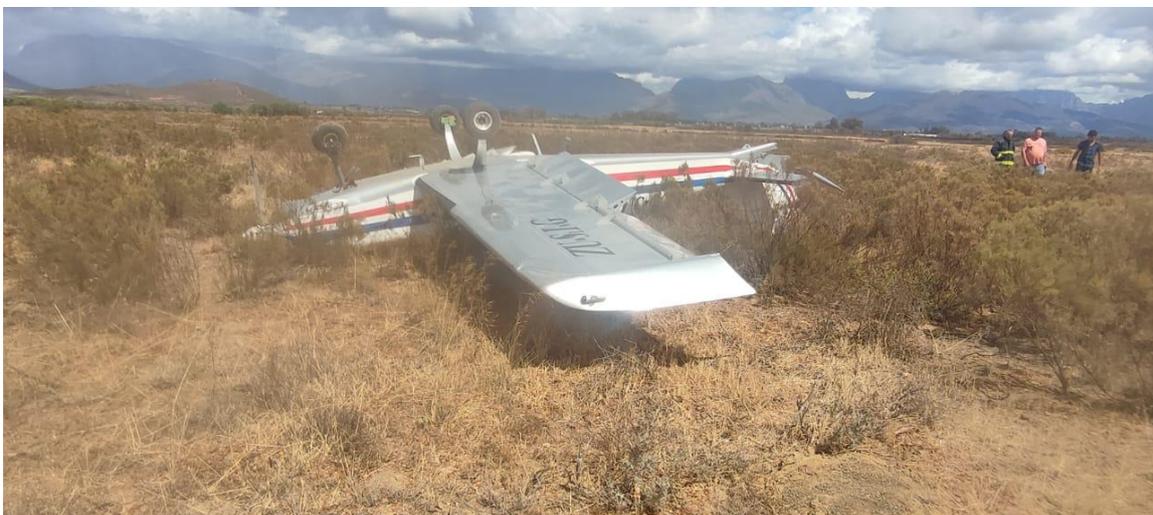
- 1.3.1. The nose gear, propeller, fuselage, left wing and vertical stabiliser were damaged; therefore, the damage was rendered substantial.

Figure 2: The aircraft post-accident.

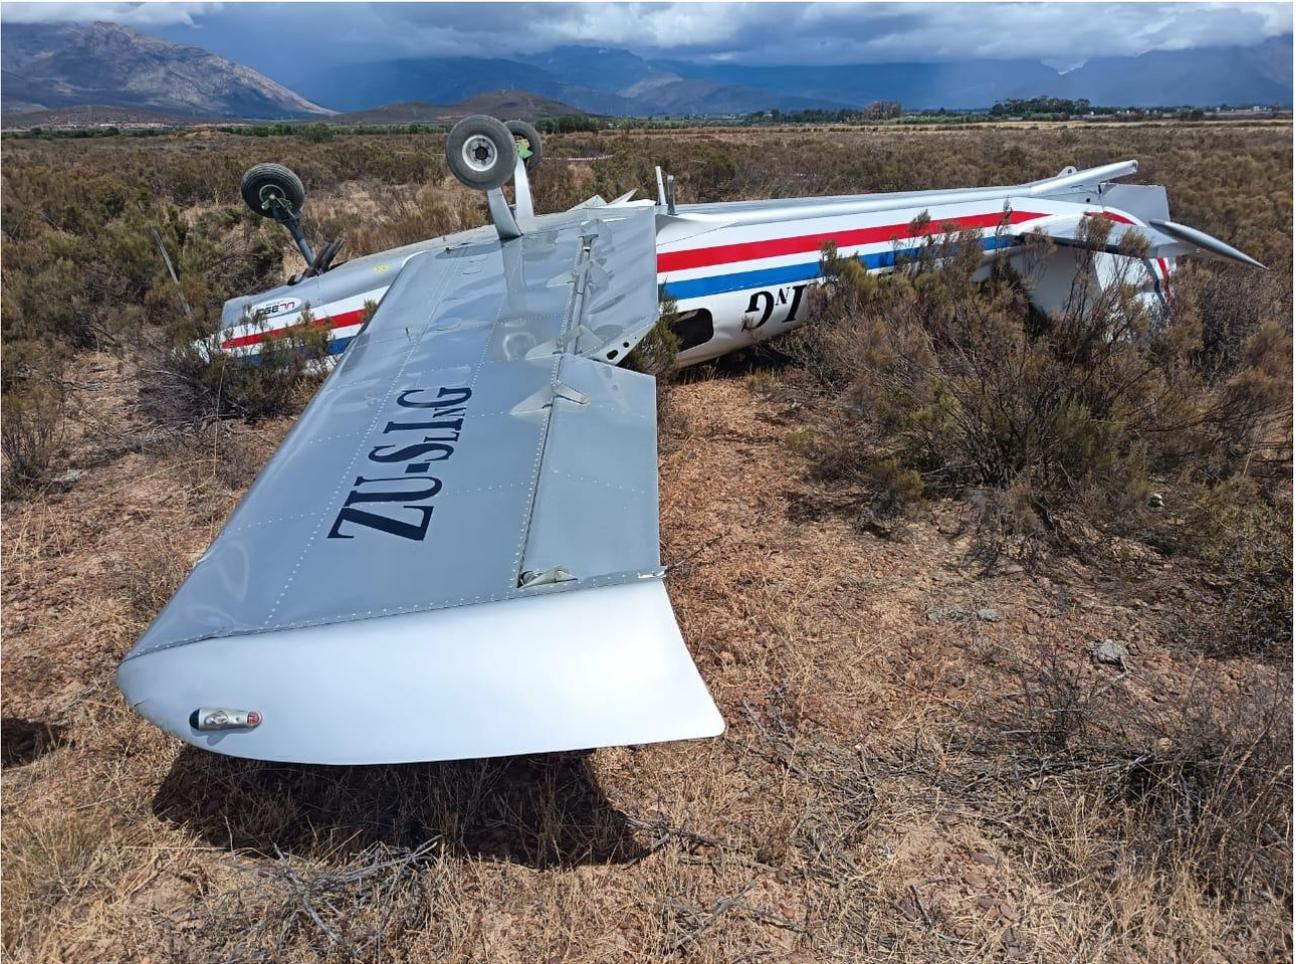
- 1.1.3. During the landing roll, the left wing contacted the ground. The nose gear and the left gear broke off which caused the aircraft to skid before the nose dug into the soft ground. The aircraft came to a sudden stop and rotated vertically on its nose for about 3 seconds before it nosed over; the windshield (canopy) shattered on impact. The aircraft's nose gear, propeller, fuselage, left wing and vertical stabiliser were damaged.

1.12.1. The aircraft nosed over during a forced landing on a bush-type terrain. The windshield shattered and the vertical stabiliser was substantially damaged due to compression forces.

Figure 3: The aircraft as it was found after the accident.

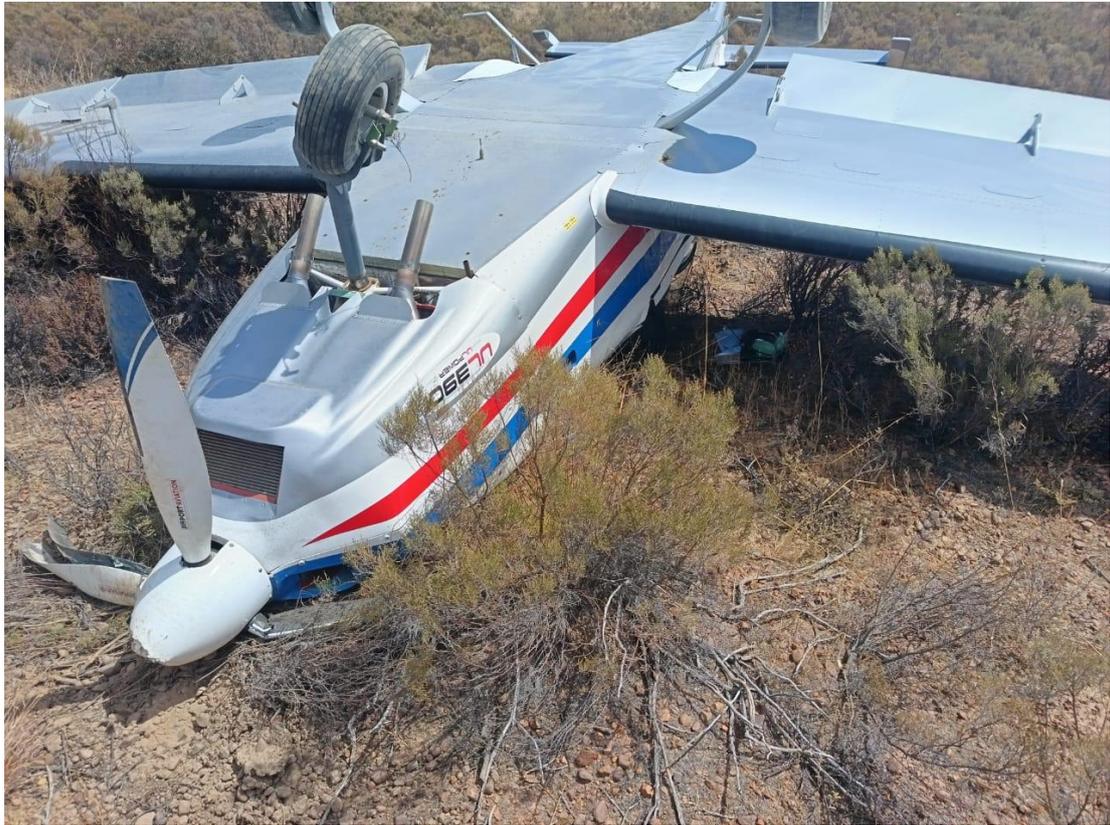
Figure 4: The bent wheel and the broken propeller blade.

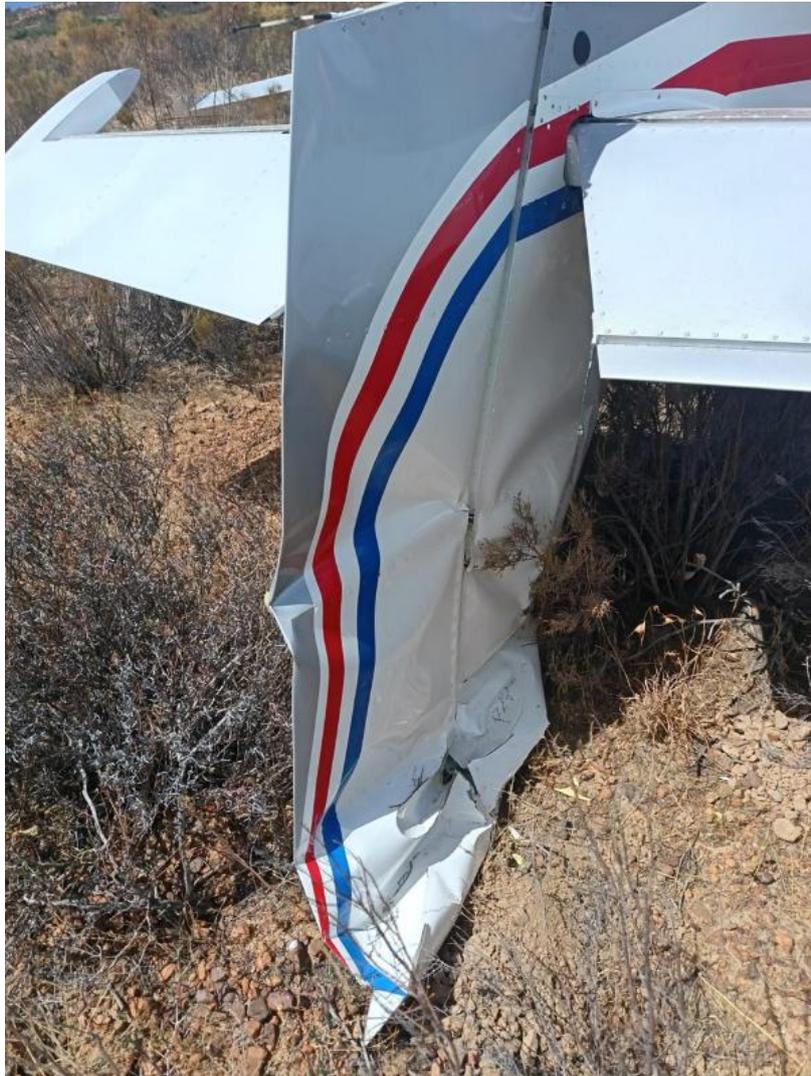
Figure 5: The buckled vertical stabiliser.

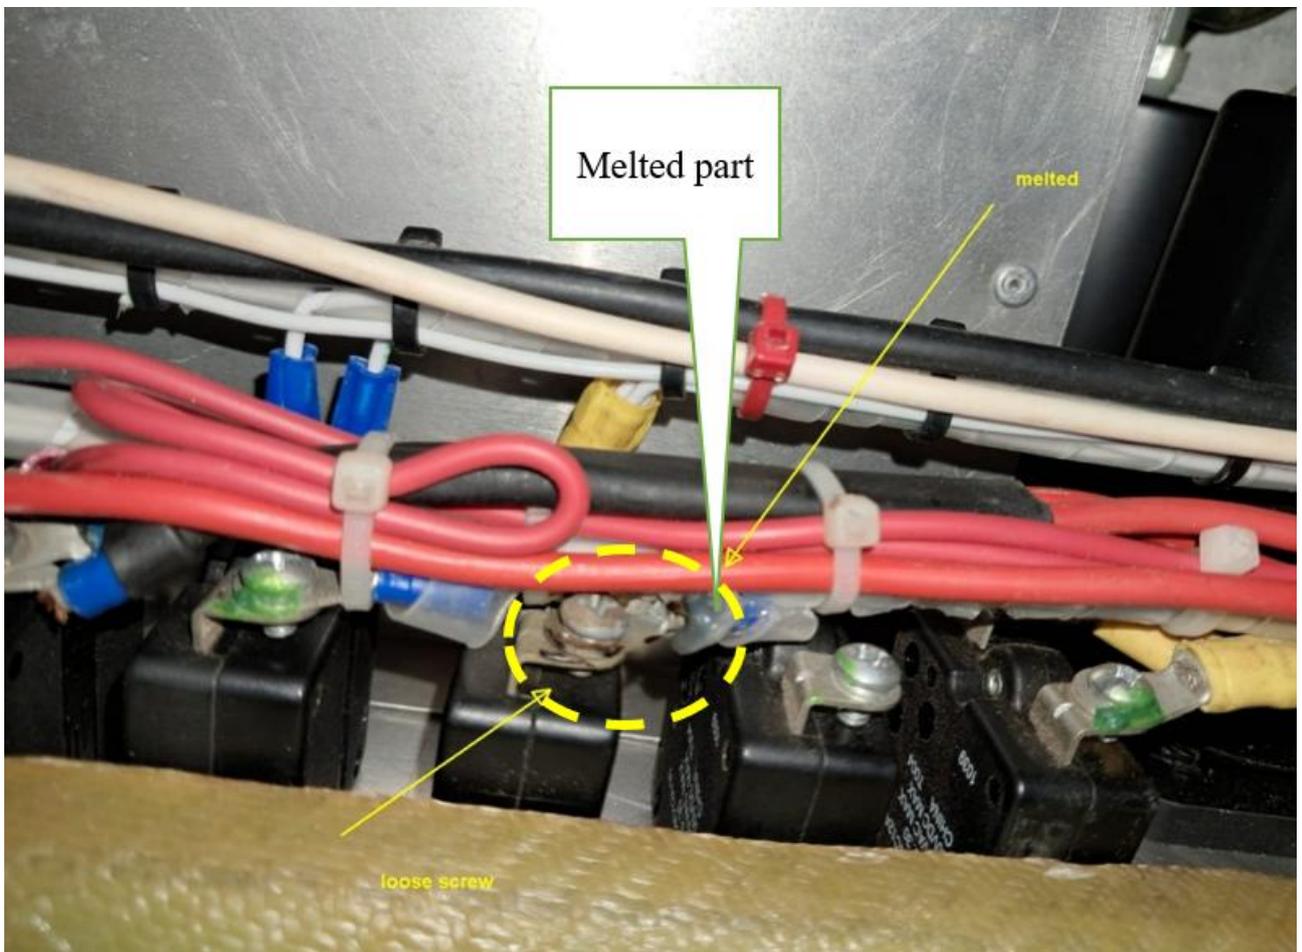
- 1.16.2 The approved person (AP) opened the engine cowlings to inspect the engine compartment; he found that the screw that attaches the electrical wires to the circuit breaker panel was loose and that the wire insulation had melted. The propeller was turned by hand with the intention to remove possible oil on top of the cylinders. The plugs were checked, and no anomalies were found. After the loose screw was tightened, a loaner propeller was fitted to the engine flange to perform a test run. The crankshaft runout was measured and found to be within 0.05mm. The engine ground run was conducted, and it met all parameters as outlined in the aircraft maintenance manual (AMM).

Figure 6: The melted wire and the loose screw.

- 2.2.6. The investigation revealed that the cause of the engine stoppage was attributed to electrical failure which was caused by the circuit breaker that popped due to the short circuit, likely caused by the loose screw that attaches the electrical lug to the circuit breaker.

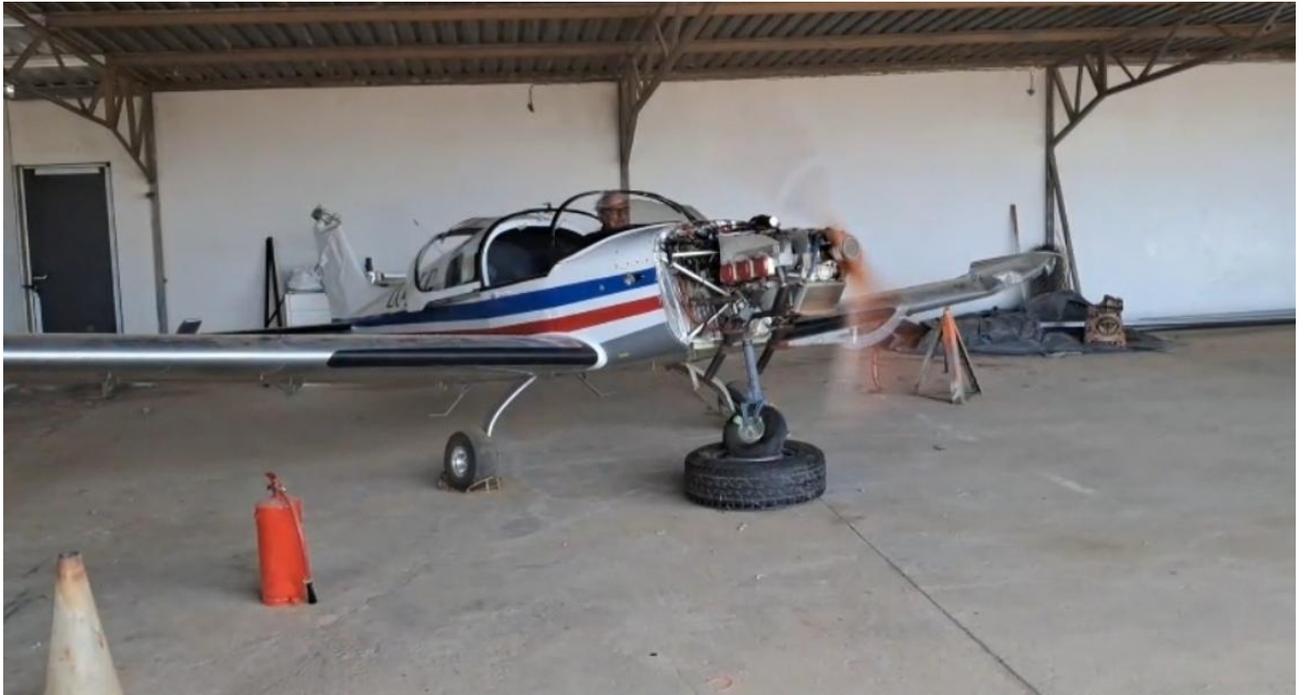
Figure 7: A still video image of the aircraft inside the hangar during engine run.

3.2.7. The engine ran without any anomalies after it was tested post-accident.
