LIMITED OCCURRENCE INVESTIGATION REPORT – FINAL

Reference Number	CA18/2/3/10557						
Classification	Accident	Date	1 March 2025		Time	0830Z	
Type of Operation	Private (Part 94)						
Location							
Place of Departure	Howick Aerodrome (FAHC), KwaZulu-Natal Province		Place of Intended Landing		Howick Aerodrome (FAHC), KwaZulu-Natal Province		
Place of Occurrence	On a maize field, 1.4 nautical miles (nm) east of Howick Aerodrome (FAHC)						
GPS Co-ordinates	Latitude	29°33'05.58" S	Longitude	030°14'12.24" E	Elevation	3 650 feet	
Aircraft Information							
Registration	ZU-WAG						
Make; Model; S/N	Kitplanes for Africa (KFA); Explorer (Serial Number: 164-12-13)						
Damage to Aircraft	Substantial		Total Aircraft Hours		351.5		
Pilot-in-command							
Licence Type	National Pilot Licence		Gender	Male		Age	48
Licence Valid	Yes	Total Hours	311.7		Total Hours on Type	286.6	
Total Hours Past 30 Days	3.1		Total Hours on Type Past 90 Days		20.8		
People On-board	1 + 0	Injuries	0	Fatalities	0	Other (on ground)	0

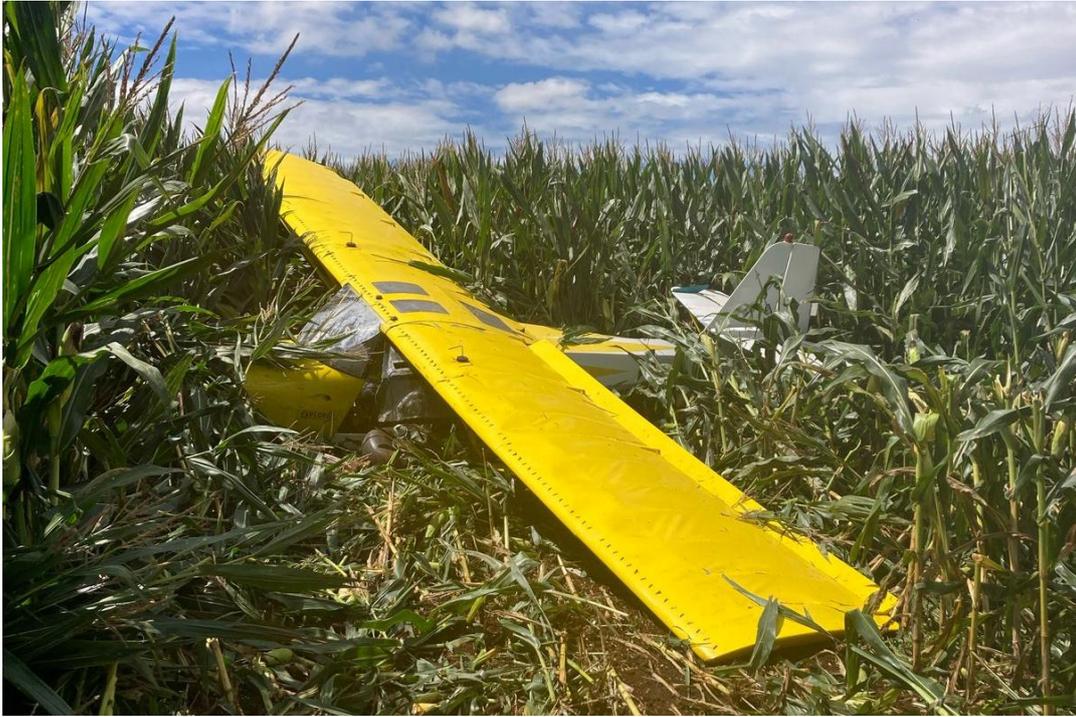
The aircraft sustained substantial damage; the pilot was not injured.

Figure 4: The aircraft as it came to rest in a maize field. (Source: Pilot)

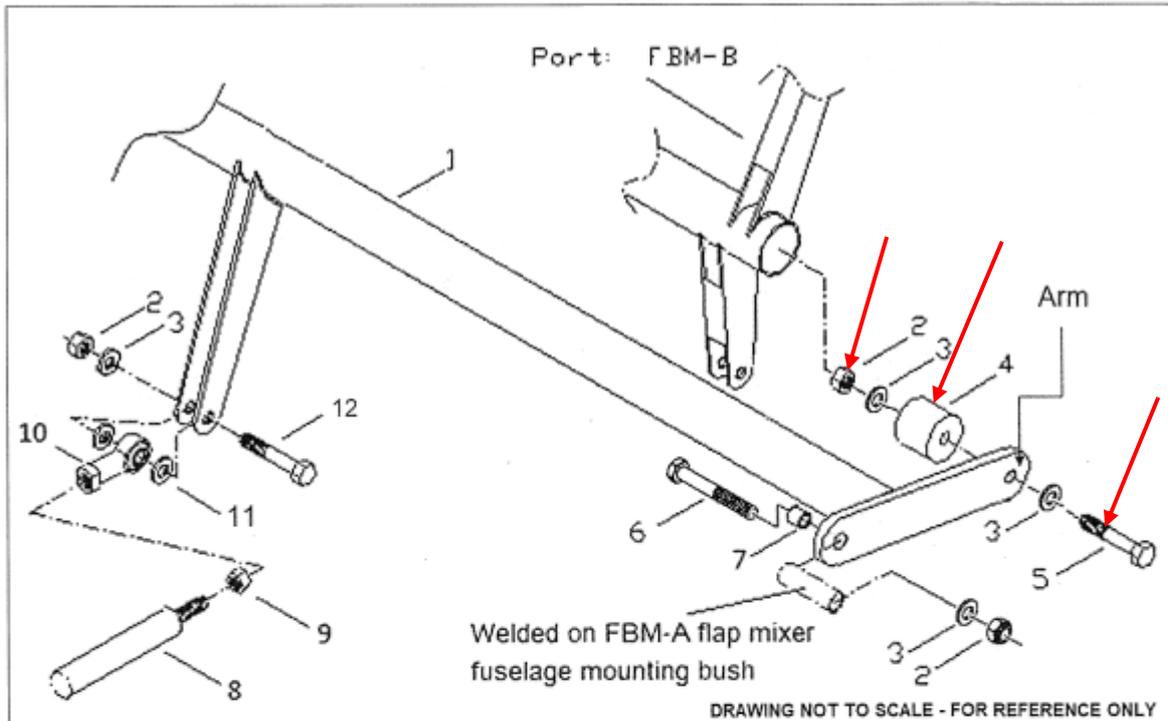
Diagram 2: The aileron/flap mixer assembly. (Source: Fuselage Assembly Manual)

The bolt (item 5) became dislodged from the bush (item 4).

There was no evidence of a self-locking nut (item 2) fitted to either side of the bushes as illustrated.

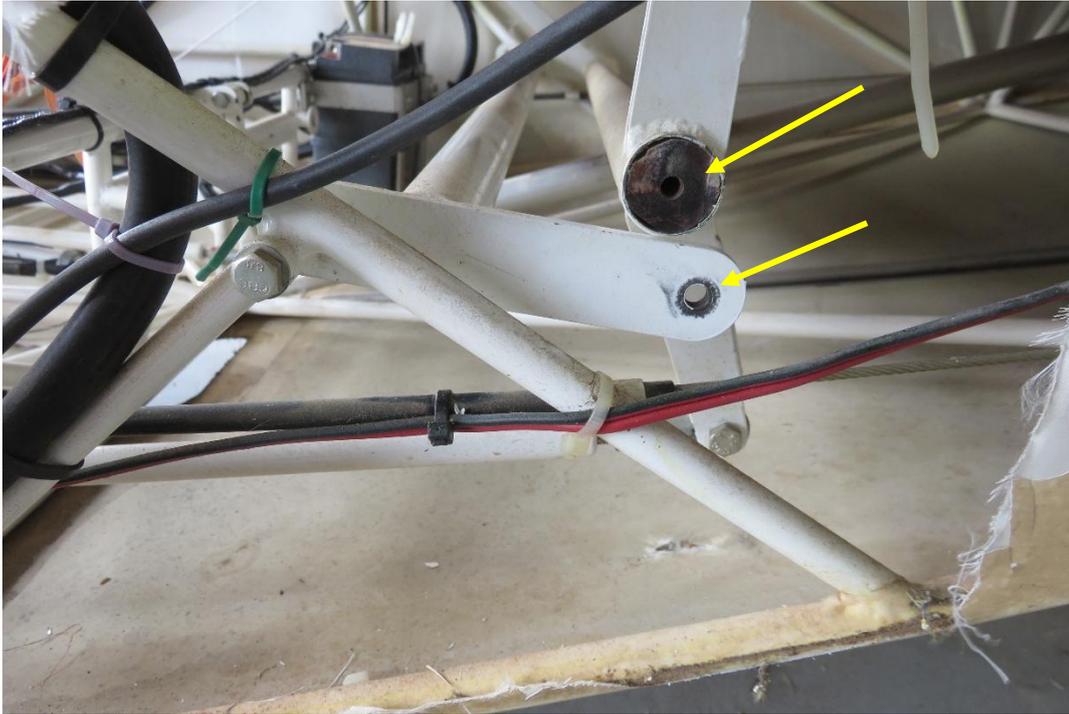
Figure 5: The fabric was cut to access the mixer assembly on the left side. The yellow arrows indicate the missing bolt.

The bolts (M6 x 20) were used on either side of the mixer as indicated in Diagram 2 (item 5). The bolt that became dislodged was found lying on the fabric on the belly of the aircraft. These bolts were of substandard length as the construction manual required M6 x 35 bolts to be fitted with a self-locking nut at each end.

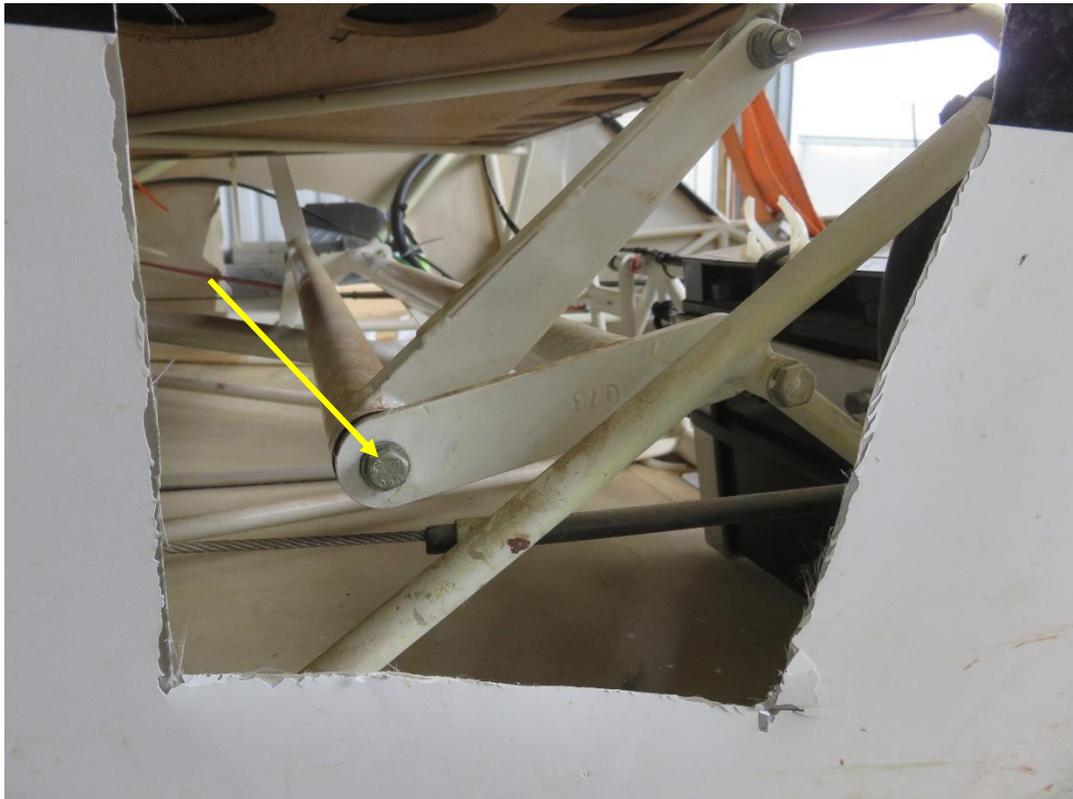
Figure 6: The fabric was cut to access the mixer assembly on the right side. The bolt was still in position.

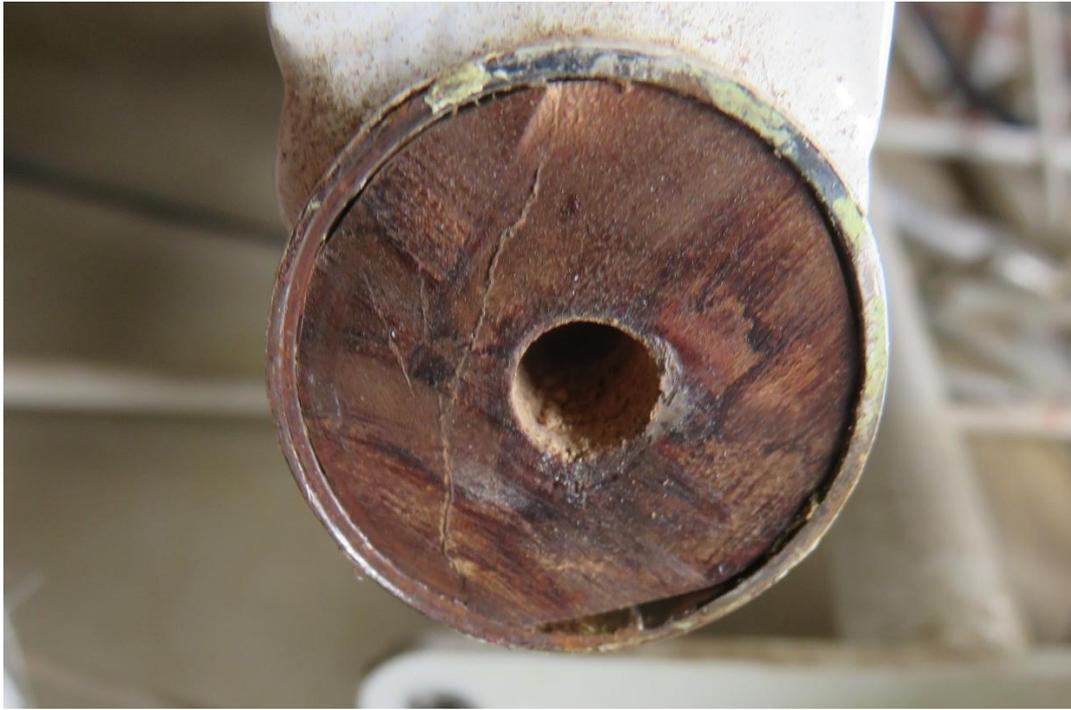
Figure 7: The bush that was installed in the aileron/flap mixer assembly was manufactured from wood, which was in contradiction to the aircraft's Fuselage Assembly Manual guidelines.

- 2.7 The owner/pilot at the time of the accident flight was unaware that the aileron/flap mixer assembly was fitted with wooden bushes as it was found during the post-accident investigation. This was a fundamental deviation from the fuselage assembly manual on the mixer assembly.

- 2.8 It could not be determined who had installed the wooden bushes as some of the people who have worked on the aircraft had passed away prior to this accident.

It is recommended that the Director for Civil Aviation issue an urgent safety notice/directive to inform all owners and prospective owners of this aircraft type to not deviate from the Fuselage Assembly Manual when building the aircraft in their private capacity (from a kit) as it might result in loss of aileron and flap control in-flight.

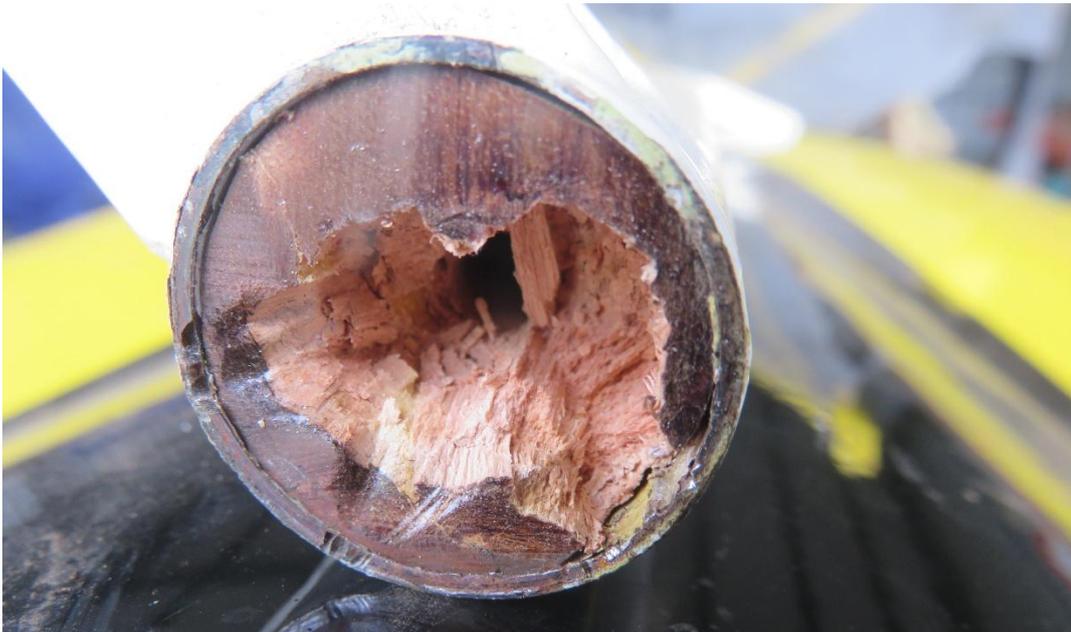
Figure 8: A piece of the structure was penetrated to confirm the bushes were made from wood.

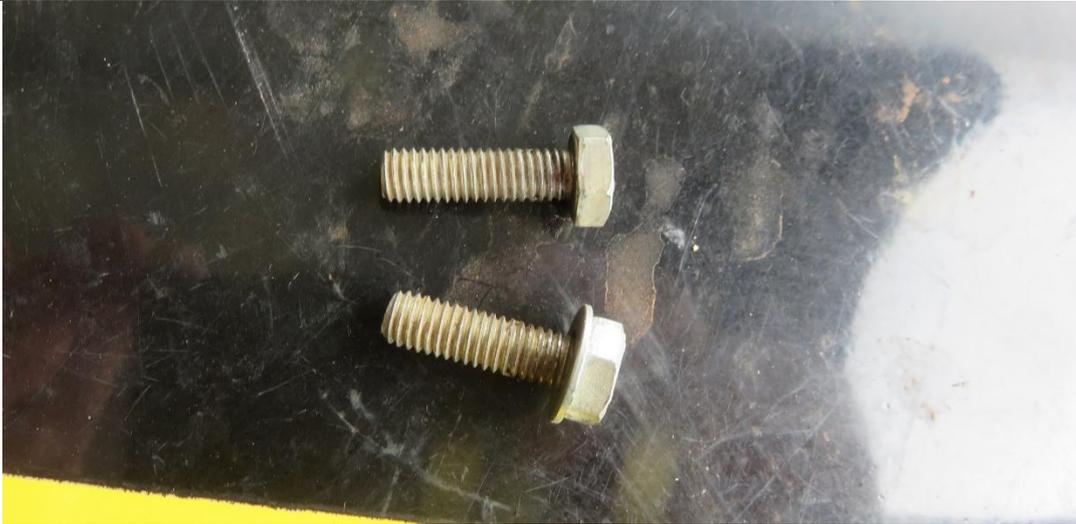
Figure 9: The two bolts (M6 x 20) that were used on either side of the mixer.

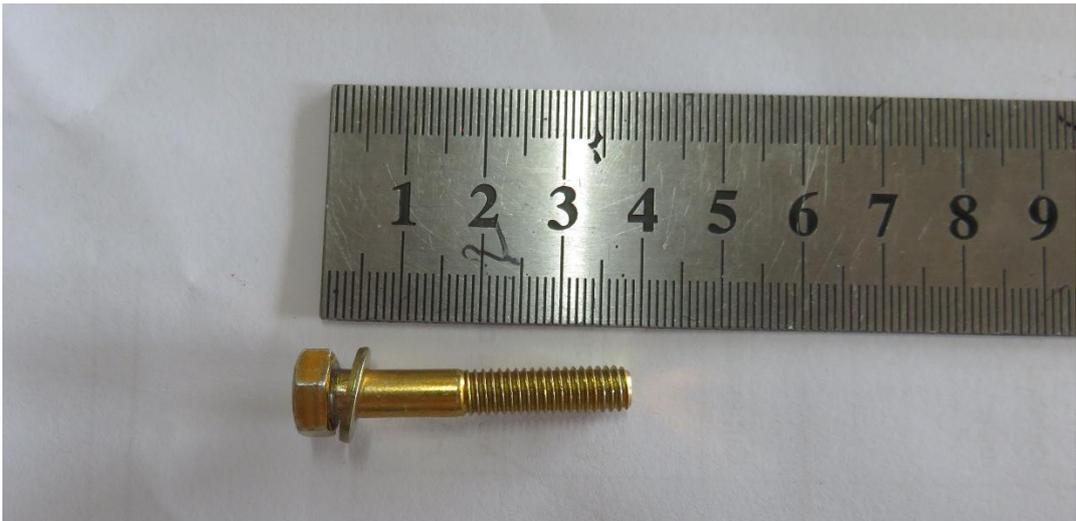
Figure 10: An example of the bolt (M6 x 35) that should have been used.

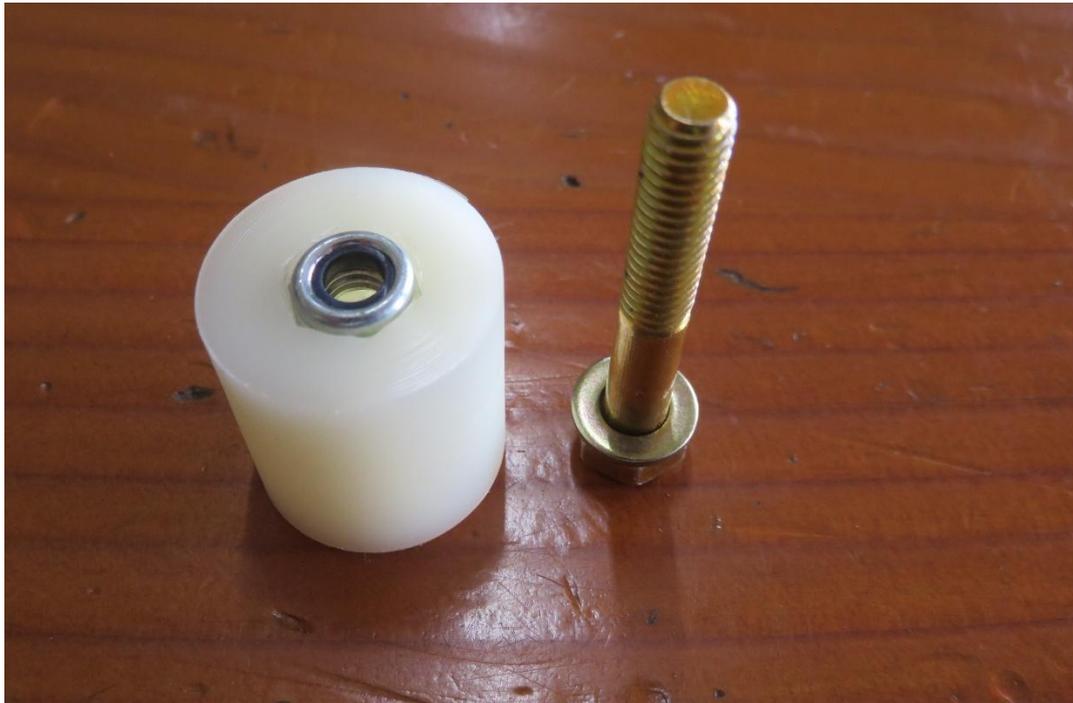
Figure 11: The nylon 'bearing' (Diagram 2, item 4) with the self-locking nut secured as part of it.
