**LIMITED OCCURRENCE INVESTIGATION REPORT – DRAFT**

| <b>Reference Number</b> | CA18/2/3/10558 | | | | | | |
| <b>Registration</b> | ZU-EOA | | | | | | |
| <b>Make; Model; S/N</b> | Storm RG (Serial Number: S8-00E-0026) | | | | | | |

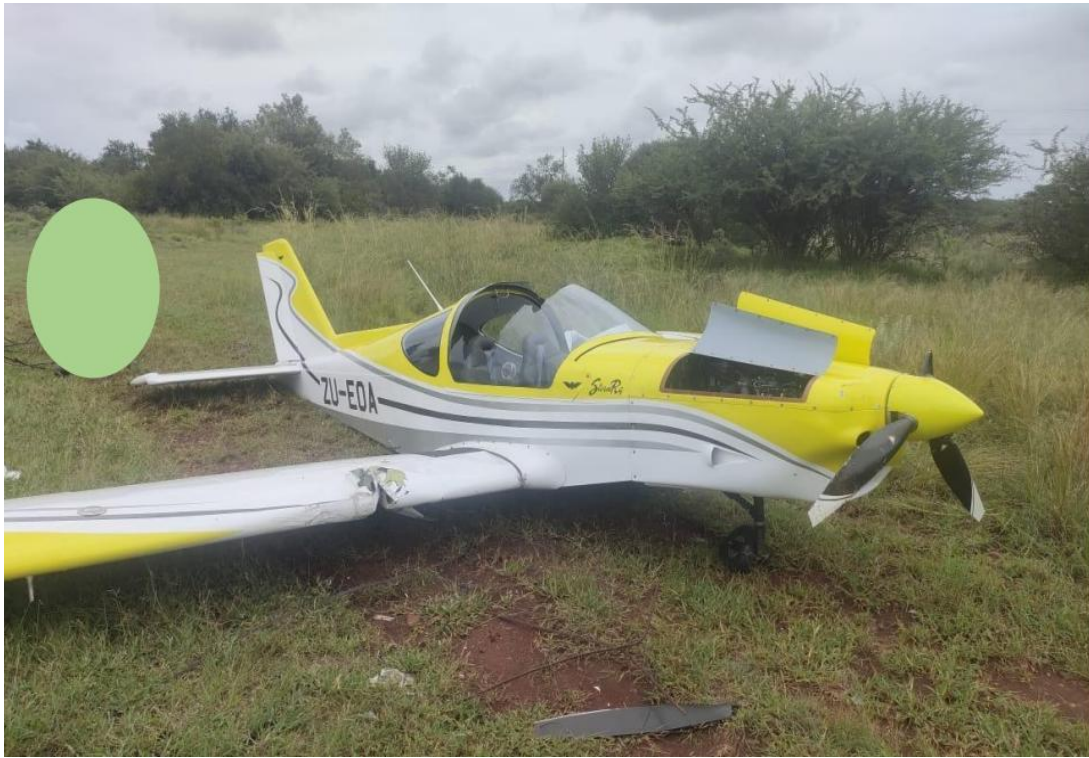
Thereafter, the engine stopped. The pilot attempted to restart the engine but was unsuccessful. He then decided to perform a forced landing on Vaalfontein Road (R33) in Mpumalanga province. During the landing roll, the pilot lost control of the aircraft and it veered off to the left of R33 and impacted a perimeter fence. The aircraft came to rest approximately 5 nautical miles (nm) south-east of Marble Hall. The pilot disembarked from the aircraft; he was not injured. However, the aircraft sustained substantial damage to the landing gear, propeller, both wings (right and left), canopy and engine (which was significantly damaged).

**Figure 2:** The aircraft as it came to rest. (Source: Pilot)

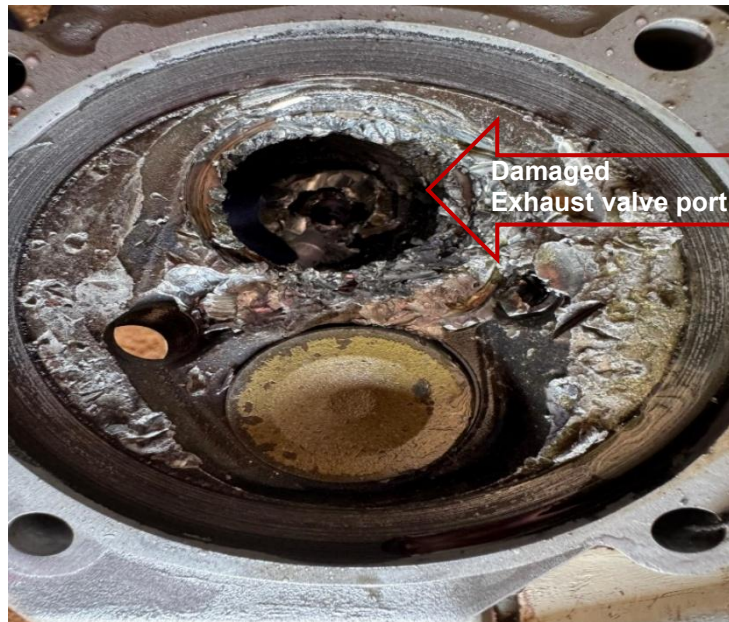
On 9 March 2025, the engine was disassembled and inspected by an Approved Person (AP). During the disassembly process, it was observed that the exhaust valve port of cylinder number 2 had sustained significant damage (refer to Figure 3).

Subsequent detailed inspection and analysis revealed that the valve spring retainer (item 8, Figure 4) had fractured. *The exhaust valve spring retainer plays a critical role in securing both the exhaust valve (item 4, Figure 4) and ensuring proper alignment of the piston assembly (Item 8, Figure 5) during engine operation.* The failure of this component allowed the exhaust valve assembly to lose structural integrity. As a result of the retainer's failure, the piston assembly was displaced from its normal position and forced into the combustion chamber. This mechanical disruption led to abnormal combustion behaviour which contributed to the engine running rough and emitting smoke.

The mechanical failure propagated secondary internal engine damage which resulted in a significant loss of engine power.

**Figure 3:** Number 2-cylinder exhaust valve port. (Source: Engineer)

Engine stoppage in-flight followed by an unsuccessful forced landing on the road. The engine stoppage was a result of a fractured exhaust valve retainer spring which led to the loss of structural integrity of the valve and piston assembly.

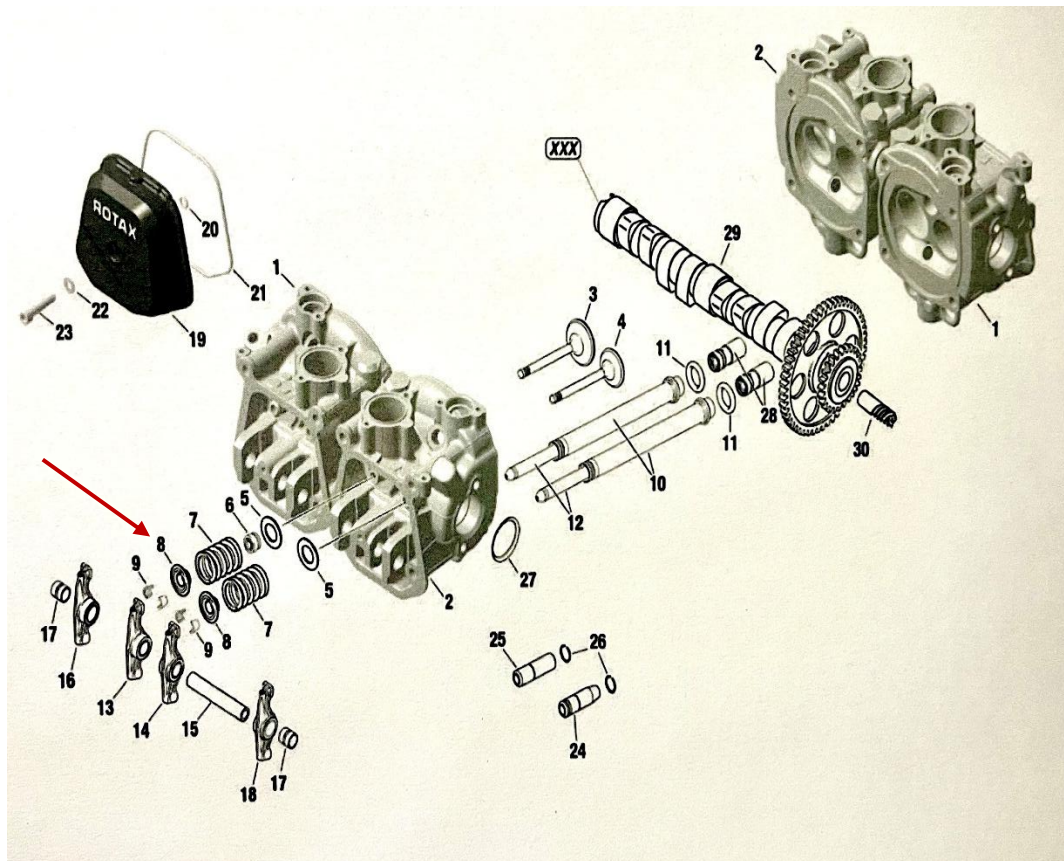
**Figure 4:** Engine cylinder head and valve components. (Source: Rotax 914 Illustrated Parts Catalogue, Chapter 72-20-00)

- 2.4. The aircraft's Certificate of Registration (C of R) was issued to the present owner on 18 November 2022.
- 2.5. The exhaust valve spring retainer fractured and compromised the positioning and control of the exhaust valve. The valve and piston assembly were no longer retained in their proper positions which resulted in mechanical interference in the engine. The mechanical disruption caused the loss of engine power and the subsequent stoppage during operation.

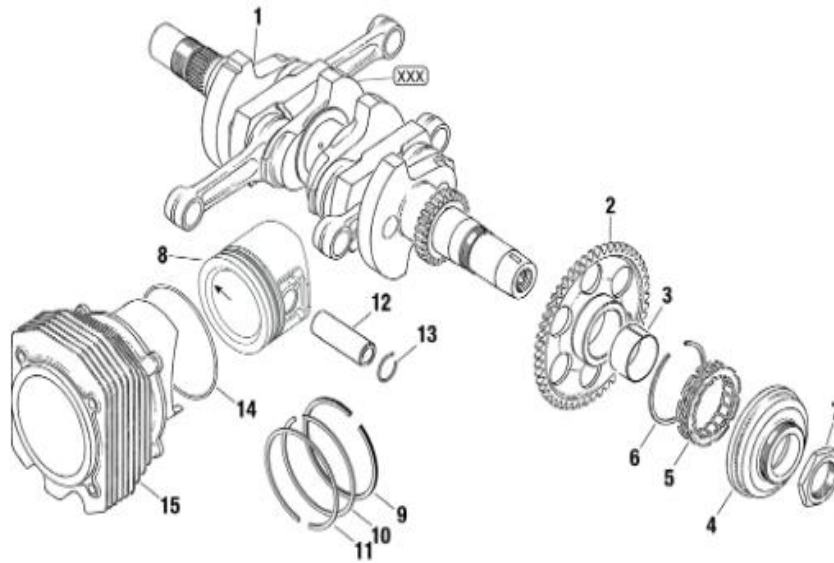
**Figure 5:** Engine crankshaft, piston, cylinder and spag clutch components. (Source: Rotax 914 Illustrated Parts Catalogue, Chapter 72-20-00)
