**LIMITED OCCURRENCE INVESTIGATION REPORT – FINAL**

| <b>Reference Number</b> | CA18/2/3/10561 | | | | | | |
| <b>Registration</b> | ZS-MOZ | | | | | | |
| <b>Make; Model; S/N</b> | Air-Tractor; AT-502B (Serial Number: 502-0212) | | | | | | |

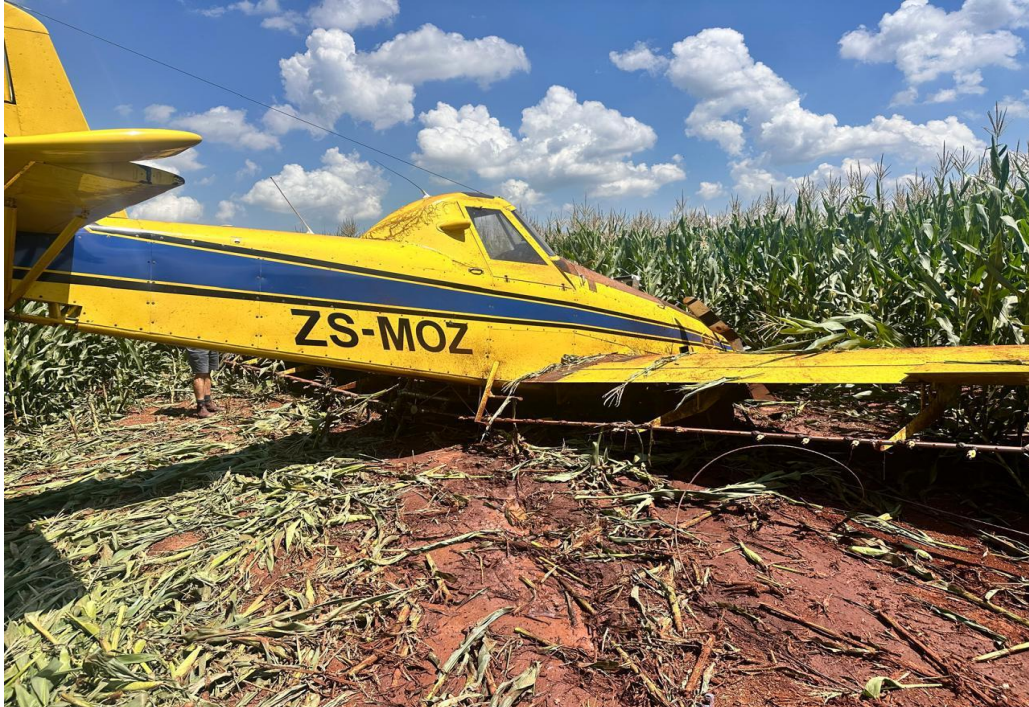
| <p>On Monday morning, 10 March 2025 at 0905Z, a pilot on-board an Air Tractor AT-502B aircraft with registration ZS-MOZ was engaged in a crop-spraying operation (aerial application) at a private farm near Ventersdorp in North West province when the accident occurred. The flight was conducted under visual meteorological conditions (VMC) by day and under the provisions of Part 137 of the Civil Aviation Regulations (CAR) 2011 as amended.</p> <p>According to the pilot, he took off from a private farm near Ventersdorp to another private farm situated 8 kilometres (km) north-east of Ventersdorp to conduct a crop-spraying operation; his ground crew was stationed in the designated landing zone near the same maize field to be sprayed. This was the pilot's first operation on the farm; the farm owner was a new client. The pilot stated that he familiarised himself with the area on the same morning (10 March 2025) using a ground vehicle and escorted by the farm's foreman who showed him all the fields to be sprayed as well as highlighted obstacles in the area, including electrical powerlines. After he had familiarised himself with the area, he conducted a pre-flight inspection of the aircraft and found no anomalies. The aircraft had approximately 500 US gallons of insecticide in the hopper. At approximately 0850Z, the aircraft took off and headed to the maize field that needed spraying; he completed three uneventful spray runs. As he positioned the aircraft for the fourth chemical application run, the aircraft impacted the high-voltage powerlines on his flight path. The powerlines snapped and entangled the aircraft which landed hard on the field. Third-party damage was caused to the maize crops. The aircraft sustained substantial damage. The pilot was not injured; he vacated the aircraft unassisted.</p> | | | | | | | |

**Figure 1:** The aircraft as it came to rest after the accident. (Source: Pilot)

8. Clear weather conditions prevailed at the time of the flight. The low cloud-cover reduced visibility and casted a shadow over the powerlines which made it difficult for the pilot to identify obstacles well in advance. The accident may have been avoided had the powerlines been properly marked with high-visibility indicators.
9. The pilot was engaged in a crop-spraying operation in the area for the first time, he conducted a ground survey of the site before commencing with the crop-spraying operation. Therefore, he was aware of the high-tension powerlines. However, during repositioning of the aircraft for a fourth spray run, he lost situational awareness due to the low cloud which casted a shadow on the powerlines; the aircraft impacted the powerlines and lost forward momentum, thus, the subsequent hard landing on the maize field.

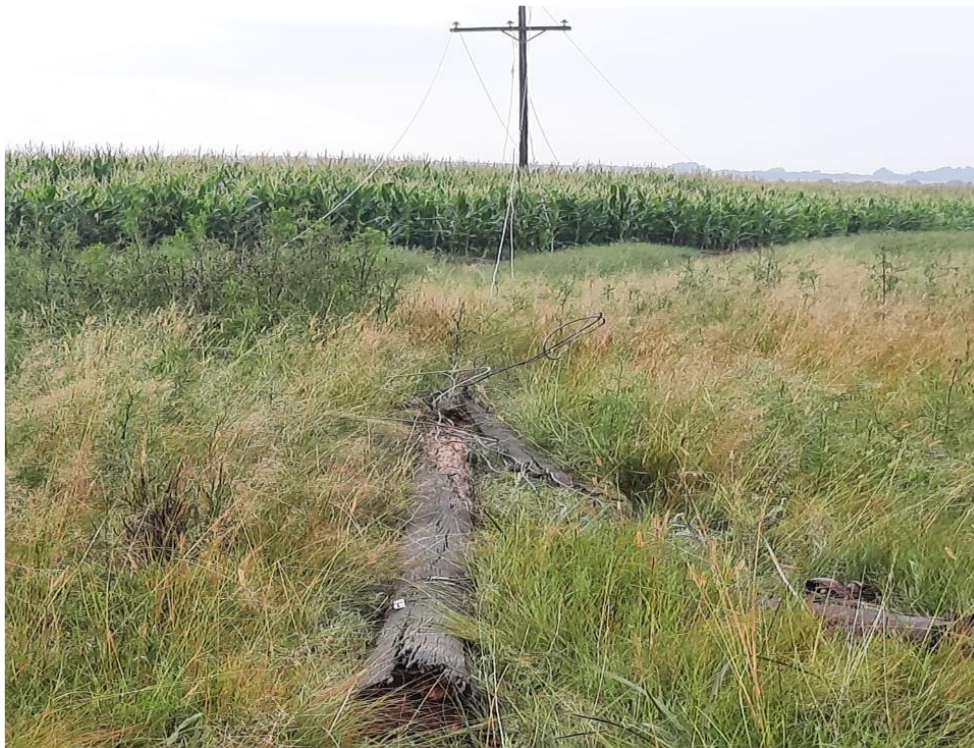
During the interview, the pilot stated that he was aware of the location of the powerlines; however, his vision was compromised by the shadow of the cloud at the time, and the aircraft impacted the powerlines.

**Figure 2:** A damaged pole that secured the powerlines after the accident. (Source: Pilot)

To reduce the risk of obstacle-related accidents during crop-spraying operations, hazards such as powerlines should be physically marked with high-visibility devices. Site familiarisation should include aerial reconnaissance where safe, supported by detailed obstacle briefings with diagrams, GPS data and photos. The use of GPS-based guidance systems is recommended to enhance situational awareness. Pilots should receive training for visually deceptive conditions, and operators should conduct standard risk assessments for new sites. Pre-flight crew briefings, including obstacle walkarounds with local ground personnel, are essential for safe operations.
