**LIMITED OCCURRENCE INVESTIGATION REPORT – FINAL**

| <b>Reference Number</b> | CA18/2/3/10562 | | | | | | |
| <b>Registration</b> | ZS-SNR | | | | | | |
| <b>Make; Model; S/N</b> | Piper Seneca II; PA-34-200T (Serial Number: 34-7970428) | | | | | | |

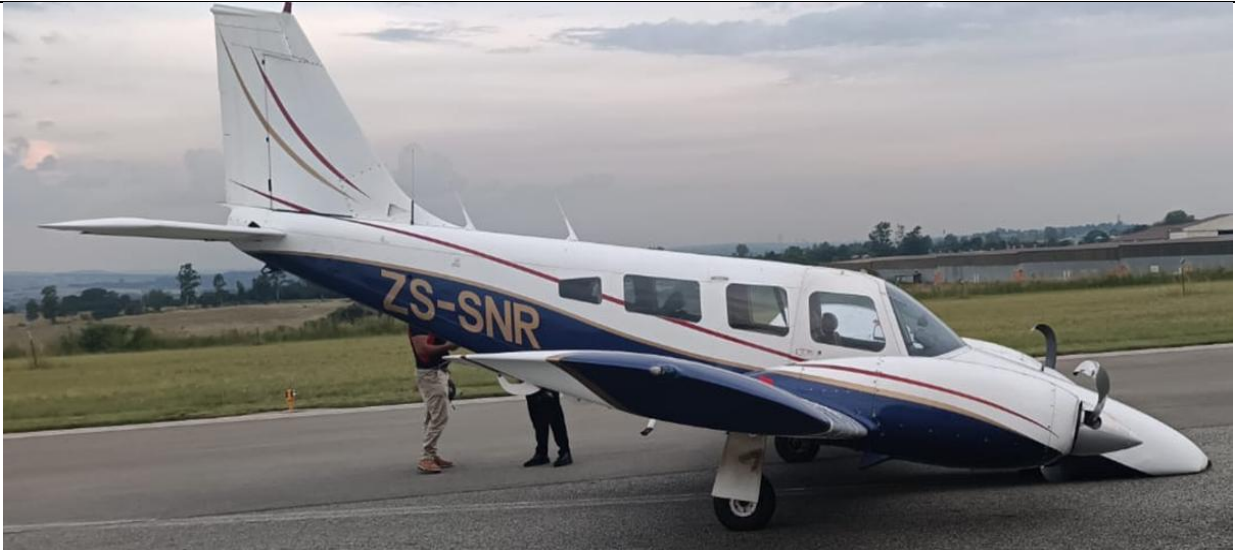
The FI reported that during the downwind leg, they completed the pre-landing checks and confirmed the illuminated three green lights on the instrument panel, which indicated that all landing gears were extended and locked to position. The first stage flaps were selected and the aircraft was correctly configured for landing. On final approach for Runway 25, the aircraft was approximately 400ft AGL with 80 knots (kts) indicated airspeed (KIAS). The pilot continued the approach to land and entered the landing flare, the main landing gear wheels touched down first, followed by the nose landing gear wheel which collapsed during the landing roll. Subsequently, the propellers struck the runway and the aircraft skidded on its nose cone. The aircraft came to a stop on the runway, approximately 100 metres (m) from the initial touchdown point.

**Figure 2:** The aircraft at the accident site. (Source: Pilot)

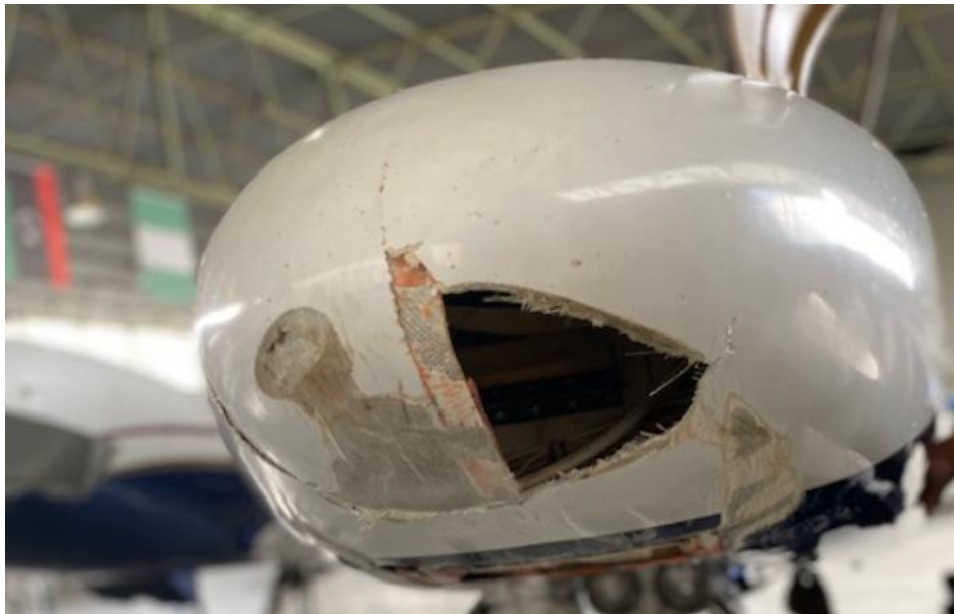
The aircraft sustained substantial damage to the nose cone and propeller blades. The FI and the pilot were not injured.

**Figure 3:** The damaged nose cone. (Source: Pilot)

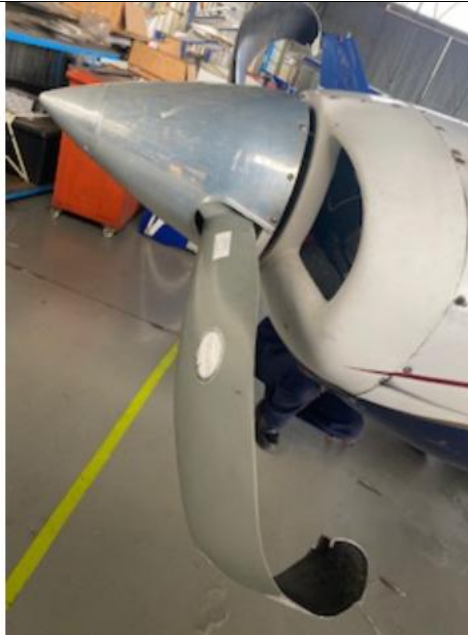
**Figure 4:** The bent propeller blades. (Source: Pilot)

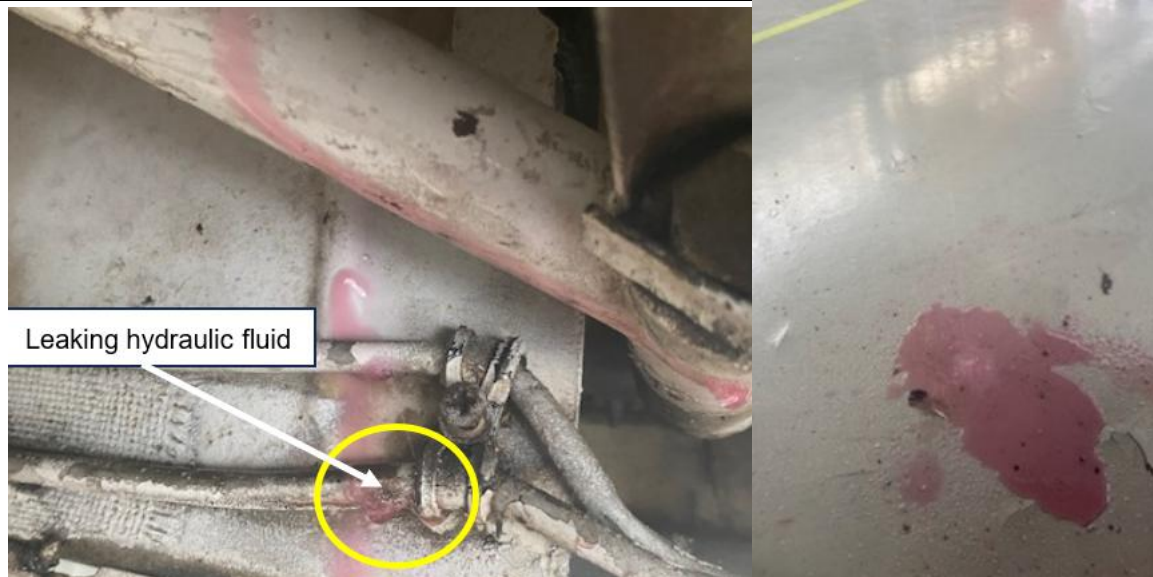
The aircraft was recovered to a SACAA-approved aircraft maintenance organisation (AMO) and was placed on jacks so that gear retraction tests can be conducted. Access panels underneath the nose section were found undamaged; they were removed to gain access to the hydraulic pipes (for the nose landing gear). It was found that the pressurised MIL-H 5606 hydraulic fluid in the hydraulic retraction pipe was leaking. It seemed as though the hydraulic retraction pipe was rubbing against an object, possibly, the clamp that was located nearest to the leak. However, upon inspection, there was no evidence to support the assumption. The hydraulic fluid leak in the hydraulic retraction pipe was concealed by the access panels. The investigation determined that the leak could not have resulted from the impact damage during the accident sequence. The hydraulic pipes for the main landing gears were undamaged; they remained intact with no anomalies observed.

**Figure 5:** The yellow circle indicates a leak on the hydraulic retraction pipe.

A hydraulic retraction pipe for the nose gear with pressurised hydraulic fluid was found leaking. This caused the loss of hydraulic pressure required to keep the nose gear extended and locked to position, and thus, led to the collapse of the nose gear.

| A leak in the pressurised hydraulic retraction pipe led to insufficient pressure to maintain the nose gear extension, resulting in the collapse of the nose gear. |
