<b>AIRCRAFT ACCIDENT REPORT AND EXECUTIVE SUMMARY</b>
---

<b>Reference:</b>		CA18/2/3/10564	
<b>Aircraft Registration</b>	ZS-NJD	<b>Date of Accident</b>	19 March 2025	<b>Time of Accident</b>	1500Z
<b>Type of Aircraft</b>	Piper Aerostar PA-60-600		<b>Type of Operation</b>	Private (Part 91)	
<b>Pilot-in-command Licence Type</b>	Airline Transport Pilot Licence (ATPL)		<b>Age</b>	29	<b>Licence Valid</b> Yes
<b>Pilot-in-command Flying Experience</b>	<b>Total Flying Hours</b>		2116	<b>Hours on Type</b>	234
<b>Last Point of Departure</b>	Bethlehem Aerodrome (FABM), Free State Province				
<b>Next Point of Intended Landing</b>	Wonderboom Aerodrome (FAWB), Gauteng Province				
<b>Damage to Aircraft</b>	Substantial				
<b>Location of the accident site with reference to easily defined geographical points (GPS readings if possible)</b>					
On a private farm, 750m beyond the end of Runway 11 at FABM at GPS co-ordinates: 28°14'56.91"S 028°20'56.81"E, at a field elevation of 5599 feet (ft)

<div style="border: 1px solid red; width: 100px; height: 15px; margin: 5px auto;"></div>	PAGE 2 OF 13	
COMPILED FOR: AAS (Pty) Ltd		DOCUMENT NUMBER FA-014-04-25	
	<b>INVESTIGATION REPORT: AEROSTAR 600A CSU F

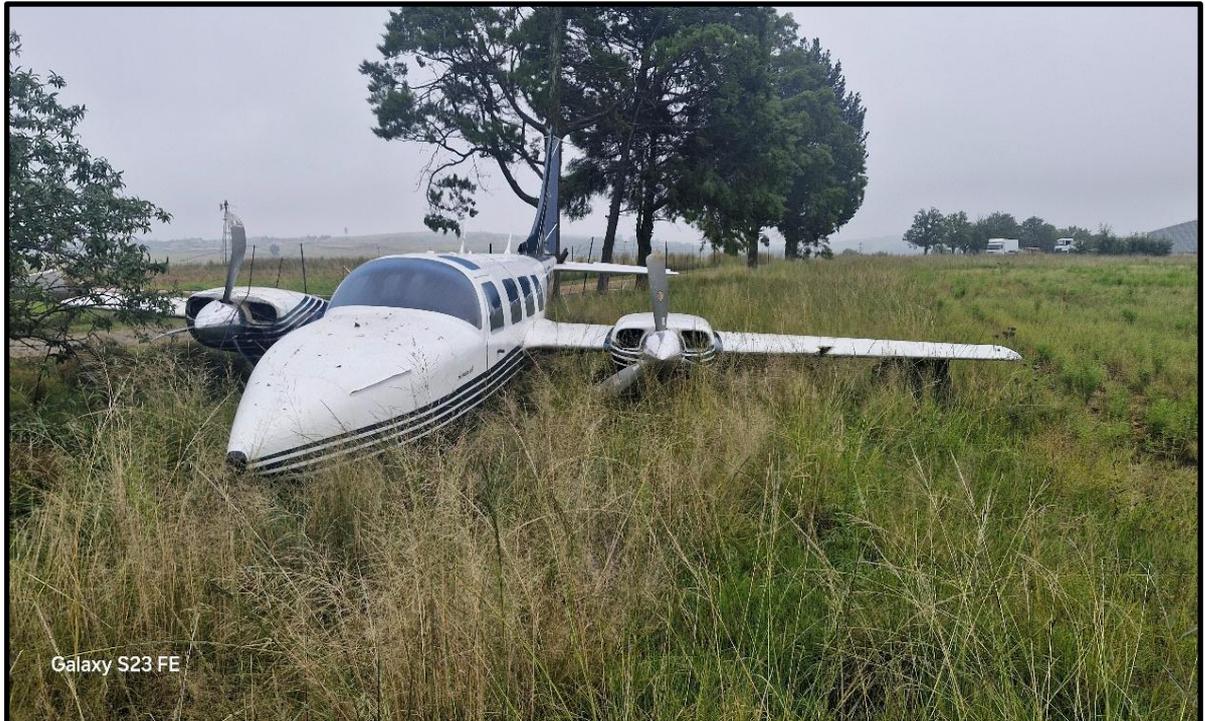
1.3.1 The aircraft sustained damage to the under fuselage (belly), both wings, both engines and both propellers.

**Figure 2:** The aircraft post-accident.

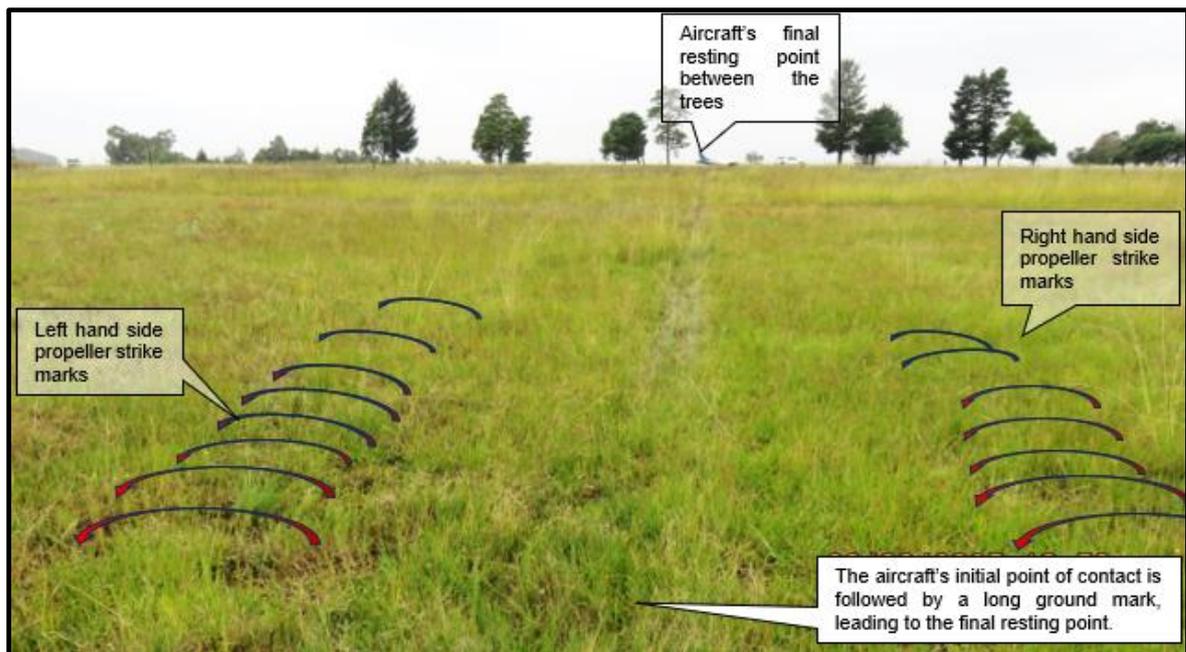
**Figure 9:** The point at which the aircraft initially touched down.

1.12.2. After rotation, the aircraft was unable to gain a positive rate of climb, and the pilot executed a forced landing; the aircraft crashed shortly after clearing the aerodrome parameter fence. The initial impact occurred approximately 500m beyond the end of RWY 11; the aft section of the aircraft struck the ground first, followed by both propellers (the red and blue lines in Figure 9 indicate the propeller strike marks).

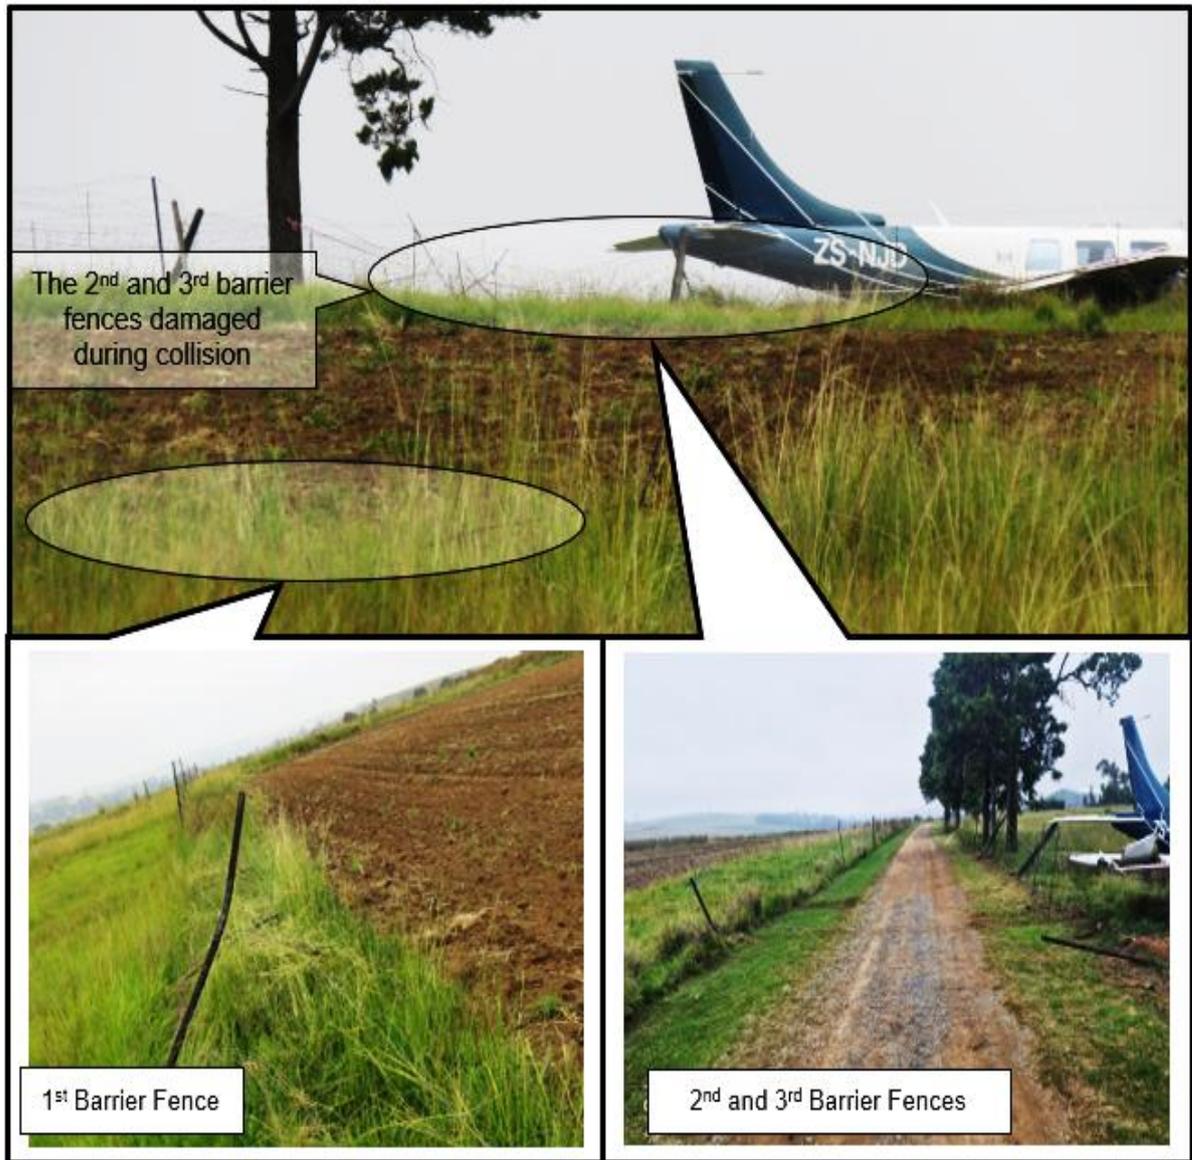
1.12.3. The aircraft skidded on the grass for approximately 42m with the retracted landing gear until it impacted the first barrier fence.

**Figure 10:** The pictures show the damage caused to the barrier fences.

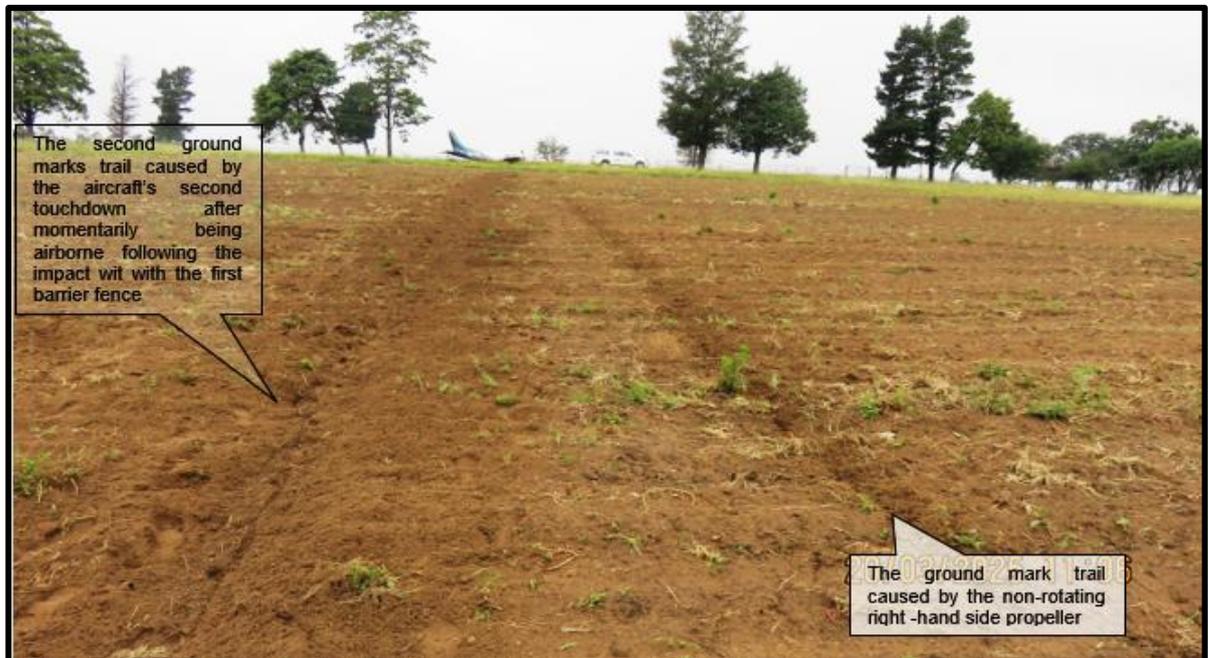
After touching down on the ground for the second time, the aircraft continued to skid; the left propeller left a prominent furrow on the ground, stretching approximately 181m before the aircraft impacted the second and third barrier fences, as well as the tree across the road (the tree was located 12m from the road).

**Figure 12:** Impact marks caused by both the fuselage and the right-side propeller.

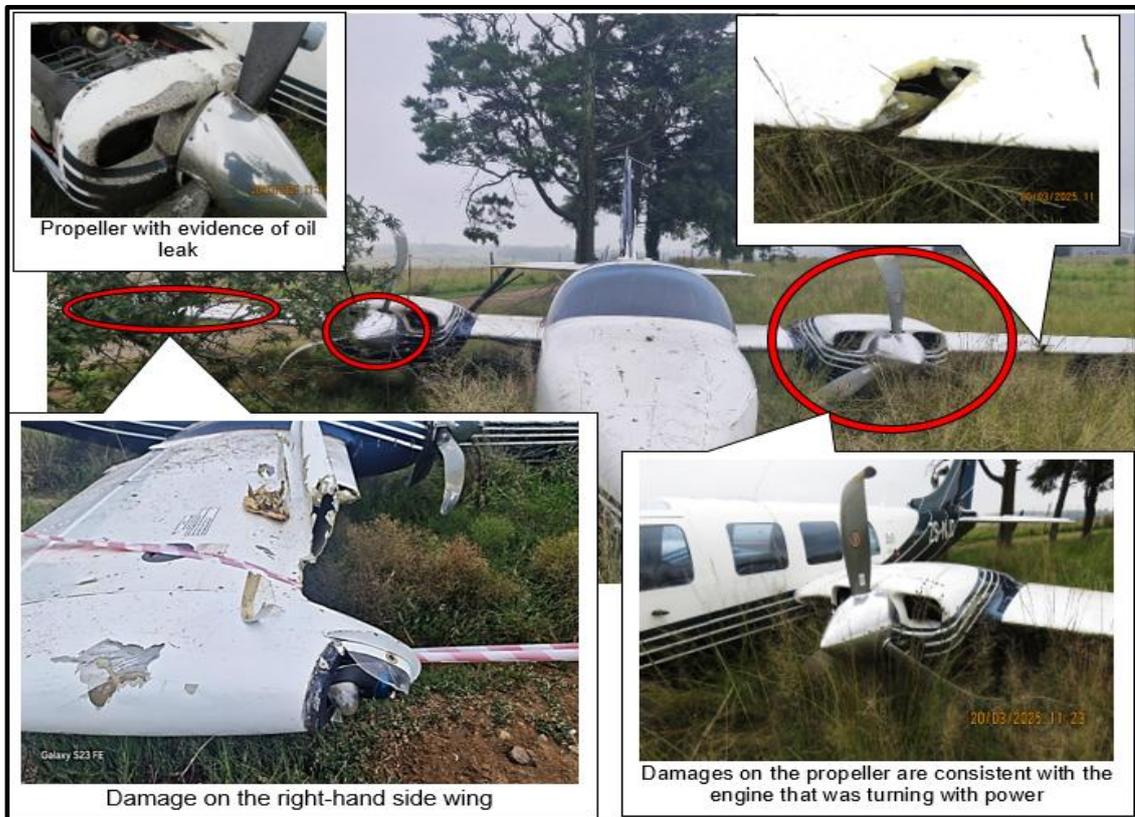
**Figure 14:** Damage on both the left and right sides of the propellers and the wings.

1.12.6. The aircraft structure was fairly intact; both wings and the propeller blade had visible damage.

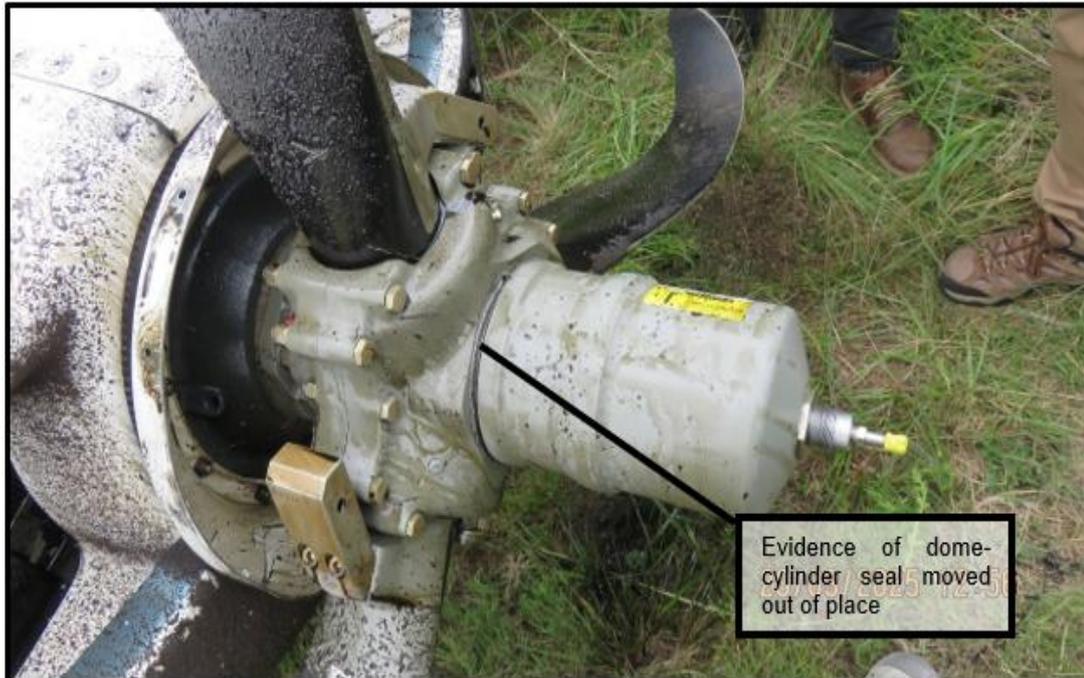
**Figure 15:** The propeller dome-cylinder mounting was found loose and showed evidence of oil leak.

1.12.7. The propeller's variable pitch mechanism housing dome-cylinder was not properly secured when examined. The oil escaped from it and caused a significant oil loss from the engine and propeller.

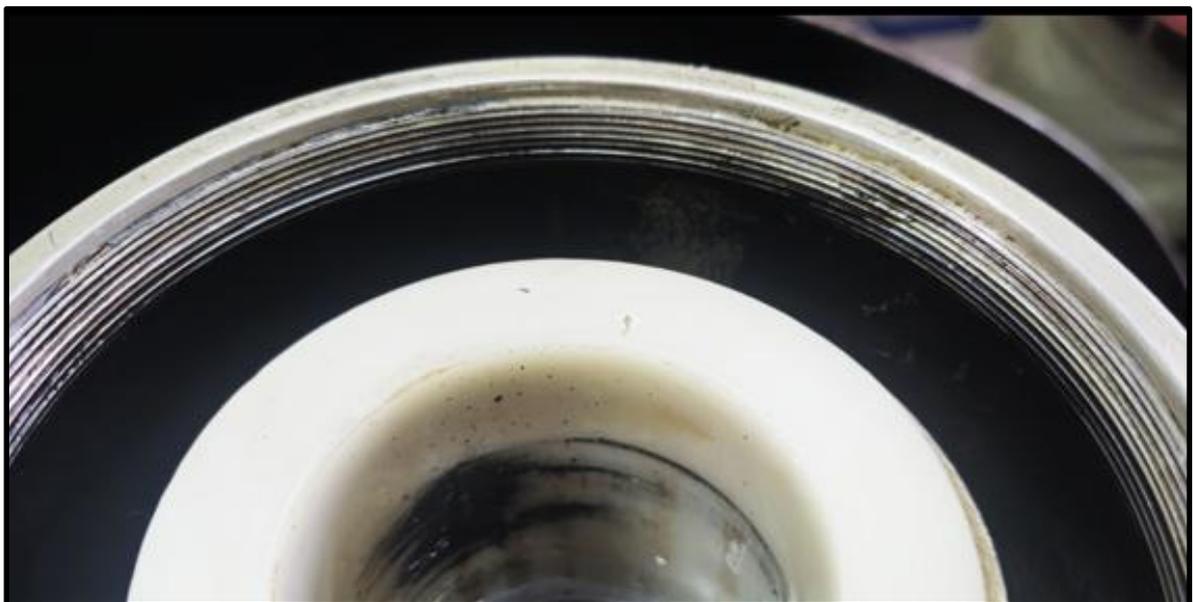
1.16.1. The on-site investigation determined that the propeller fitted to the No.2 (right side) pitch-changing mechanism housing cylinder had detached from its mounting position, which caused oil to leak. The propeller was disassembled at an approved AMO that specialised in propellers on 26 March 2025. Upon inspection, the ON switch screwing threads were found damaged (See Figure 17). A metallurgical analysis was commissioned to establish the root cause of the failure. The report is attached as Appendix A.

**Figure 17:** The damaged front threads of the dome-cylinder.

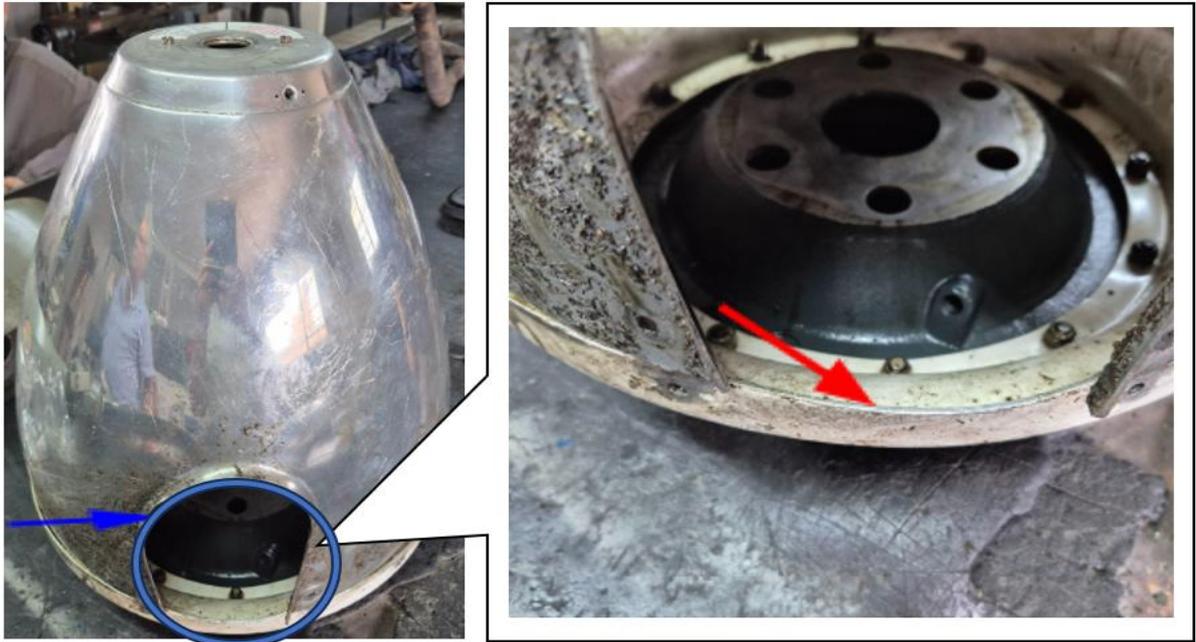
**Figure 19:** The propeller spinner condition and damage (Photo 4).

Damage to the Spinner Bulkhead (Figure 19, red arrow; Diagram 1) support the separation of the Cylinder from the Hub, allowing the Spinner Dome to move forward. Other noted damage to the Spinner Dome (blue arrow) can be attributed to the impact sequence. Damage at the propeller Blade and Fork interfaces (Figure 20; (Photo 5), red arrow) could be attributed to the forced blade pitch change during the impact sequence. No other damage that was not related to the impact sequence was noted.

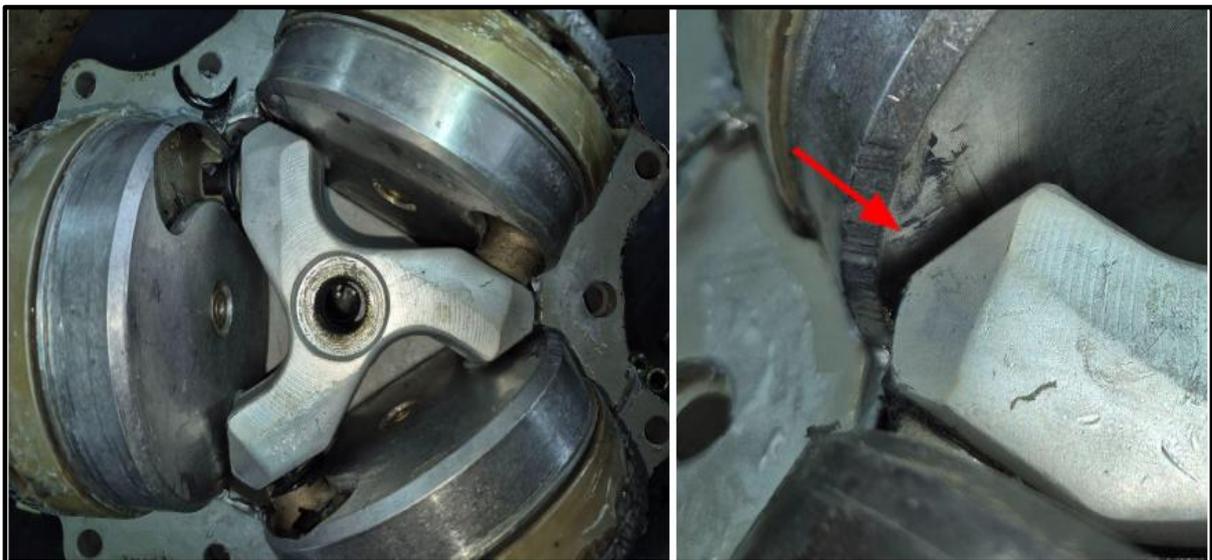
**Figure 20:** The propeller hub's internal condition and impact marks (Photo 5).

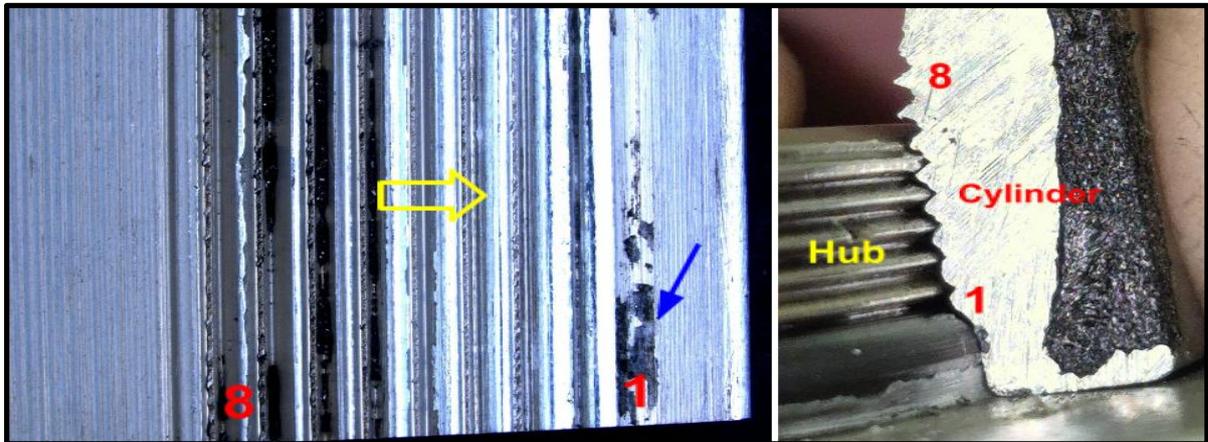
**Figure 21:** Cylinder threads condition. (Photo 6: stereo/digital)

*The Cylinder thread count is 8. However, only 5/6 out of 8 threads are exposed to the applied torque (Figure 21 or photo 6). The direction of the applied torque force onto the threads is towards the bottom (Figures 21, 22 and 23 or Photos 6, 7, and 8, yellow arrows). Remnants of an applied sealant were noted (Photo 6, blue arrow).*

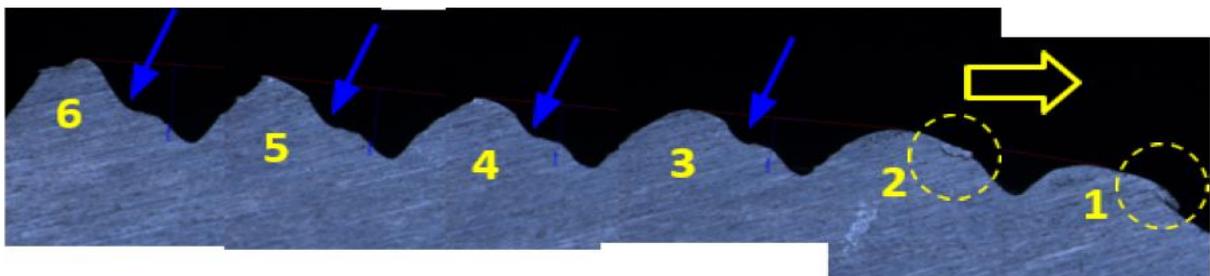
*A side-view of cylinder threads 1 (bottom) to 6 (Figure 22 or Photo 7) revealed evident and increasing mechanical damage to the thread crests from 1 to 6.*

**Figure 22:** Cylinder threads side view (Photo 7 stereo).

Thread crests 1, 2 and 3 (Figure 22 or Photo 7, yellow dashed circles; Figure 23 or Photo 8) revealed clear indications of slippage (plastic deformation) parallel to the applied torque force (yellow arrow). Higher magnifications confirmed this notion (SEM Images 1 and 2).

*Circumferential damage to the thread flanks (Figures 22 and 24 or Photos 7 and 9, blue arrows) indicates possible 'cross-threading' during fitment.*

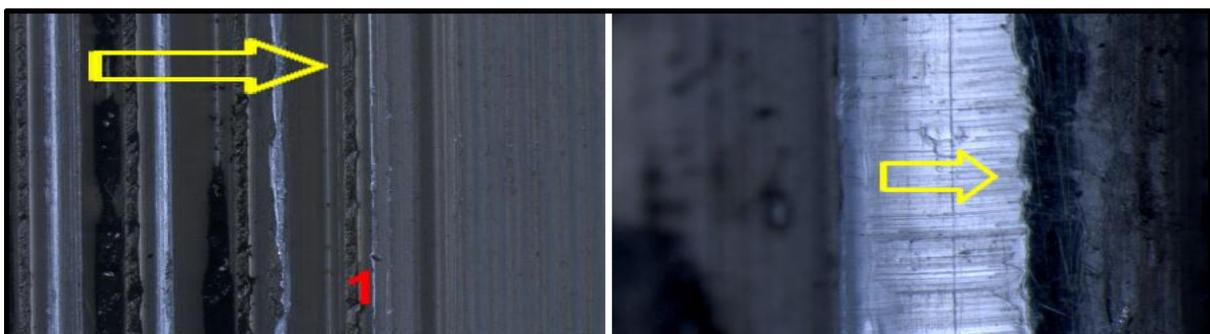
**Figure 23:** Cylinder thread condition (Photo 8: stereo).

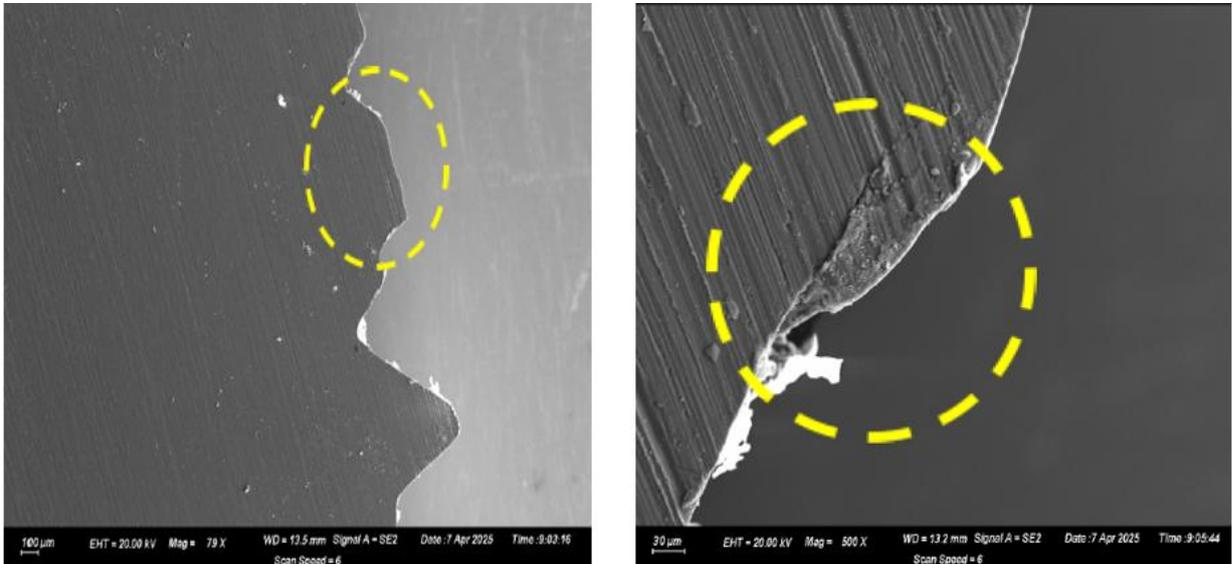
SEM Image 1 and 2 show the magnified threads condition.

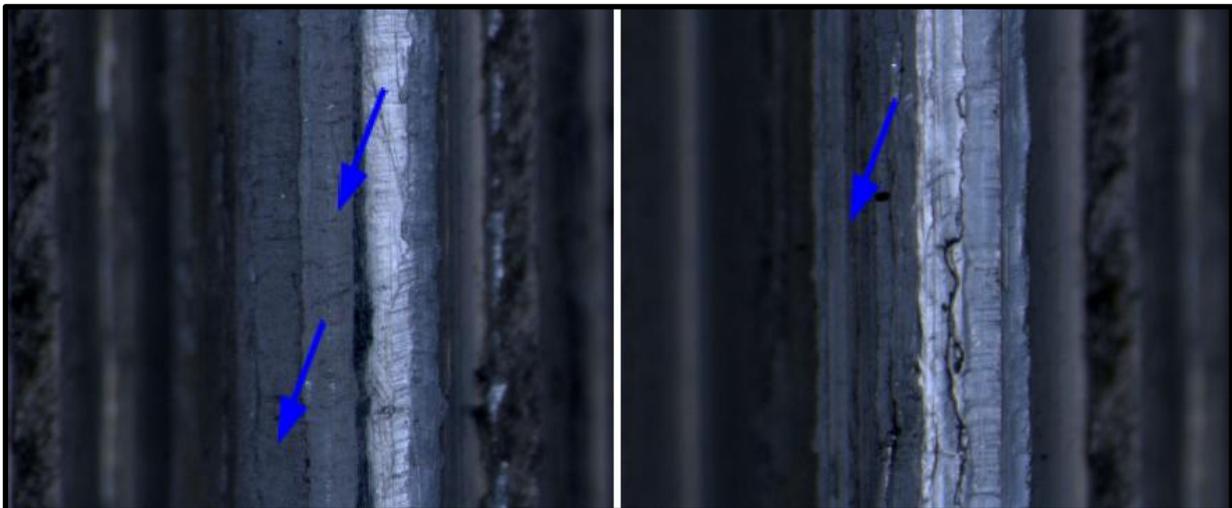
**Figure 24:** Cylinder threads condition (Photo 9: stereo).

- (a) *The Cylinder thread crest/root dimensions revealed a loss of +/-75% in thread depth between threads 1 and 8. This indicates extensive mechanical damage (plastic deformation) and is the most probable cause for the noted slippage.*

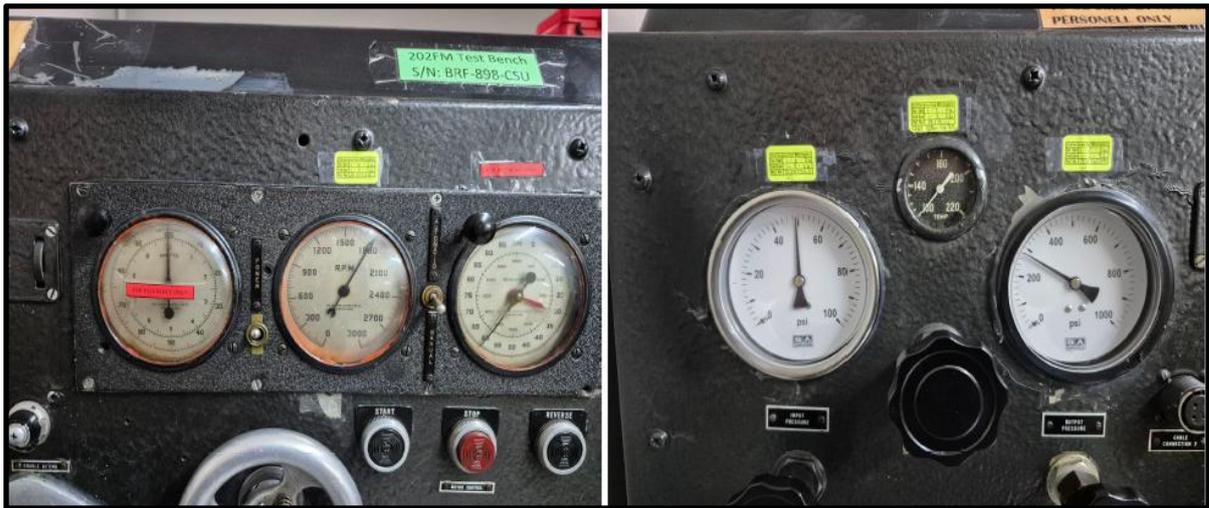
**Figure 25:** Governor bench test indicators (Photo 10: digital).

- I. A bench test was performed to determine the serviceability of the pressure relief mechanism from the propeller governor assembly. The results met the Hartzell Original Equipment Manufacturer's (OEM's) requirements with a maximum allowed pressure of 290 pounds per square inch (psi) (Figure 25 or Photo 10).

- 2.2.10. Tests showed that the governor's pressure relief mechanism was working properly and that it was set within Hartzell OEM's limits of 290 psi. This meant that it was adjusted correctly, and there was no indication that it caused unusually high pressure inside the pitch-changing cylinder. The separation of the cylinder during flight must, therefore, be linked to other factors.

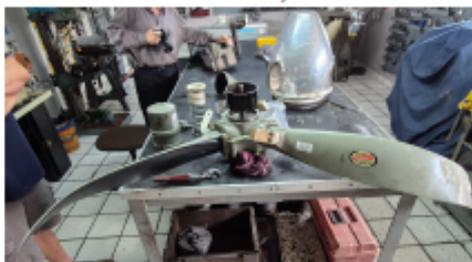
Photo 2: RH CSU assembly, as found (digital)

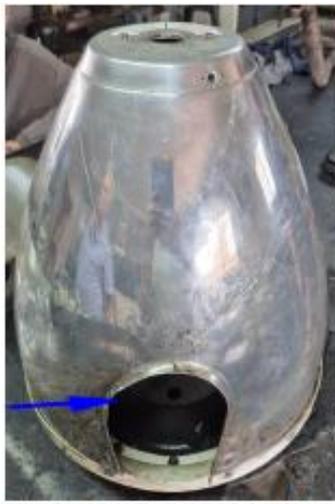
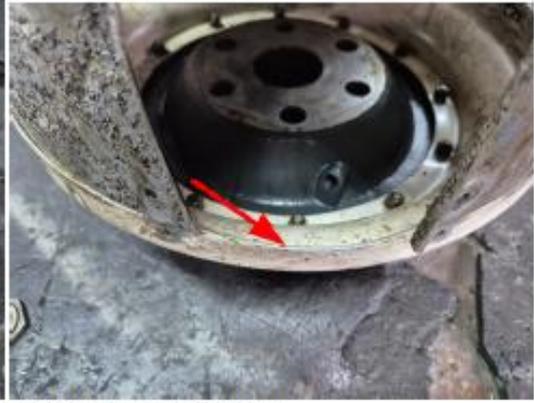
Photo 4: Spinner condition and damages (digital)

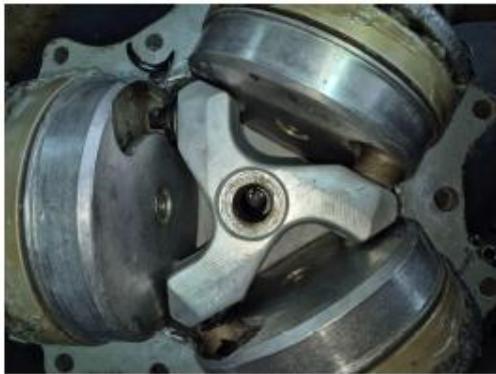
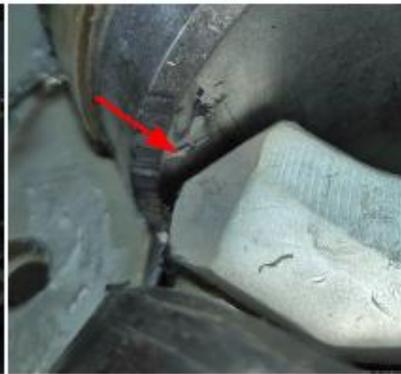
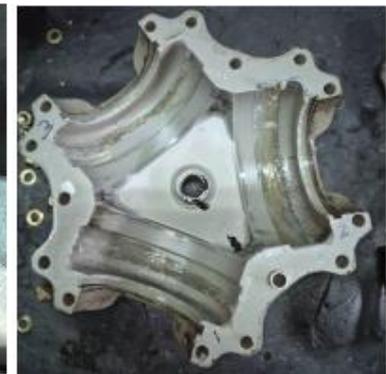
Photo 5: Hub internal condition and impact marks (digital)

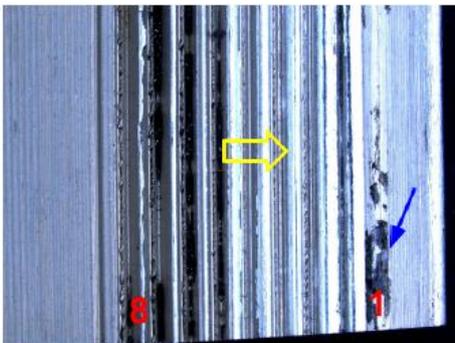
Photo 6: Cylinder thread condition (stereo/digital)

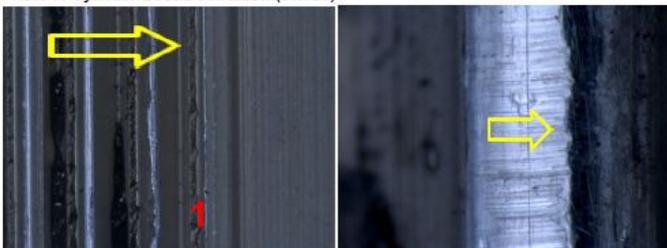
Photo 8: Cylinder thread condition (stereo)

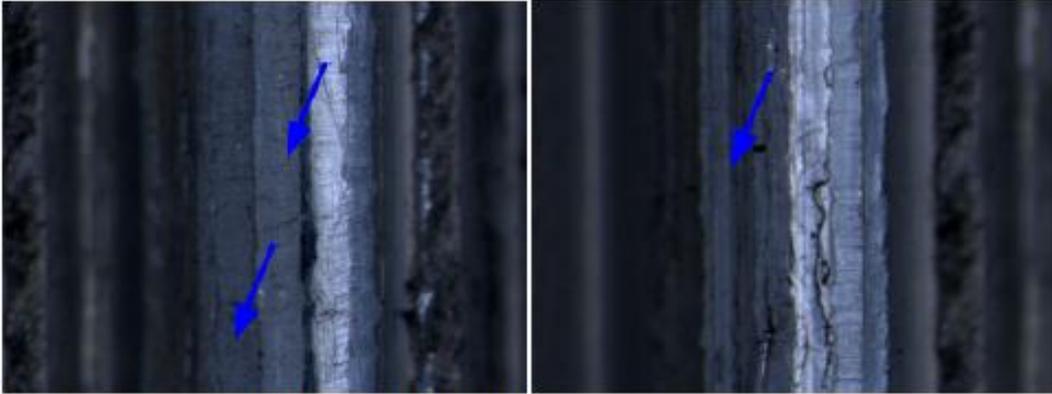
Photo 9: Cylinder thread condition (stereo)

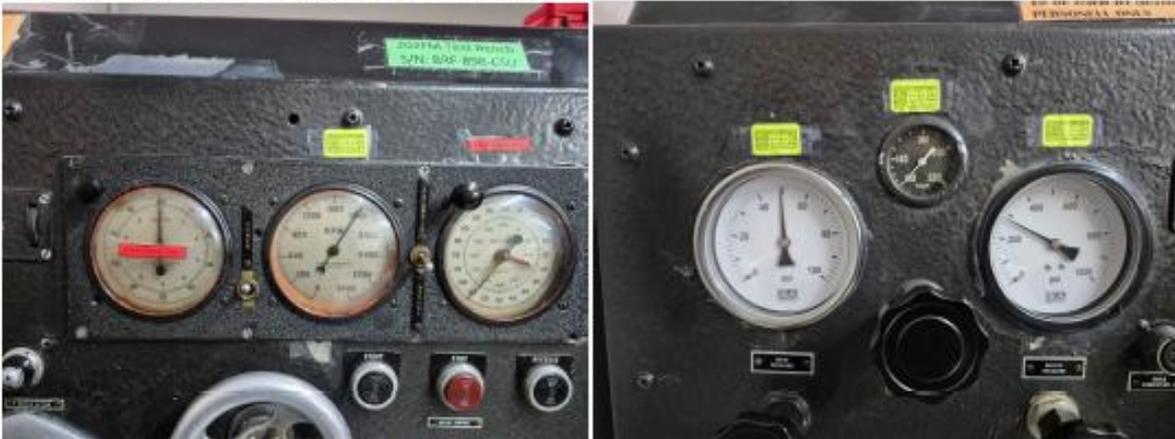
(b) A bench test was performed to determine the serviceability of the pressure relief mechanism from the propeller governor assembly. The results met the McCaulley (OEM) requirements with a maximum allowed pressure of 290psi (Photo 10).

Photo 10: Governor bench test indicators (digital)

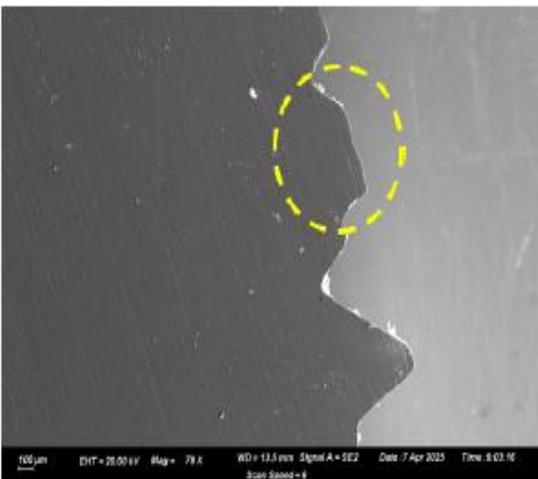
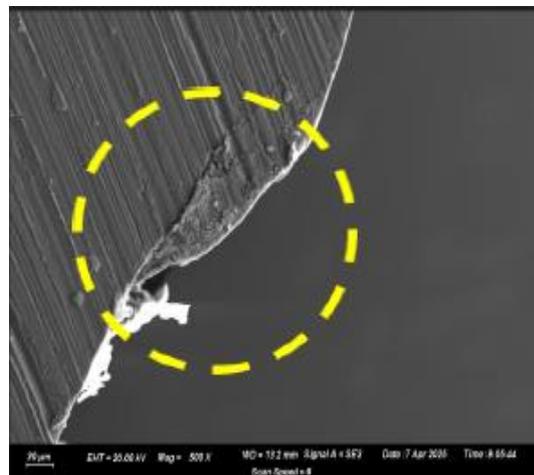
SEM Image 1: Cylinder thread condition (FEGSEM, 20kV, SE) SEM Image 2: Cylinder thread condition (FEGSEM, 20kV, SE)
