LIMITED OCCURRENCE INVESTIGATION REPORT – FINAL

Reference Number	CA18/2/3/10566						
Classification	Accident	Date	22 March 2025		Time	0940Z	
Type of Operation	Private (Part 91)						
Location							
Place of Departure	Mossel Bay Aerodrome (FAMO), Western Cape Province		Place of Intended Landing	Mossel Bay Aerodrome (FAMO), Western Cape Province			
Place of Occurrence	Mountainous terrain near Van Wyksdorp in Western Cape Province						
GPS Co-ordinates	Latitude	33°45'25.31" S	Longitude	021°28'48.62" E	Elevation	650 feet	
Aircraft Information							
Registration	ZS-FFG						
Make; Model; S/N	Hawker Beechcraft; Bonanza G36 (Serial Number: E-3845)						
Damage to Aircraft	Substantial		Total Aircraft Hours	1 366.4			
Pilot-in-command							
Licence Type	Private Pilot Licence		Gender	Male		Age	43
Licence Valid	Yes	Total Hours	660.1		Total Hours on Type	158.9	
Total Hours Past 30 Days	11.9		Total Hours on Type Past 90 Days	15.5			
People On-board	1 + 2	Injuries	0	Fatalities	0	Other (on ground)	0

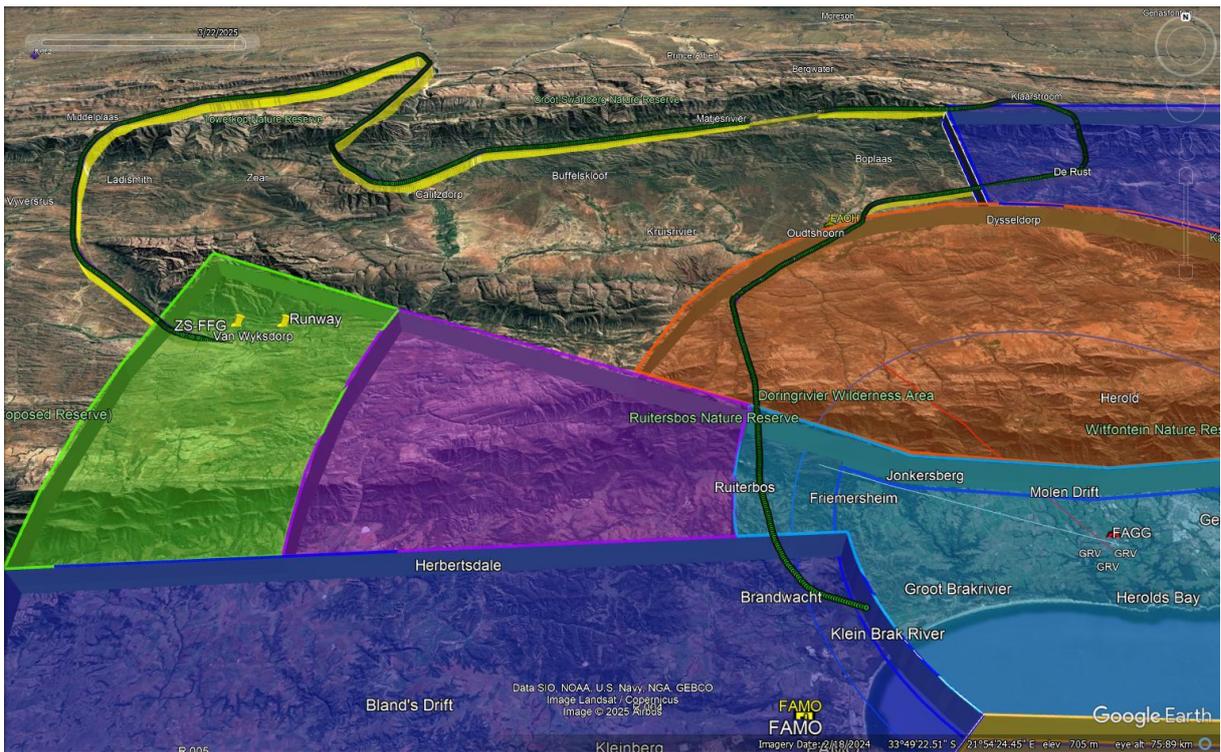
Figure 2: The radar track (green and yellow line) of the flight was picked up near Klein Brak River and stopped close to the accident site. (Source: Air Traffic Navigational Services [ATNS])

With the assistance of Air Traffic and Navigation Service (ATNS), it was possible to obtain the radar track flown by the aircraft. The aircraft was first identified on radar just north of Klein Brak River at 08:24:29Z, 7.0 nm north-east of FAMO. The flight continued as per the layout in Figure 2, turning left at De Rust towards the north, which was followed by another left turn at Klaarstroom. The aircraft continued in a westerly direction near the Swartberg Mountain range. At 09:29:08Z, the aircraft crossed the Swartberg Mountains just north of Ladismith at an altitude of 8 700ft, turning left in a southerly direction. At 09:29:38Z, the aircraft commenced a steady descent at 393 feet per minute (ft/min). At 09:32:25Z, the rate of descent increased slightly to 530 ft/min. At 09:35:51Z, the rate of descent increased to 910 ft/min, and 12 seconds later it increased to 1 575 ft/min; after 33 seconds the rate of descent was 2 070 ft/min. The last radar data plot was captured at 09:37:33Z with the rate of descent at 2 537 ft/min and the aircraft speed at 136 knots.

4.	SSR Data
4.1	From the radar data, it could be seen that the rate of descent (ROD) increased substantially over a short period before the forced landing.
Probable Cause	
The pilot executed a forced landing on a mountainous terrain following an engine stoppage. The cause of the engine stoppage could not be determined with certainty, but it was probably related to fuel supply disruption to the engine during flight as an engine ground run was successfully performed post-recovery without intervention.	
Contributing Factors

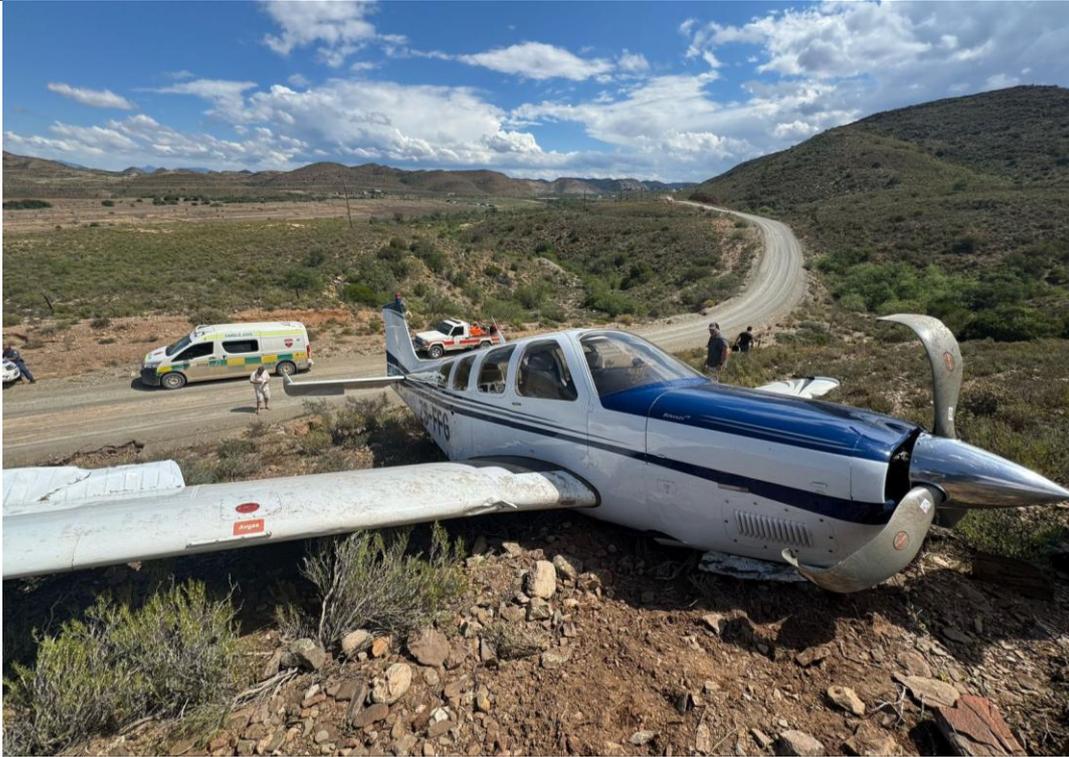
“Shortly after altering my course from the road to the rugged hillside, I heard the stall warning coming on and we contacted the ground shortly thereafter. The aircraft continued moving for approximately 50m before the right wing made contact with an object and turned the aircraft 90° to face up the slope. After touchdown and the aircraft coming to rest, I switched off the alternator and battery switches as we evacuated the aircraft. There was no post-landing fire. There were no injuries to any of the occupants.

Figure 4: The aircraft as it came to rest. (Source: Pilot)

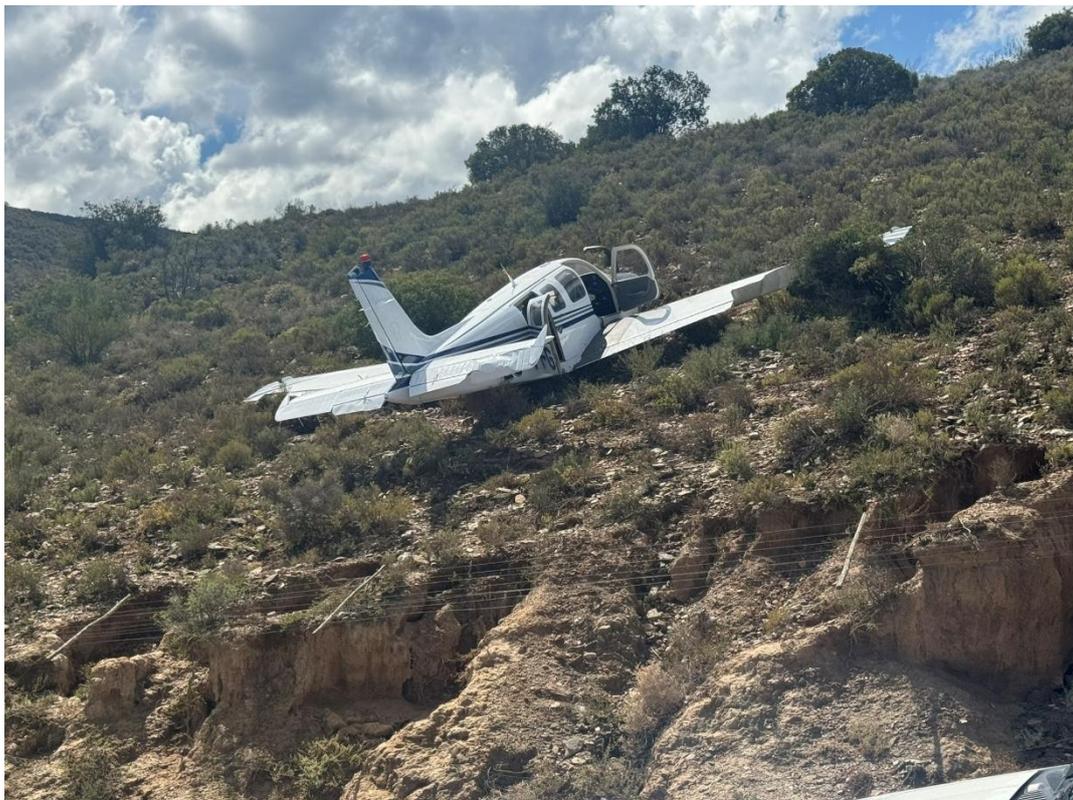
Figure 5: The aircraft resting on the steep mountainous terrain, 90° heading to the forced landing point. (Source: Pilot)

1.5 The aircraft came to rest against the mountainous slope at a 90° left-yaw angle heading to the forced landing.

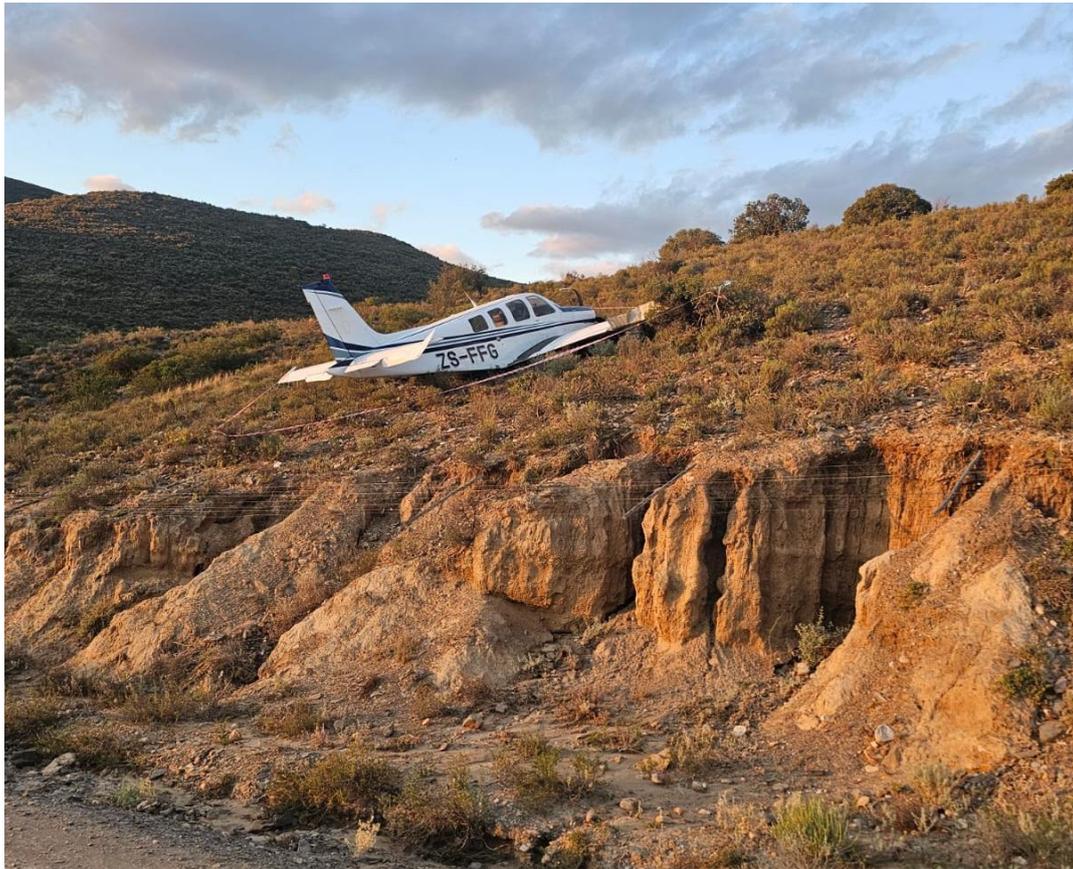
Figure 6: A view of the aircraft from the road. (Source: Recovery Team)

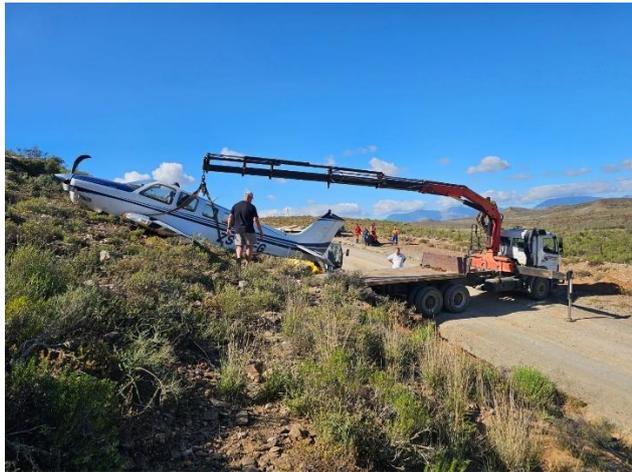
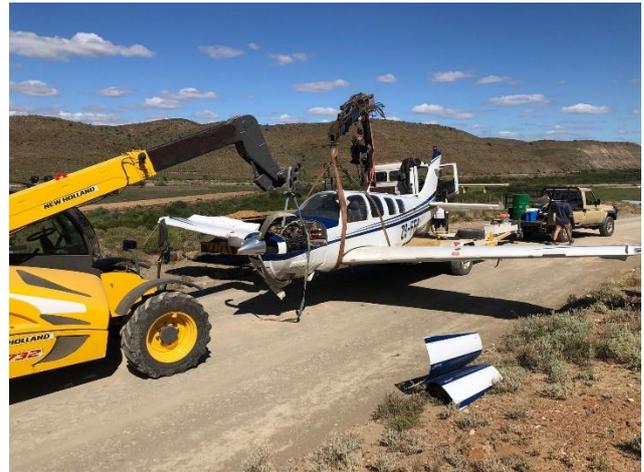
The aircraft was recovered with the wings still attached (see Figure 7 [a][b])). Both wing fuel tanks were drained once the aircraft was recovered and in a level attitude as neither of the tanks had ruptured. Five (5) litres of fuel was drained from the left-wing tank and 75 litres from the right-wing tank. *The aircraft has a total fuel capacity of 280 litres of usable fuel.* A fuel sample was taken from both tanks, and it was of the correct grade with no contamination or sediment noted. The gascolator located on the left side where the fuel selector valve is, was removed, and it contained a small amount of fuel.

Figure 7: The aircraft was recovered with the wings still attached to the fuselage. (Source: Recovery Team)

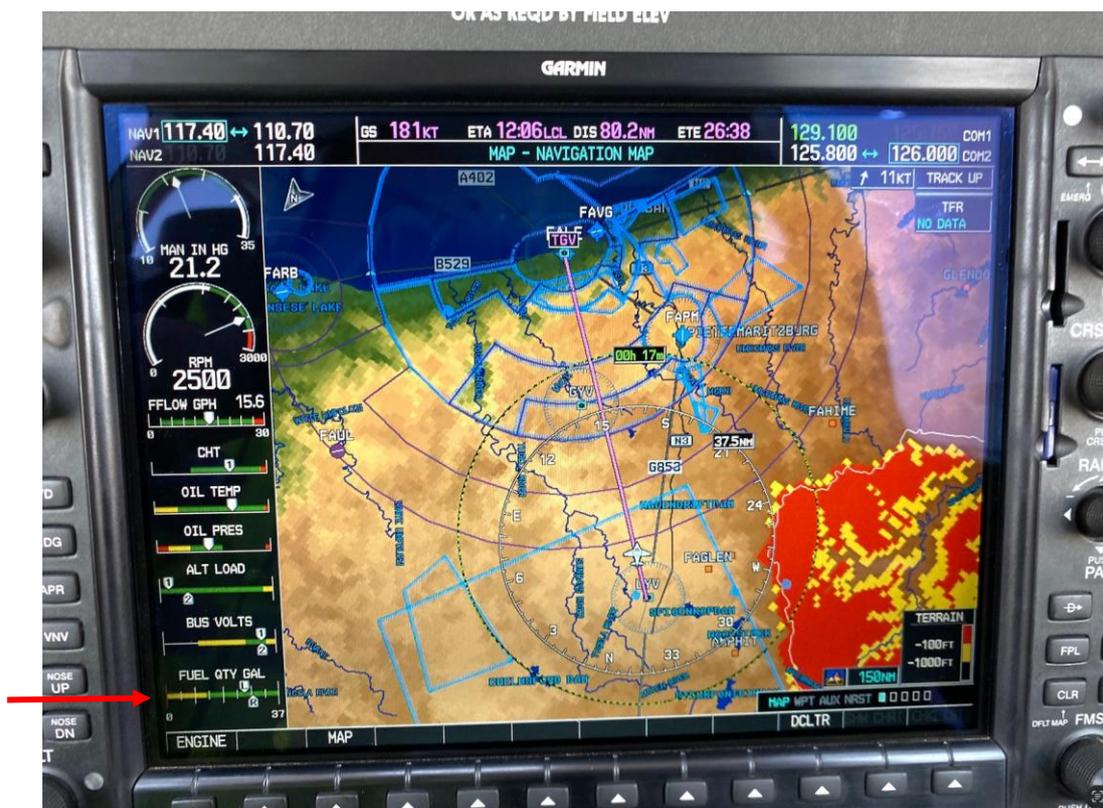
Figure 8: The red arrow indicates the fuel quantity gauge at the bottom left corner of the MFD.

2.8 The fuel gauge display is located on the bottom left corner of the MFD; the gauge is small, (see Figure 8).

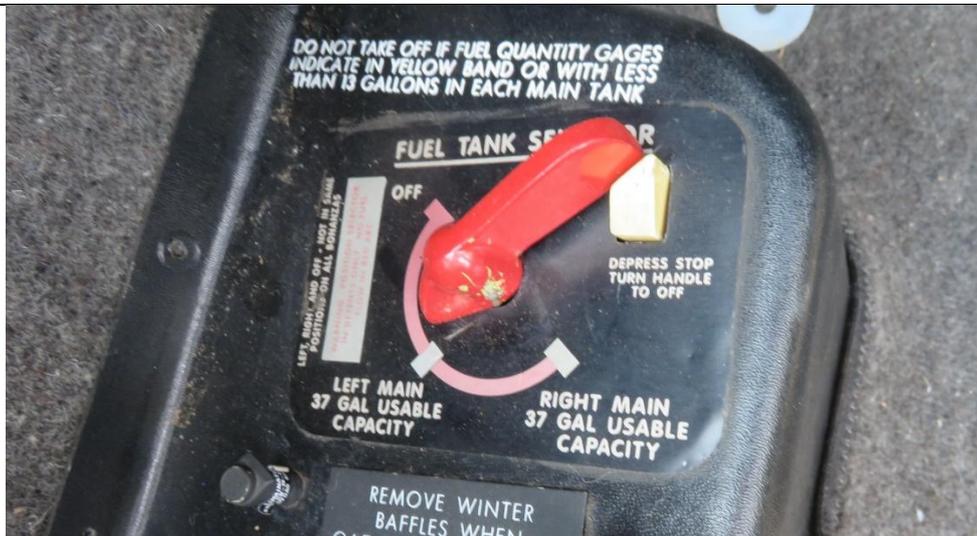
Figure 9: The fuel tank selector lever of ZS-FFG.

2.7 The fuel tank selector position could not be determined as the pilot had turned it off before he disembarked from the aircraft.
