**LIMITED OCCURRENCE INVESTIGATION REPORT – FINAL**

| <b>Reference Number</b> | CA18/2/3/10567 | | | | | | |
| Registration | ZT-RTF | | | | | | |
| Make; Model; S/N | Robinson; R44 Raven II (Serial Number: 13863) | | | | | | |

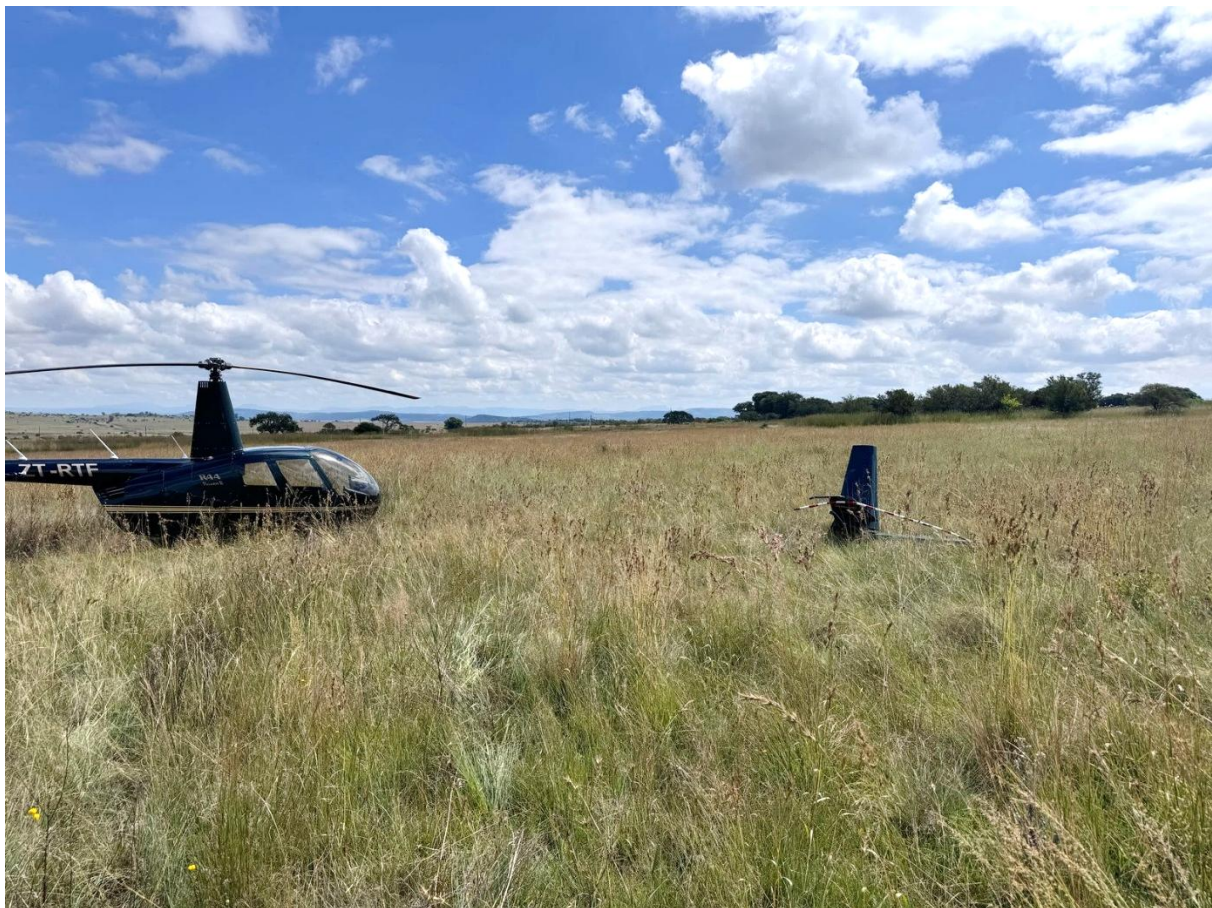
The pilot engaged autorotation to perform a forced landing in the vicinity of the aerodrome. During descent whilst transitioning, the pilot observed smoke on the right side of the engine cowls. The helicopter landed hard on the grass-covered terrain, north of Runway 11/29.

The landing gear skids were level during the hard landing. One of the main rotor blades severed part of the tail boom aft section (which consisted of the tail rotor, part of the tail rotor drive shaft and the tail rotor drive gearbox).

The pilot was not injured during the accident sequence. The helicopter's tail boom and the landing gear skid were damaged.

**Figure 1:** The helicopter at the accident scene. (Source: Pilot)

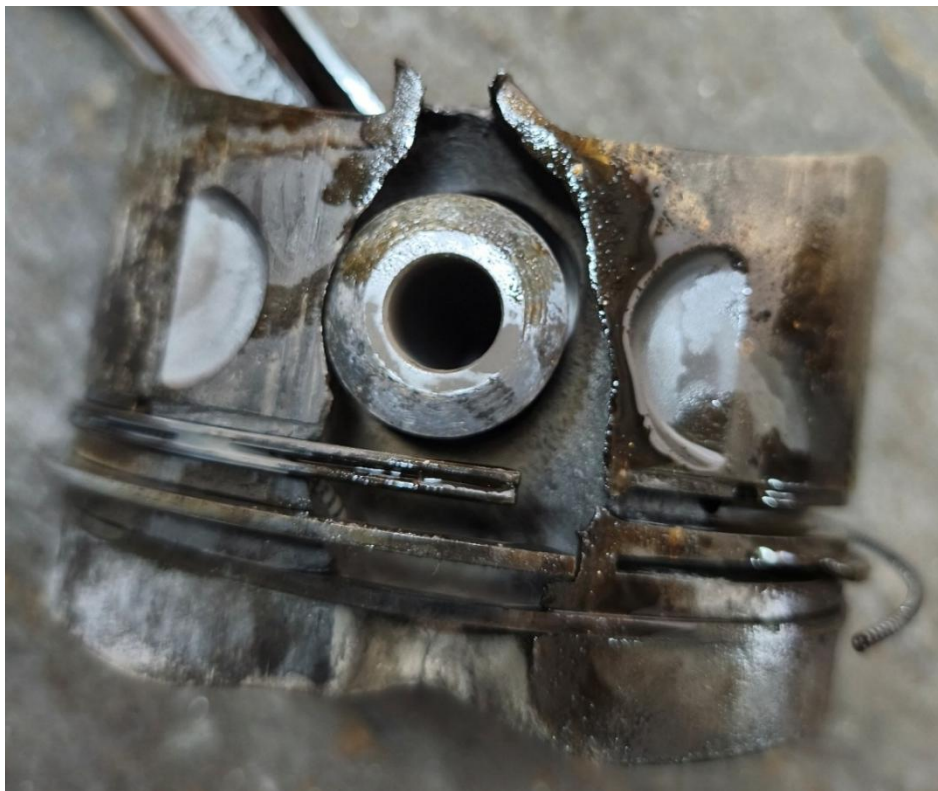
The engine teardown inspection was conducted on 7 April 2025. It was found that the Number 3 piston was damaged, one of the piston pin plugs on the Number 3 piston head was missing, the engine oil was contaminated with magnetic and non-magnetic metallic particles, and the oil pump suction filter screen was blocked with magnetic and non-magnetic metallic debris.

The non-magnetic metallic debris found in the oil sump was silvery-white in colour, which is indicative of aluminium presence. *Aluminium is the same material used for the manufacture of the piston pin plug.* It was then concluded that the contamination material found in the oil was residue and particles of the failed piston plug, damaged piston, and failed engine journal bearings which led to the engine failure during the flight.

**Figure 2:** The failed engine piston pin plug from the damaged Number 3 piston.

*Piston Pin Plug failure is caused by unusually high wear of the piston pin plug ultimately leading to failure of the piston pin plug. This condition, in turn, may lead to complete engine failure.*

- 2.6. The piston of the Number 3 engine cylinder was missing a pin plug, and the piston head was damaged on both ends (above and below) where the piston pin plug was missing.

Safety message: Operators of all Lycoming direct drive and TIGO-541 piston engines are strongly advised to implement a spectrometric oil analysis programme for oil samples taken during engine oil changes to detect possible piston pin plug failure at an early stage as per the recommendation in the Lycoming mandatory Service Bulletin Number 480F, dated 25 May 2017.

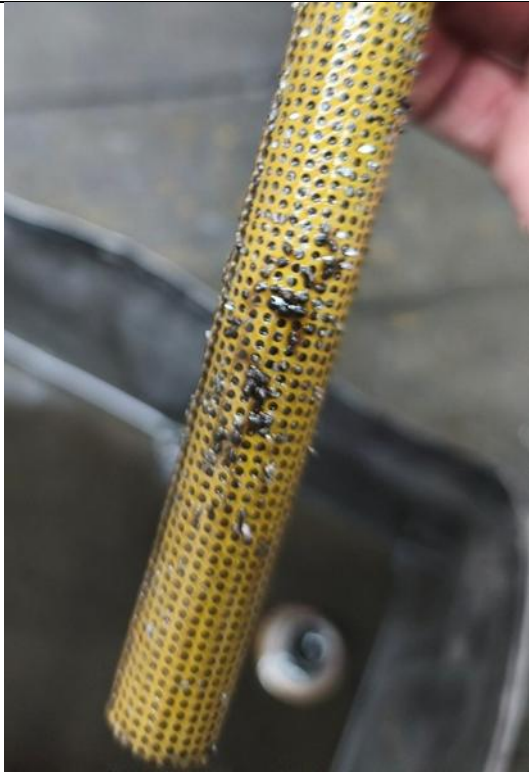
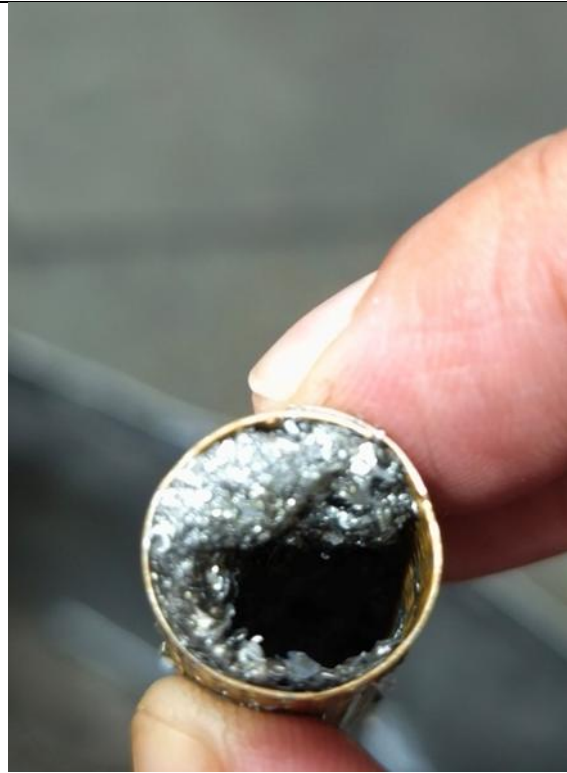
**Figures 3 and 4:** Metal particles on the oil pump suction screen and tubing. (Source: Investigator)

2.8. Damage to the Number 3 piston and pin plug was extensive, which resulted in severe contamination of the engine oil, as well as the clogged engine oil pump suction screen and tubing. This, therefore, led to loss of lubrication and rapid deterioration and failure of other internal engine components which ultimately caused a complete engine stoppage. This failure is a known issue that was addressed by the engine manufacturer through the mandatory Service Bulletin 480F. The bulletin required the inspection of the engine oil and oil filter for metallic and non-metallic particles during routine oil changes, which would serve as an early detection method of potential failure of the piston pin plugs.

Unsuccessful forced landing after an in-flight engine stoppage due to the failed piston pin plug which disintegrated and severely contaminated the engine oil. The metal contaminants in the oil blocked the oil pump suction screen and tubing; this led to loss of lubrication and rapid deterioration, and failure of other internal engine components.

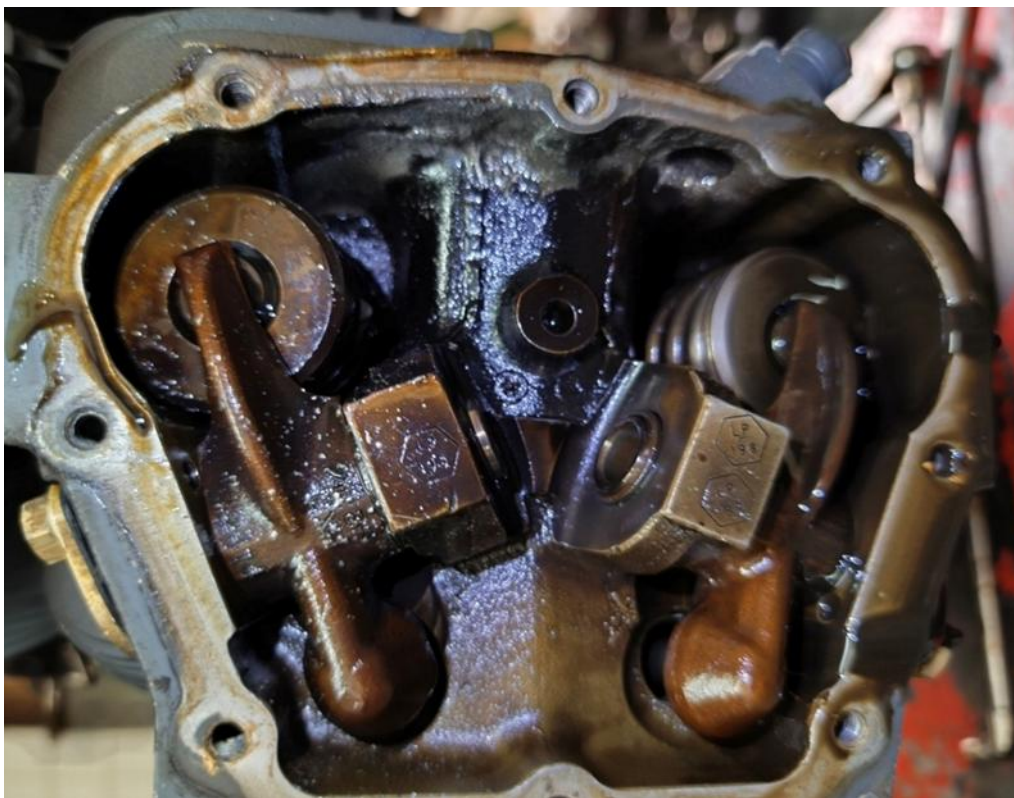
**Figure 5:** Metal particles found on engine cylinder valves and rocker assemblies due to the circulated contaminated oil.

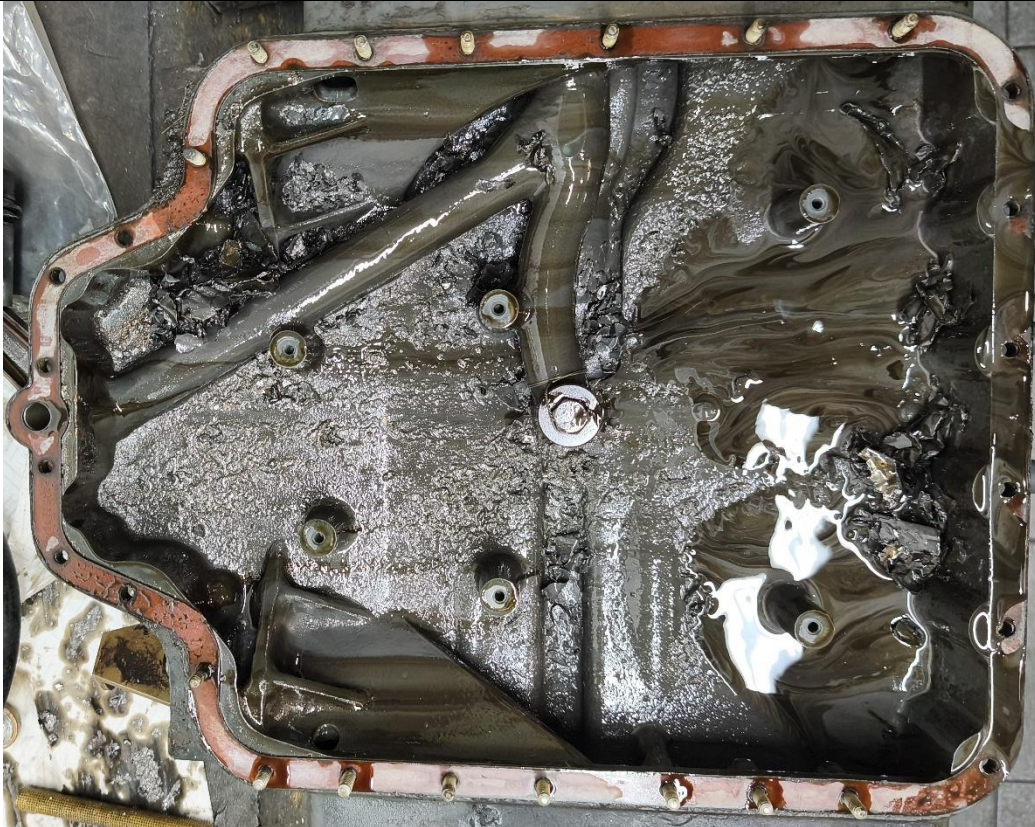
**Figure 6:** The severely contaminated oil in the engine oil sump.
