AIRCRAFT ACCIDENT REPORT AND EXECUTIVE SUMMARY

Reference:		CA18/2/3/10569	
Aircraft Registration	ZU-MJM	Date of Accident	23 March 2025		Time of Accident	0745Z	
Type of Aircraft	Jabiru J430			Type of Operation	Private (Part 94)		
Pilot-in-command Licence Type	Private Pilot Licence (PPL)		Age	22	Licence Valid	No	
Pilot-in-command Flying Experience	Total Flying Hours			262.2	Hours on Type	158.9	
Last Point of Departure	R100 Nandoni Private Airstrip, Limpopo Province						
Next Point of Intended Landing	Louis Trichardt Aerodrome (FALO), Limpopo Province						
Damage to Aircraft	Destroyed						
Location of the accident site with reference to easily defined geographical points (GPS readings if possible)							
On a field, approximately 1.2 nautical miles (nm) south-west of PR Mphephu Aerodrome (FATH) in Levubu area at GPS co-ordinates 23° 4'58.97" S 30°21'5.80" E							
Meteorological Information	Surface wind: light and variable; Visibility: 5000m; Temperature: 25°C; Dew: point: unknown; Clouds: BKN; Cloud base: 3000 ft; QNH: unknown

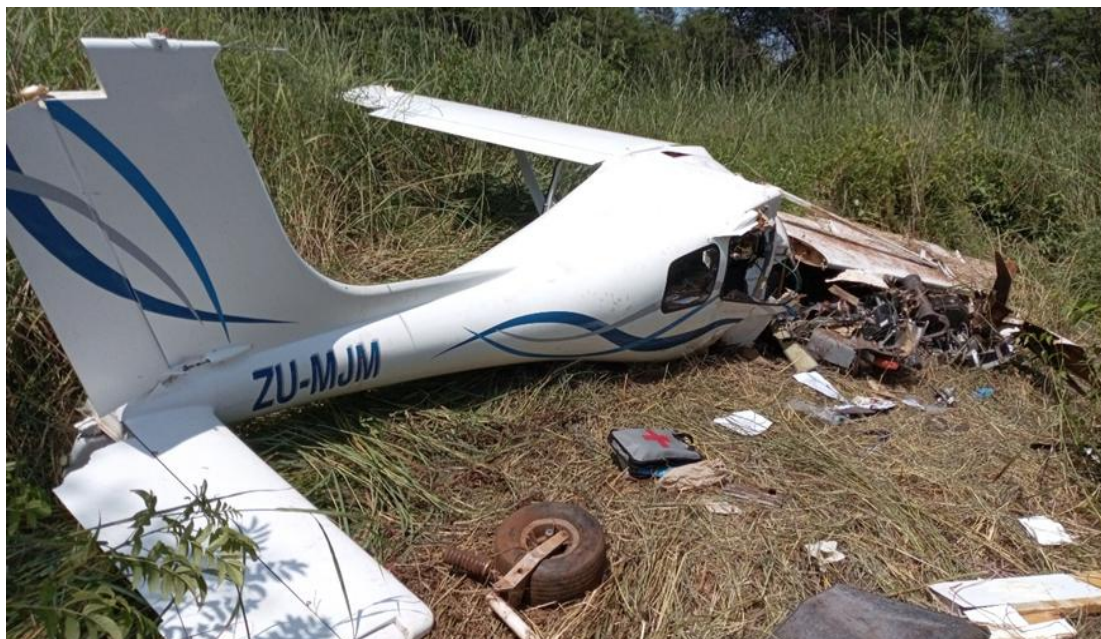
- 1.3.1. The aircraft was destroyed.

Figure 1: The wreckage at the accident site.

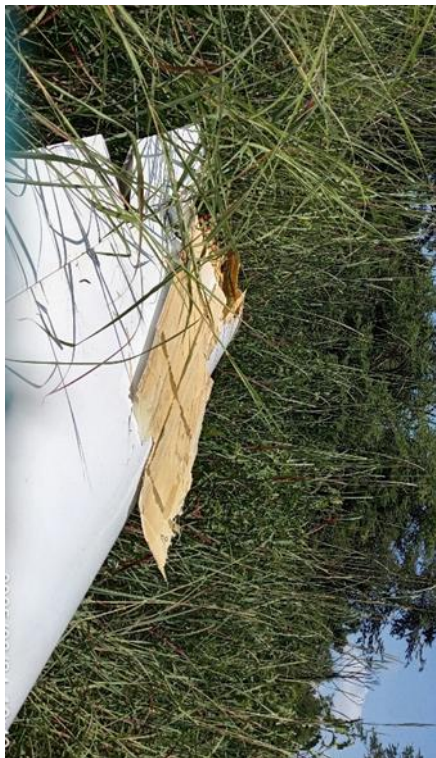
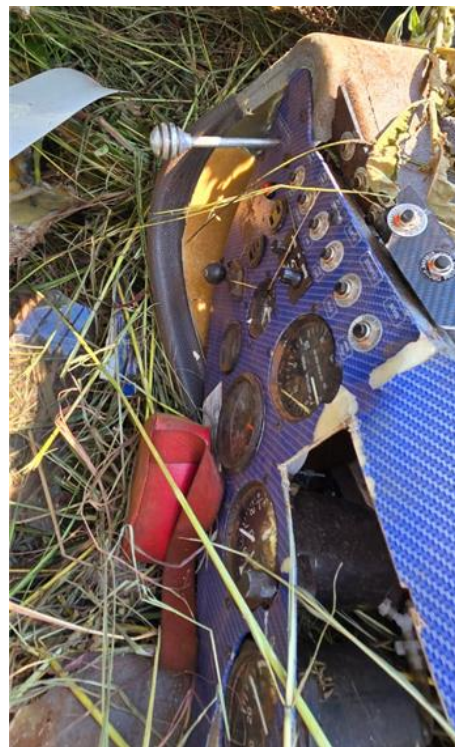
1.12.4. The cabin sustained serious damage. The windshield was shattered, the instrument panel was destroyed, and the floor was deformed after the collapse of the right main landing gear. The safety harnesses were not damaged. The pilot assisted the passengers to exit the aircraft and then called for help.

Figures 3 and 4: The damaged left-wing tip and instrument panel (left). The pulled back power lever (right).

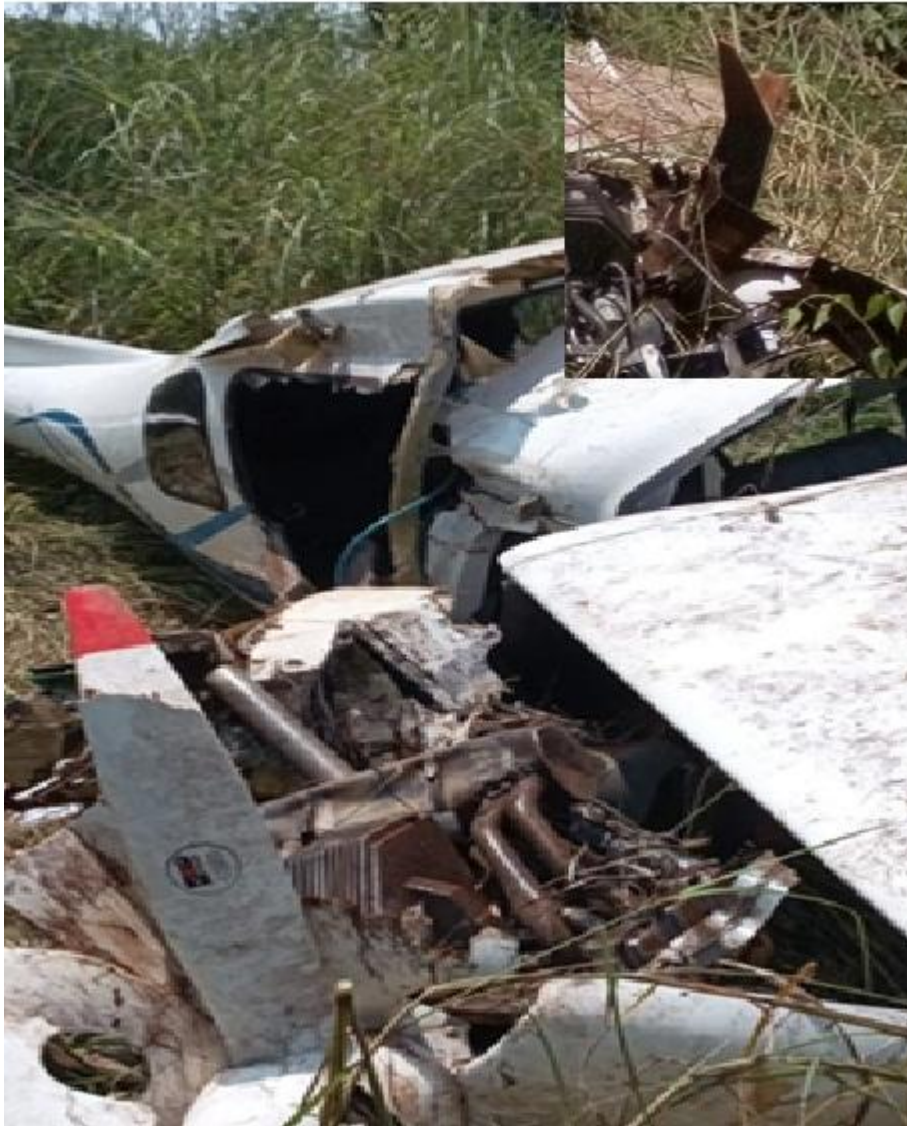
Figure 5: The main fuselage after the accident. Inset picture shows the broken propeller.

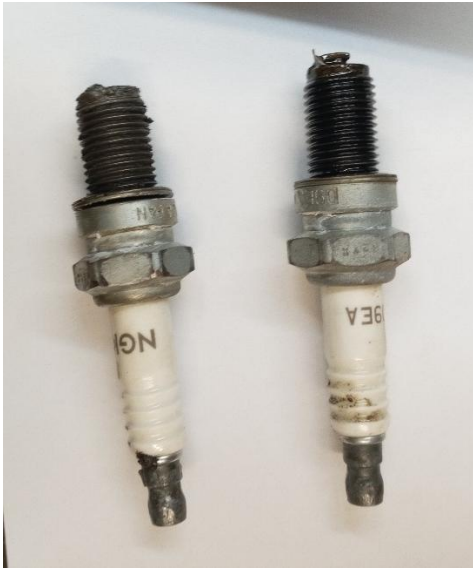
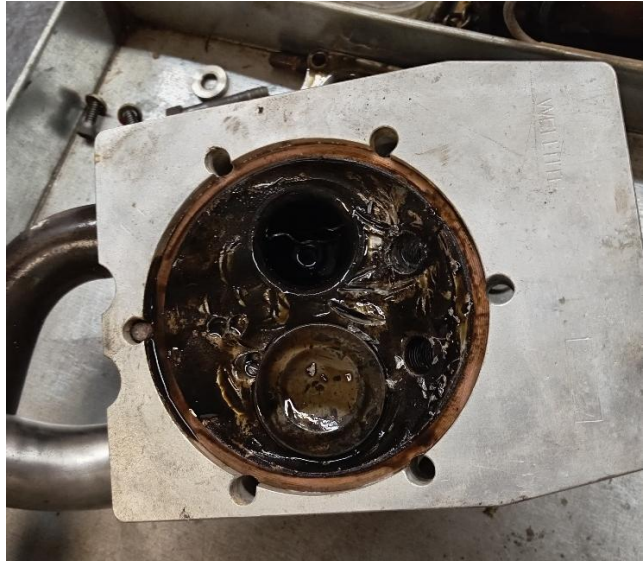
1.16.1. The aircraft was recovered to the aircraft maintenance organisation (AMO) facilities at Rhino Park Aerodrome. The investigating team was present when the aircraft maintenance engineer (AME) started the engine teardown on 2 April 2025. Initially, the AME removed all the engine attachments and turned the engine by hand, but it would not turn. The AME then removed the spark plugs for cylinder Number 6 and the cylinder cover after which he found the top of the two spark plugs damaged, as well as debris on the inside of the cylinder cover.

1.16.2. Cylinder Number 6 head was removed from the engine, and it was found that the exhaust valve was missing from its seating position. There were multiple dents on the cylinder inner surface that were caused by the exhaust valve head (Figure 8). The piston crown also sustained damage, and the valve stem punched a hole and disappeared into the exhaust system. A connection rod had separated from the piston but was still attached to the crankshaft. The exhaust valve had broken into three parts (lower stem still attached to the engine; middle stem was missing; and head which was inside the cylinder). The valve stem was later found inside the exhaust muffler box. The piston crown sustained damage during the accident sequence.

Figures 6 and 7: The damaged spark plugs (left) and cylinder head with the missing exhaust valve.

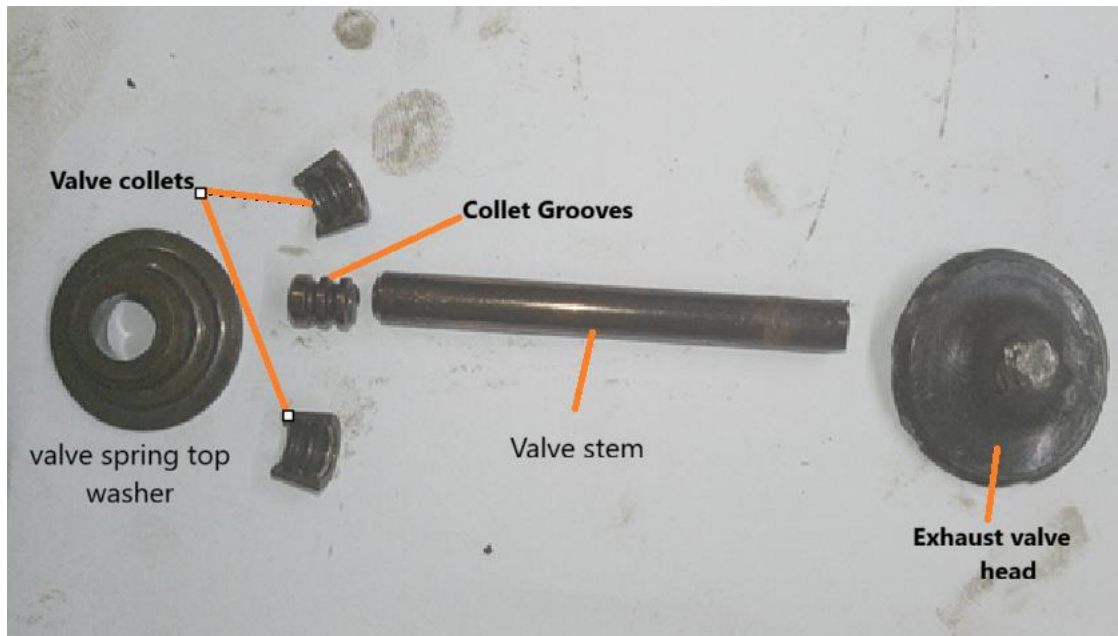
1.16.3. The AMO report is attached as Annexure 5.1 and it concluded that: *“Although we (AMO) are not specialised metallurgical qualified personnel, it is my opinion from that observation and type of damage that the Exhaust Valve from Cylinder # 6 failed just below the Valve Collet Grooves, leaving the Top Washer, Collets and Collet Groove part of the Valve to stay intact. This resulted in the Valve falling inside the Cylinder, causing damage to the Piston and the Valve Head to separate from the Valve Stem. It is my experience from previous Valve Failures where Valve Heads came adrift that the Valve Stem remained in the Valve Guide. This also resulted in damage to the Piston and Cylinder Head. It is not clear what the reason was for the Valve Stem to fail below the Collet Grooves.”*

Figure 8: Exhaust valve broke into three parts. (Source: AMO)

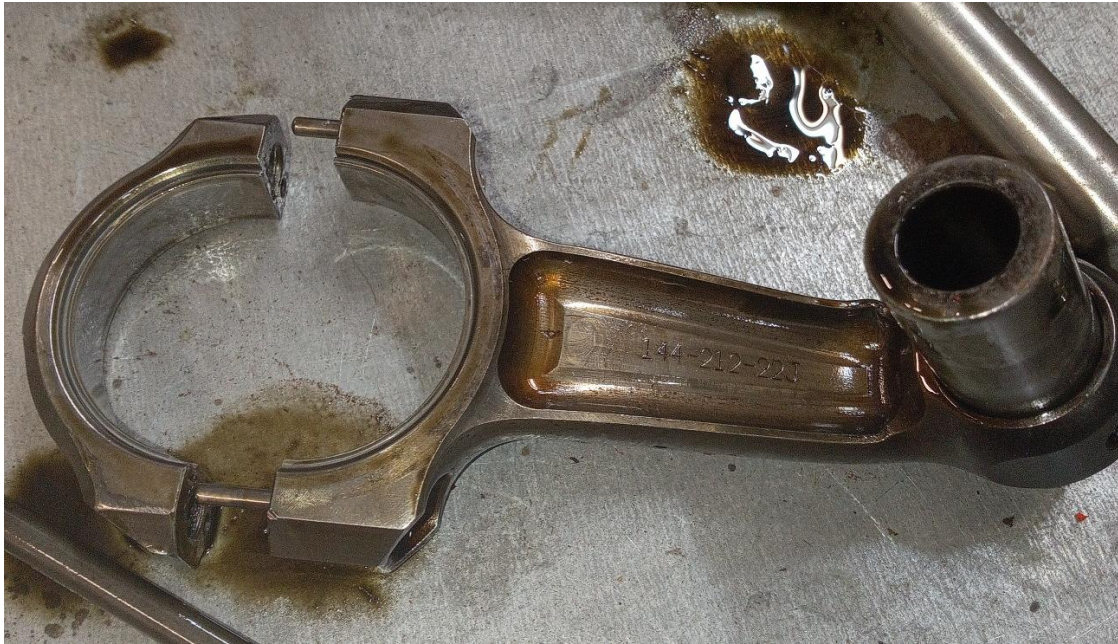
Figure 9: The damaged cylinder Number 6 connecting rod.

8. Cylinder No. 6 Conrod completely distorted.
9. Piston Crown of No. 6 severely damaged with the Exhaust Valve Head compressed in the Piston Crown as well as a round hole through the Crown.

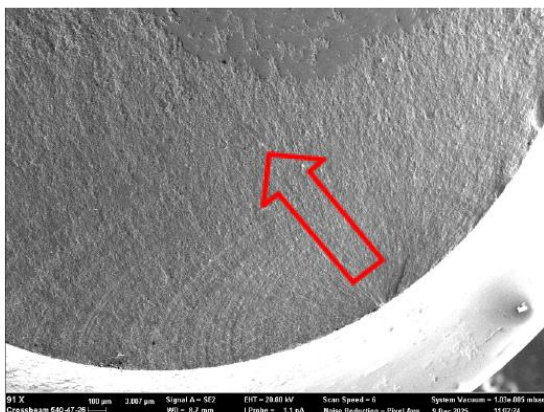
Although the fracture surfaces (carbon deposits) were somewhat damaged, the high magnification inspection revealed clear indications of fatigue striations at Fracture B (Fractograph 1), initiating within the collet radius and progressing inward (red arrow) until final fast rupture (Fractograph 4).

Fractograph 1: Fatigue beechmarks, Fracture B

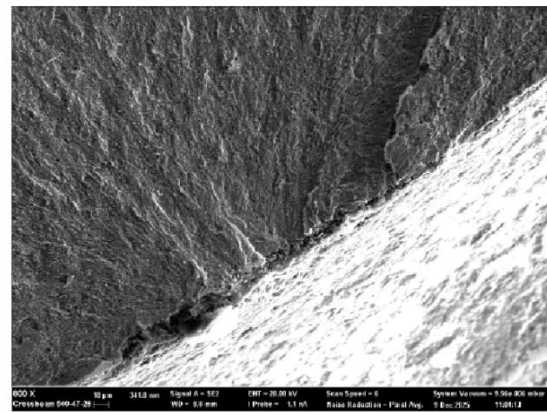
Fractograph 2: Fatigue initiation point

No clear indicators towards the cause for initiation could be detected at the initiation point (Fractograph 2). However, the presence of widespread corrosion pitting damage (Fractograph 5) suggests that the localised stress-raiser effect of a corrosion pit could have contributed to the initiation of the fatigue fracture.

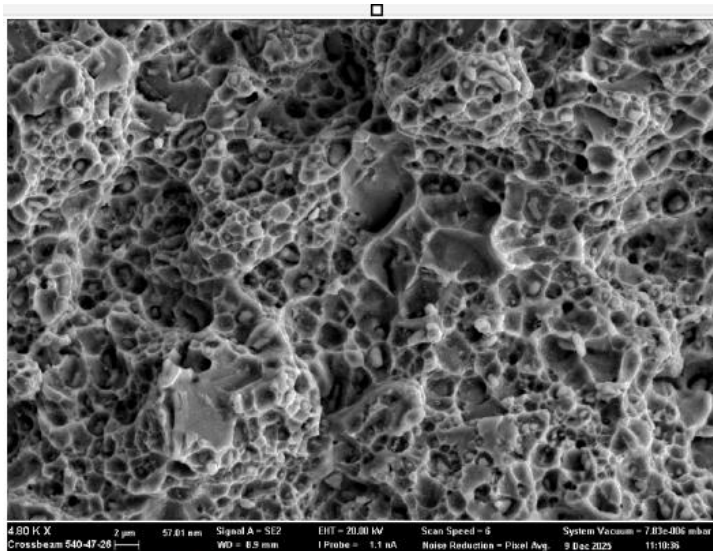
Fractograph 4: Final Fast fracture surface

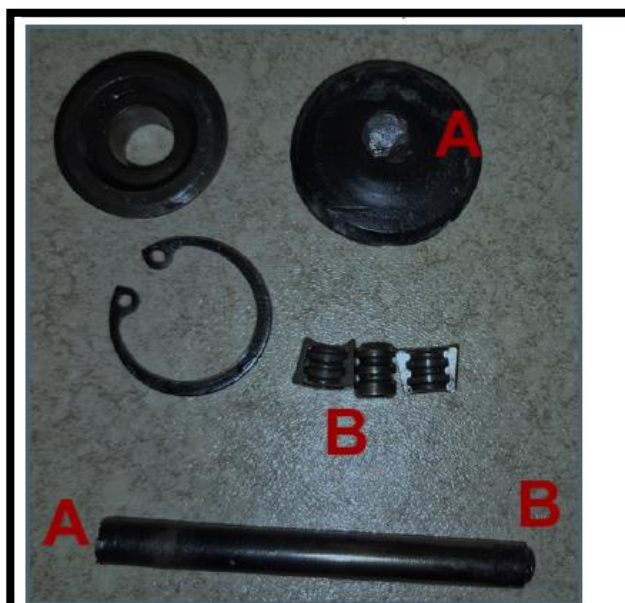
Photo 5: Fractured exhaust valve

- (a) The visual inspection revealed a fractured exhaust valve. The valve fractured at two locations.
- (b) The primary fracture initiated adjacent to the collet with the radius.
- (c) The primary fracture mode is fatigue, suggesting the fracture progressed over an undetermined period of operation until final fast rupture.
- (d) Although no clear surface stress raisers (nick marks, corrosion pitting, etc.) were noted, the noted corrosion pitting on the remainder of the valve stem surface suggested that it could have been a contributing factor.
- (e) The valve stem surface revealed extensive foreign material build-up, consistent with exposure to high temperatures and the use of 100LL fuel.

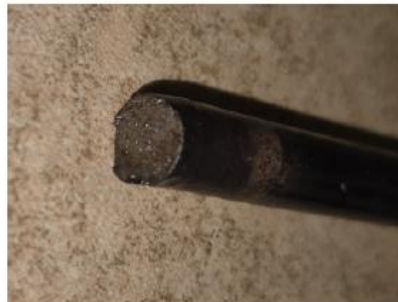
Photo 6: Fracture surface B, exhaust valve

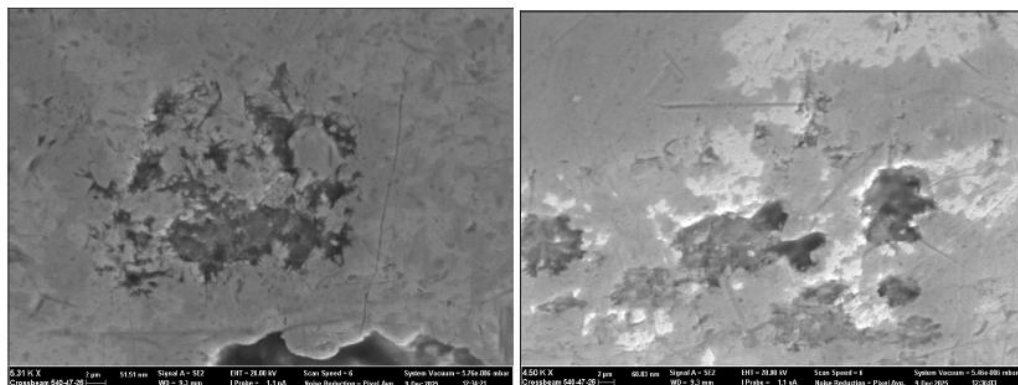
Fractograph 5: Valve stem surface, corrosion damage (4500-5310X, 20kV, SE, FEGSEM)

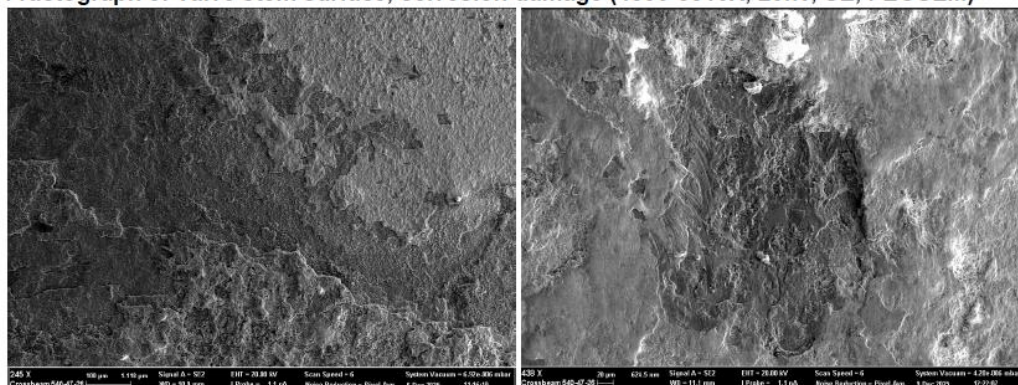
The valve stem surface revealed clear signs of foreign material build-up (Fractograph 6). The Energy-Dispersive X-ray Spectroscopy (EDS) analysis confirmed the origin to be fuel - and oil-related (EDS Result 2). This buildup of hard layers results in flaking and is attributed to prolonged exposure to high temperatures and to 100LL fuel. However, the possibility of these hard flakes at the valve stem/guide interface resulting in a 'stuck' valve cannot be ruled out.

Fractograph 6: Valve stem surface, corrosion damage (245-438X, 20kV, SE, FEGSEM)
