**LIMITED OCCURRENCE INVESTIGATION REPORT – FINAL**

| <b>Reference Number</b> | CA18/2/3/10542 | | | | | | |
| <b>Registration</b> | ZU-IJS | | | | | | |
| <b>Make; Model; S/N</b> | Sling 4 (Serial Number:094) | | | | | | |

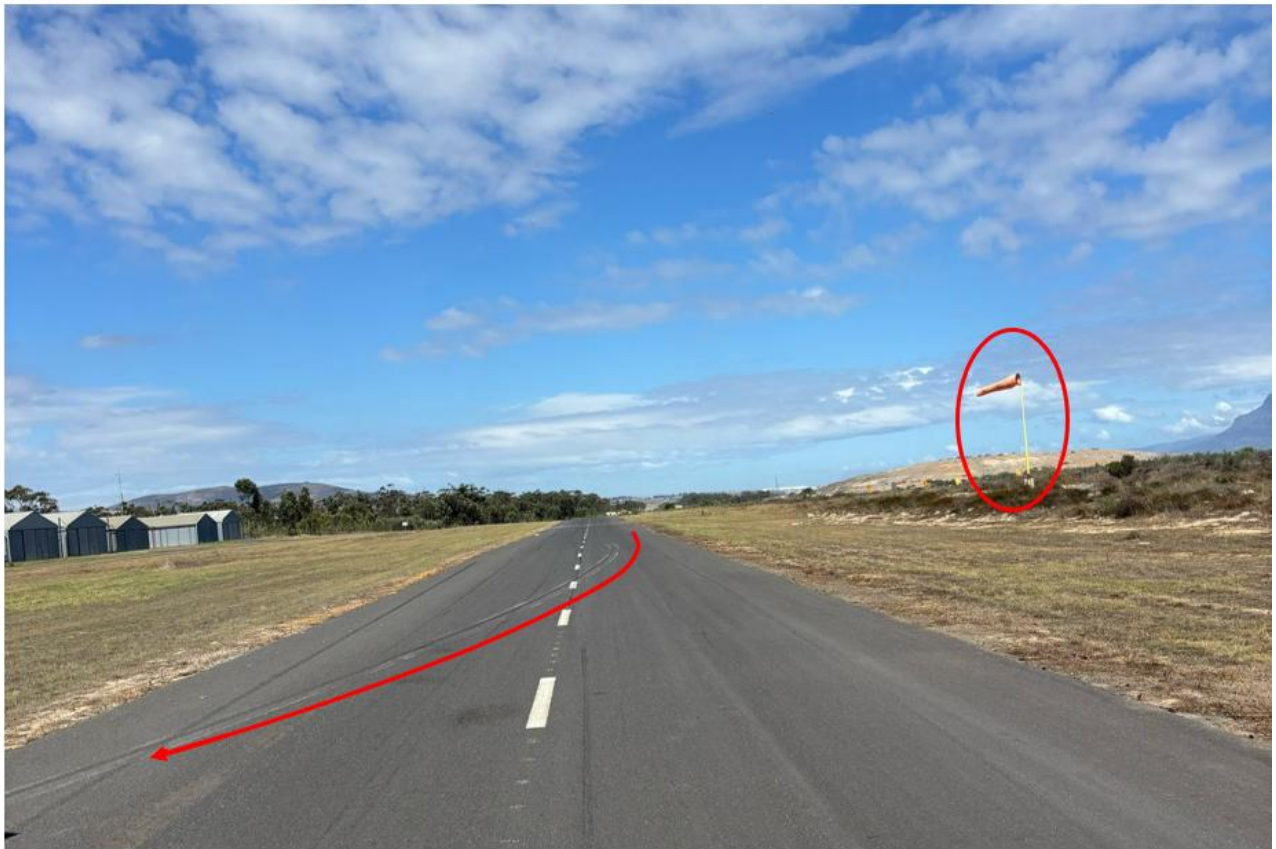
aircraft's approach speed was 75 knots (kts) indicated air speed (KIAS); as the aircraft crossed the runway threshold, the pilot flared the aircraft for landing. During the landing flare, it ballooned which resulted in a rapid increase in altitude. In an attempt to correct the situation, the pilot pushed forward the control column to lower the nose and the aircraft impacted the ground hard with the nose landing gear first, which broke and, thus, the propeller struck the ground. The aircraft skidded on its engine cowl on the runway and veered off towards the right. It exited the runway and came to rest on a dry grassy terrain on the right-side shoulder of RWY02.

**Figure 1:** RWY02 with ground scars and a fully extended windsock in view. (Source: Pilot)

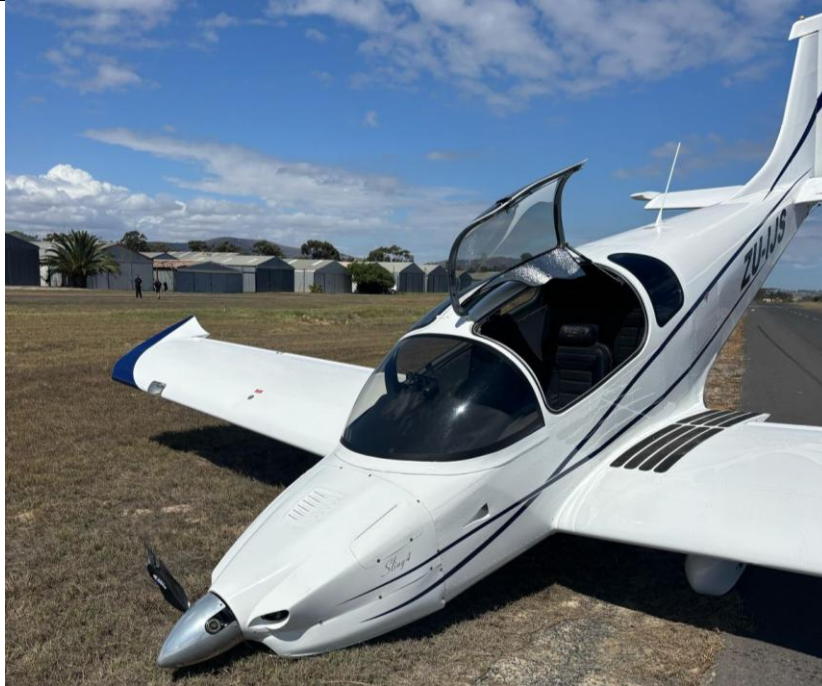
The pilot was not injured during the accident sequence. The aircraft sustained substantial damage to the nose landing gear, engine nose cowl and propeller.

**Figure 2:** The aircraft on the right-side shoulder of Runway 02 with a damaged nose landing gear and propeller. (Source: Pilot)

| <p>2. <u>Aircraft</u></p> <p>2.1 The aircraft was initially issued an Authority-to-fly (ATF) Certificate on 21 November 2019. The latest ATF was issued on 11 September 2024 with an expiry date of 30 November 2025.</p> <p>2.2 The Certificate of Registration (C of R) was issued to the present owner on 20 September 2016.</p> <p>2.3 The last annual inspection of the aircraft was conducted and certified on 31 July 2024 at 337.1 airframe hours after which a Certificate of Release to Service (CRS) was issued with an expiry date of 31 July 2025 or at 437.1 airframe hours, whichever comes first.</p> <p>2.4 The aircraft had a total of 346.8 airframe hours at the time of the accident.</p> <p>3. <u>Environment</u></p> <p>3.1 The aircraft's maximum demonstrated crosswind limitation is 15kts. The crosswind component at the time of the accident was 14kts.</p> <p>3.2 The aircraft ballooned during the landing flare due to the excessive landing speed of 75kts.</p> <p>3.3 The excessive speed led to the aircraft ballooning, and the pilot's inputs resulted in the nose landing gear impacting the runway hard and, thus, breaking off. Subsequently, the pilot lost directional control.</p> |
| <p><b>Probable Cause(s)</b></p> <p>The aircraft ballooned during the landing phase and the nose gear impacted the runway surface; the pilot subsequently lost directional control of the aircraft.</p> |

| <p><b>Safety Message</b></p> <p>Pilots operating aircraft are urged to conduct a go-around and not commit to landing the aircraft when the approach profile is not suitable. This is to prevent damage to the aircraft and injury to self and/or occupants that could be caused by a hard or uncontrolled landing.</p> |
