AIRCRAFT ACCIDENT REPORT AND EXECUTIVE SUMMARY

Reference:		CA18/2/3/10572	
Aircraft Registration	ZS-KSL	Date of Accident	1 April 2025		Time of Accident	0730Z	
Type of Aircraft	Cessna 152		Type of Operation		Training (Part 141)		
Pilot-in-command Licence Type		Commercial Pilot License (CPL)	Age	76	Licence Valid	Yes	
Pilot-in-command Flying Experience		Total Flying Hours		6 380	Hours on Type	3 100	
Last Point of Departure		Virginia Aerodrome (FAVG), KwaZulu-Natal Province					
Next Point of Intended Landing		Virginia Aerodrome (FAVG), KwaZulu-Natal Province					
Damage to Aircraft		Substantial					
Location of the accident site with reference to easily defined geographical points (GPS readings if possible)							
Approximately 300 metres from the threshold of Runway 05 (GPS co-ordinates: 29°46'33.5" South 031°03'18.1" East); elevation of 46 feet (ft)							
Meteorological Information		Surface wind: 060°/2kts; temperature: 28°C; dew point: 21°C; Cloud Cover: CAVOK; QNH: 1011hPa

Synopsis

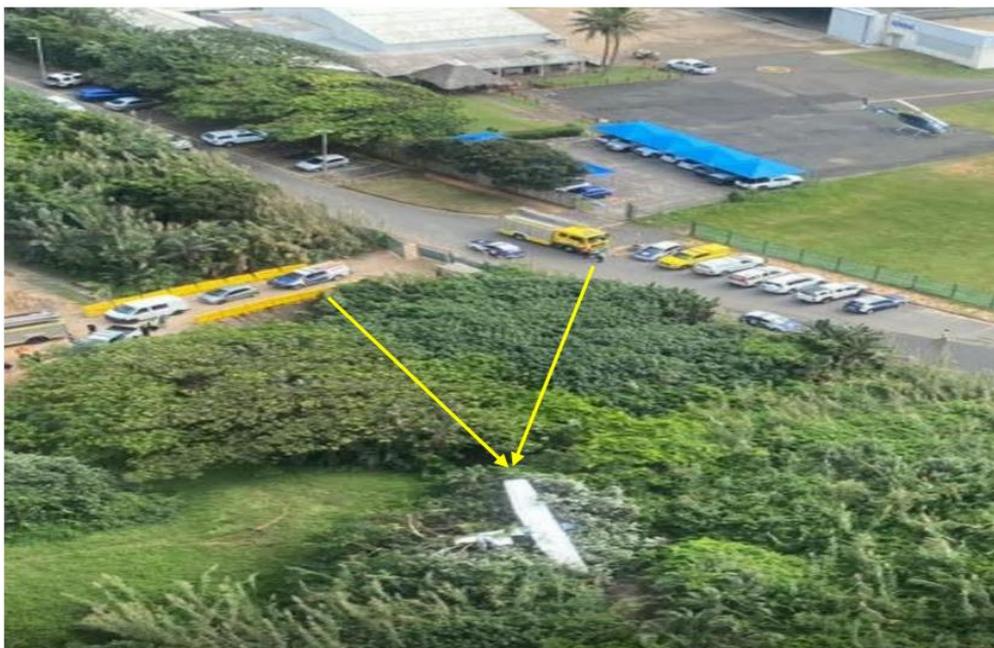
Figure 2: The aircraft and the emergency vehicles at the accident site. (Source: Operator)

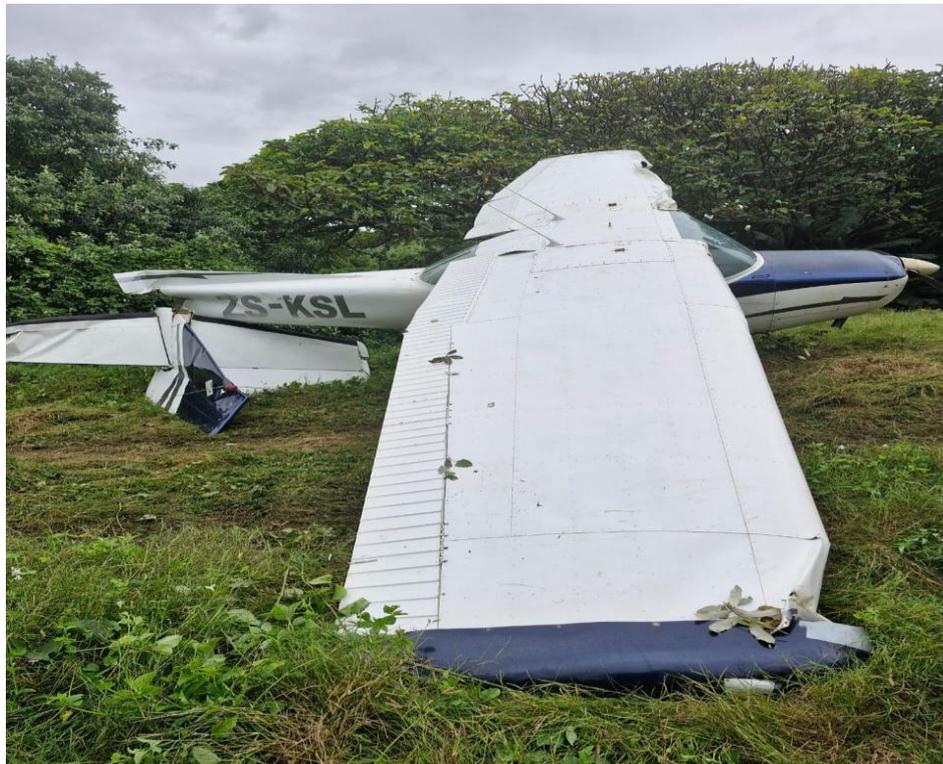
1.3.1. The aircraft sustained substantial damage.

Figure 3: The aircraft after it was removed from the treetops.

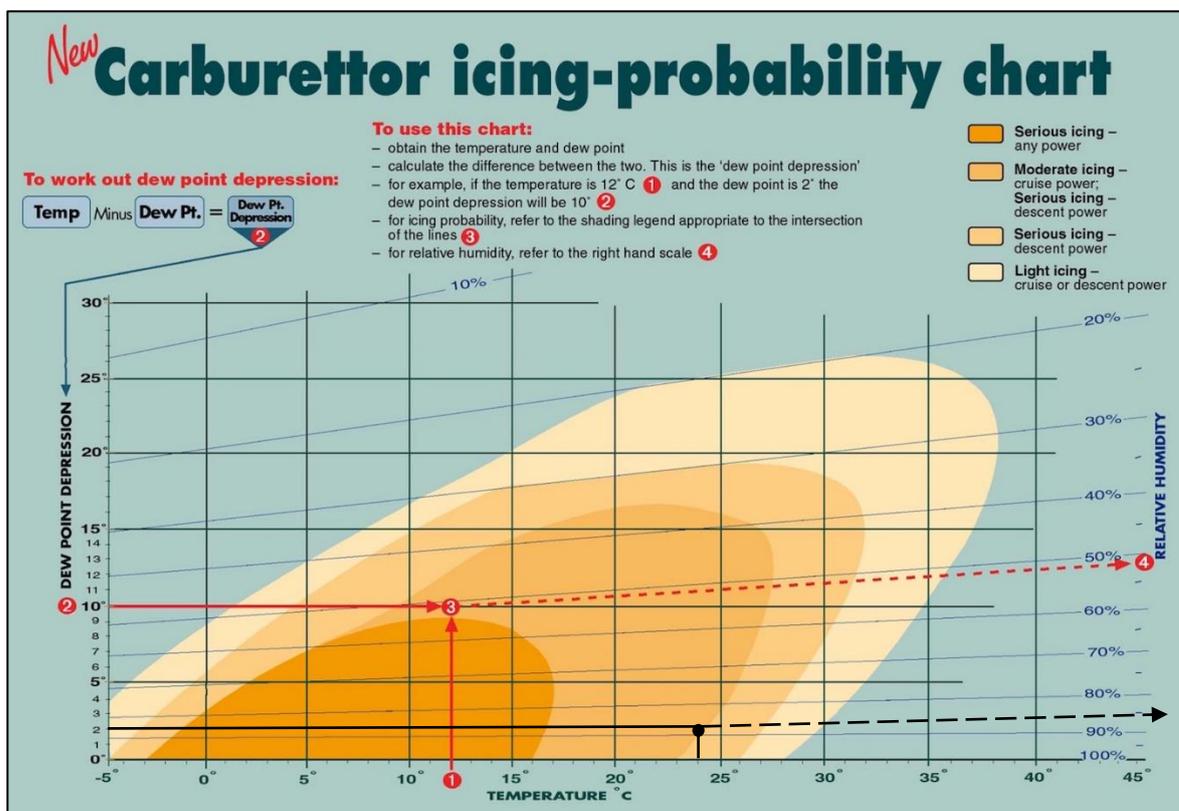
1.7.4. The calculated dew point depression suggested that the weather conditions at the time of the accident were favourable for the formation of serious icing at descent power. These conditions increased the likelihood of carburettor icing during the landing phase (as indicated by the black solid and dotted lines, along with the round spot in Figure 5).

Temperature	24°C
Dewpoint	22°C
Dewpoint depression	2°C
Relative humidity	86%

Figure 5: The Carburettor icing-probability chart calculations.

2.2.14. The weather conditions at the time of the accident (temperature 24°C, dew point 22°C, dew point depression, relative humidity 86%) fell within the serious icing range at descent power. The relative humidity of 86% increased the risk of carburettor icing significantly. The aircraft was on a flapless approach at a low power setting during descent phase, which increased the risk of carburettor icing. There was no application of carburettor heat during this critical phase, which exacerbated the risk. The symptoms of engine unresponsiveness that were reported are consistent with carburettor ice-induced power loss. Severe carburettor icing may have prevented the pilot from increasing power. Based on this, it is likely that the aircraft experienced serious carburettor icing during the landing (approach) phase.

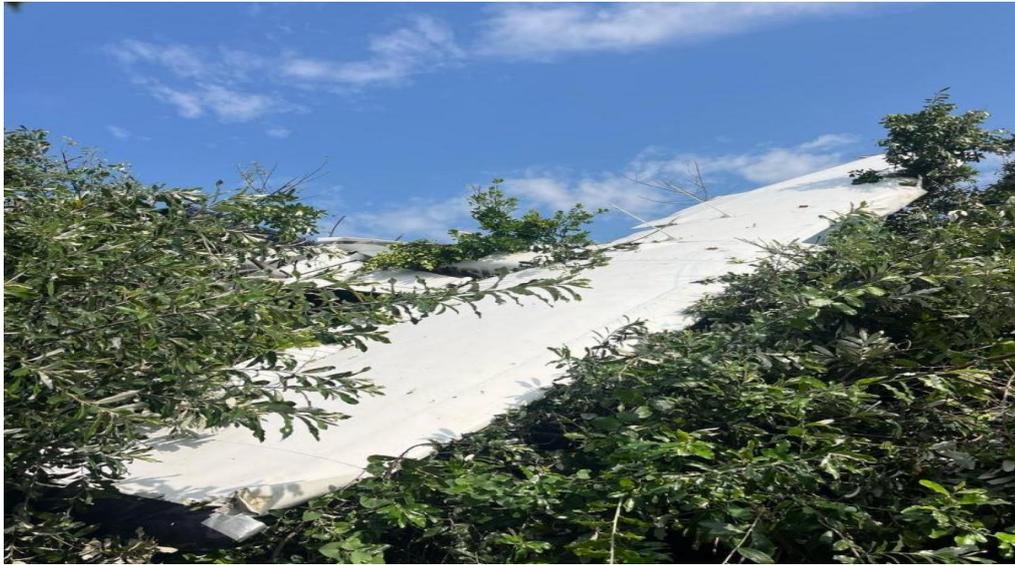
1.12.1. The aircraft impacted the trees on Beachwood Golf Course, approximately 300m short of the threshold of FAVG Runway 05. Upon inspection of the aircraft after the accident, the engine oil level was found at the maximum mark after a dipstick check was conducted. There was no trace of oil leakage at the accident site. A significant amount of fuel leaked from the fuel tanks, and the ARFF team administered foam to avoid the possibility of a post-impact fire. The instrument panel had remained intact; the engine was also found intact.

Figure 6: The aircraft at its resting position on top of the trees.

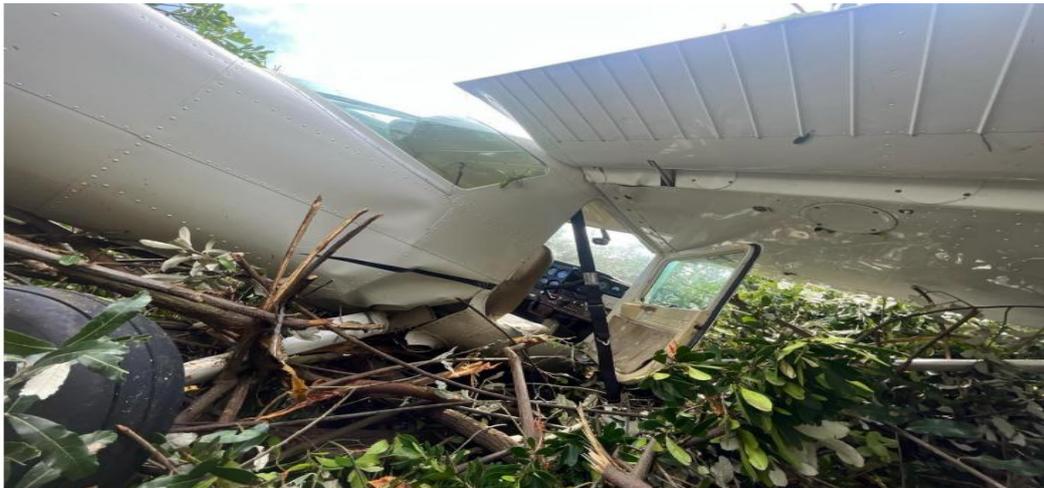
1.12.2. The aircraft came to rest in an upright position on top of the trees. Despite remaining upright, it sustained substantial damage. The fuselage exhibited significant structural deformation, and various components of the airframe showed signs of impact-related stress and breakage.

Figure 7: The right-side view of the aircraft.

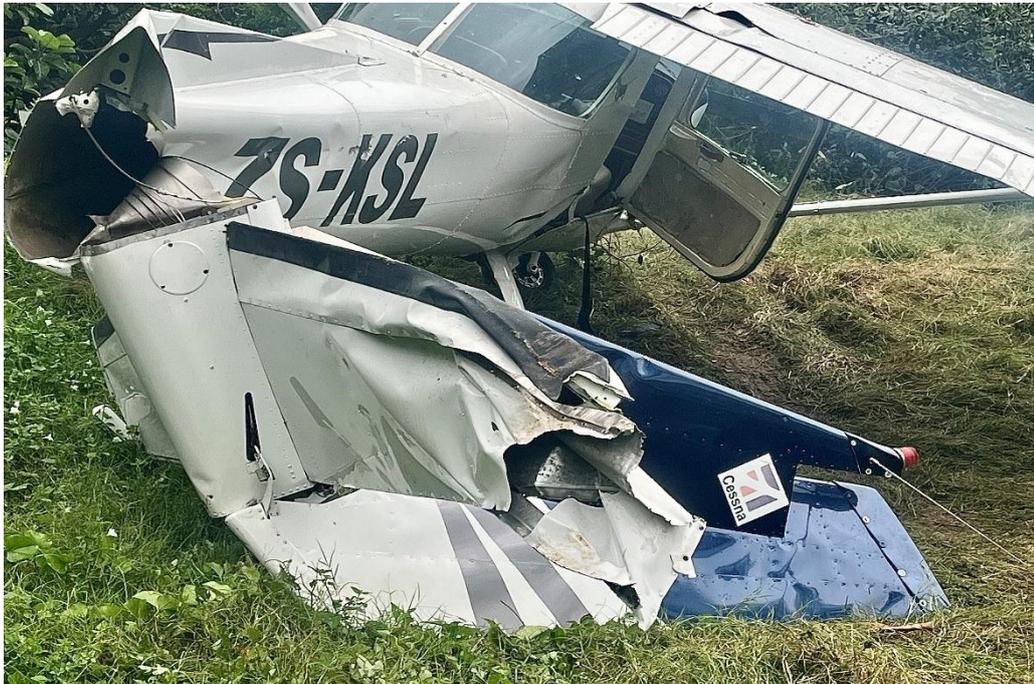
1.12.3. The empennage partially detached from the aircraft after impact. As a result, both the elevator and rudder sustained substantial damage. Despite this, the associated control cables were found intact, indicating that the control linkages had remained connected.

Figure 8: The severed empennage.

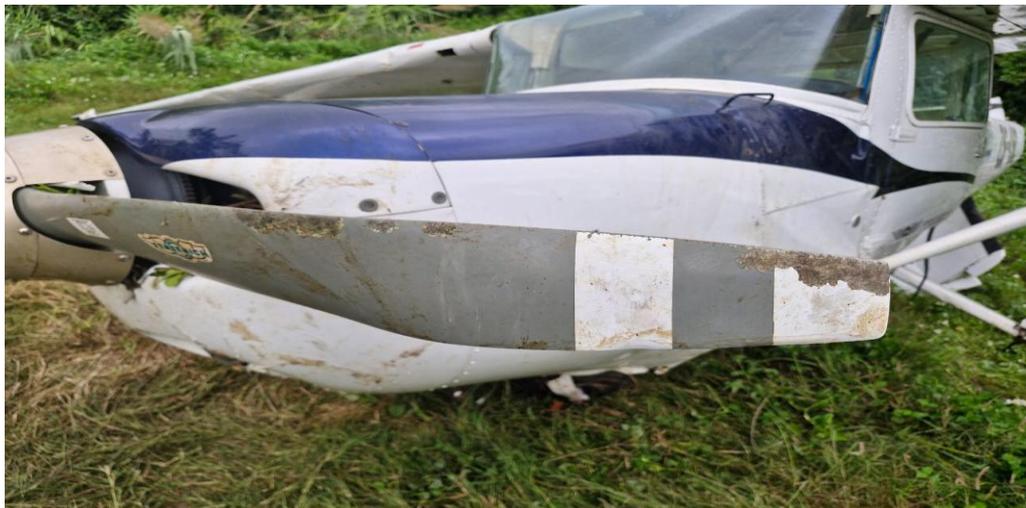
1.12.4. The nose landing gear exhibited clear signs of deformation, likely resulting from the forces experienced during impact. Despite the damage, the nose gear remained securely attached to the fuselage, indicating that the attachment points maintained structural integrity. Additionally, the propeller blades had slightly bent inwards, suggesting that the engine was not producing significant power at the moment of impact. The nature of damage to both the nose gear and propeller is consistent with a relatively low-energy impact.

Figure 9: Damage to one of the propeller blades.

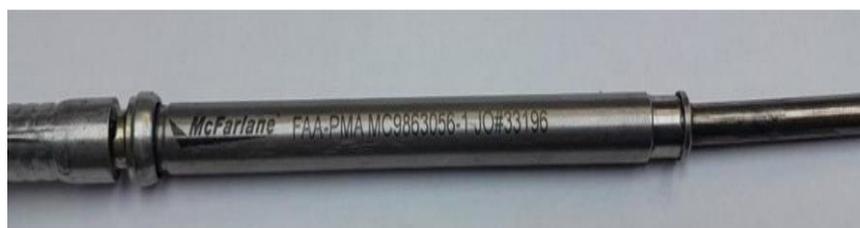
- I. After removal, the throttle control cable was inspected and found to be in good condition with no visible signs of wear or damage.

Figure 10: The throttle control cable.

2.2.9. During the examination of the throttle control cable, it was determined that the cable was in good condition with no visible signs of wear or damage. This eliminated the throttle control cable as a contributing factor.

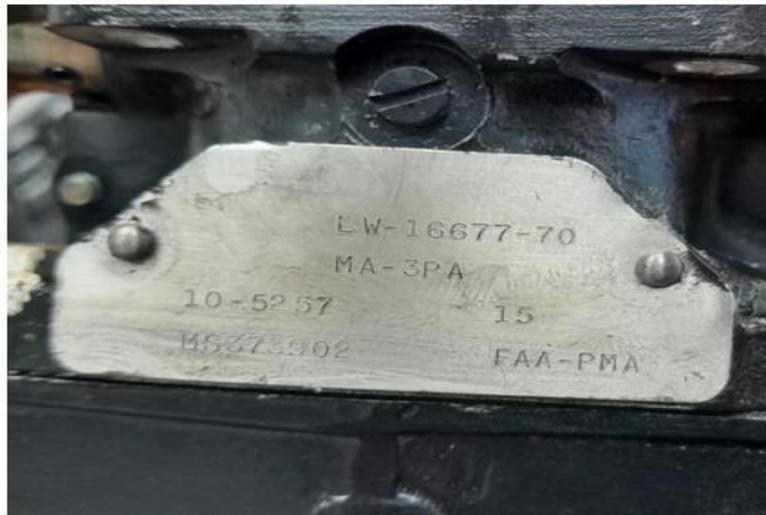
- I. The carburettor was removed and thoroughly inspected. Adequate fuel was found in the carburettor float bowl, ruling out fuel starvation as a contributing factor to the accident.
- II. The carburettor levers, shaft and butterfly valve were examined for any signs of damage, wear or defects that could have contributed to the throttle control failure.
- III. The carburettor was determined to be in good condition.

Figure 11: The carburettor.

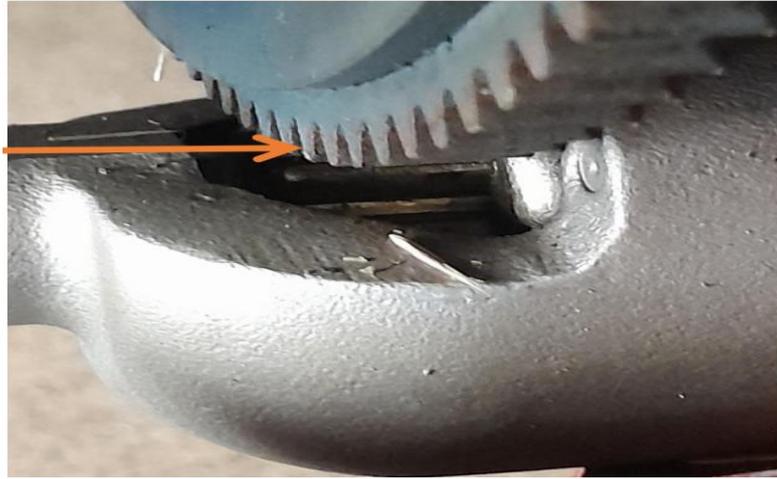
- I. It was observed that the Starter Bendix remained engaged, indicating an attempted engine restart. The Bendix can only disengage when the engine is rotating, and on similar Lycoming engines, it typically disengages at approximately 400 RPM.

Figure 12: Engaged Starter Bendix.

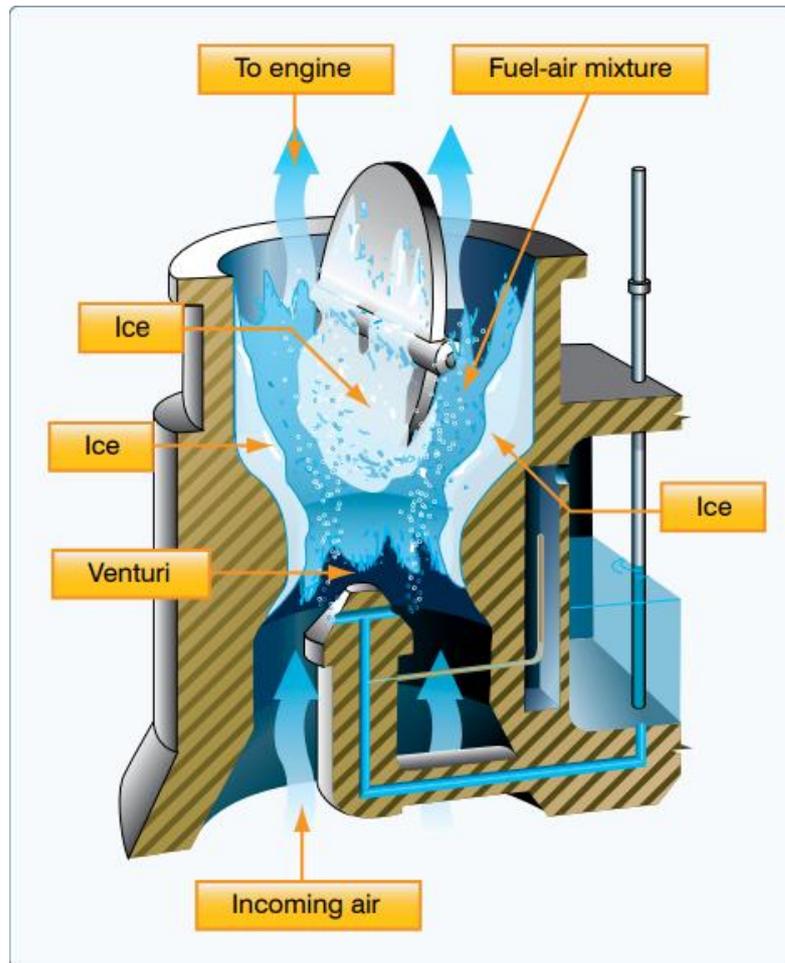
According to the ICAO, carburettor icing during descent could significantly affect an aircraft's performance by restricting or blocking airflow to the engine due to ice forming inside the carburettor. This occurs because of the cooling effect caused by fuel vaporisation and pressure drop within the carburettor, especially when engine power is reduced during descent. *The result can be a gradual or sudden loss of engine power, rough running or even engine failure if not promptly addressed. This poses a serious risk during the approach and landing phases where altitude and time to recover are limited.* During severe cases of carburettor icing, the throttle valve could become stuck due to ice build-up.

Figure 13: Typical carburettor ice build-up.
