**LIMITED OCCURRENCE INVESTIGATION REPORT – FINAL**

| <b>Reference Number</b> | CA18/2/3/10573 | | | | | | |
| Registration | ZS-IOG | | | | | | |
| Make; Model; S/N | Thrush; S2R-H80 (Serial Number: H80-157) | | | | | | |

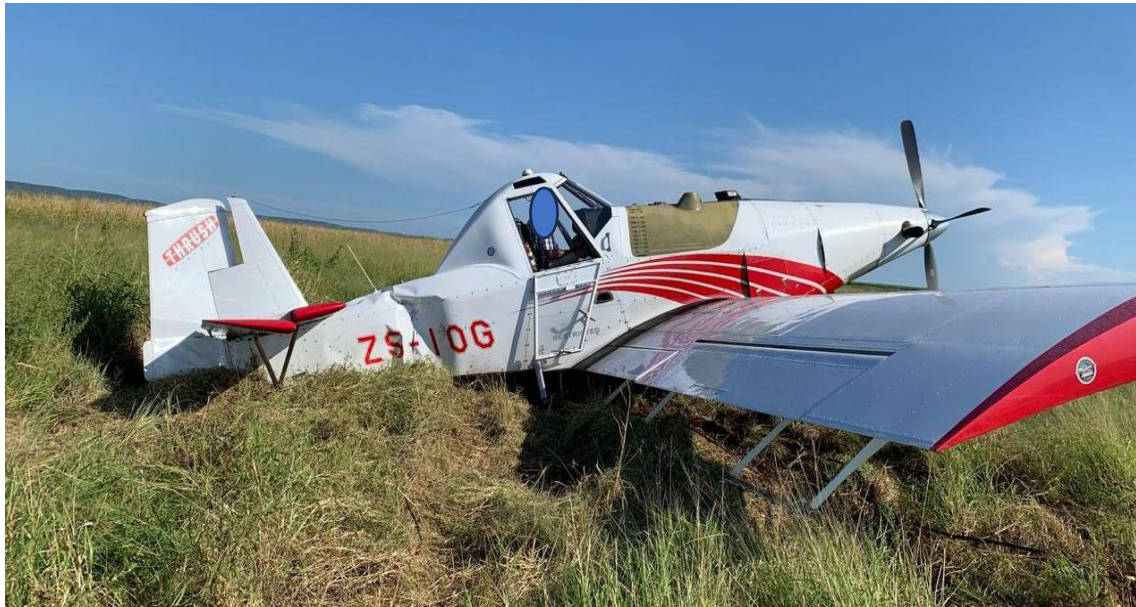
**Figure 2:** The aircraft at the accident site. (Source: Pilot)

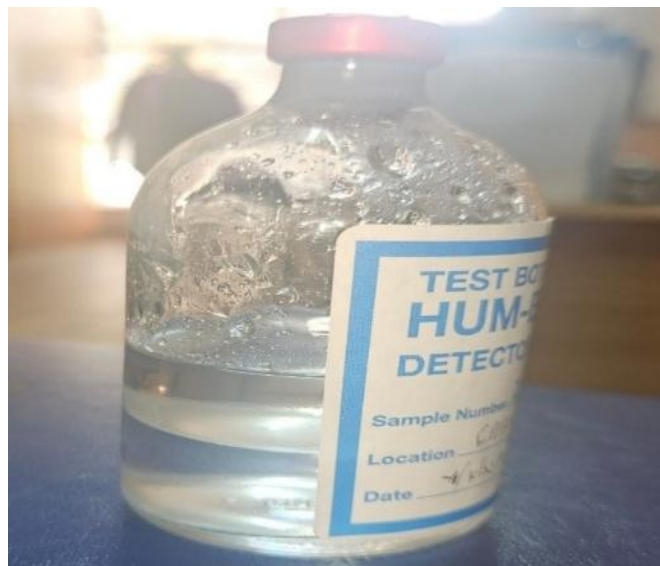
Later, the engineers removed the wings from the aircraft's fuselage for ease of recovery. The aircraft was then loaded on to a trailer and recovered to the aircraft maintenance organisation (AMO) facility at Bethlehem Aerodrome (FABM) in the Free State for further investigation. Upon arrival at FABM, the engineers removed the airframe fuel filter and inspected it; they drained less than average fuel which indicated that there was insufficient fuel. Attempts were made to drain fuel from the FCU; however, nothing came out of it (it was empty). A fuel sample extracted from the airframe filter bowl was tested using the Hum-Bug test method and no sign of water or bacteria growth was found after 48 hours.

**Figure 3:** The Hum-Bug test came up negative for water or bacterial growth. (Source: Operator)

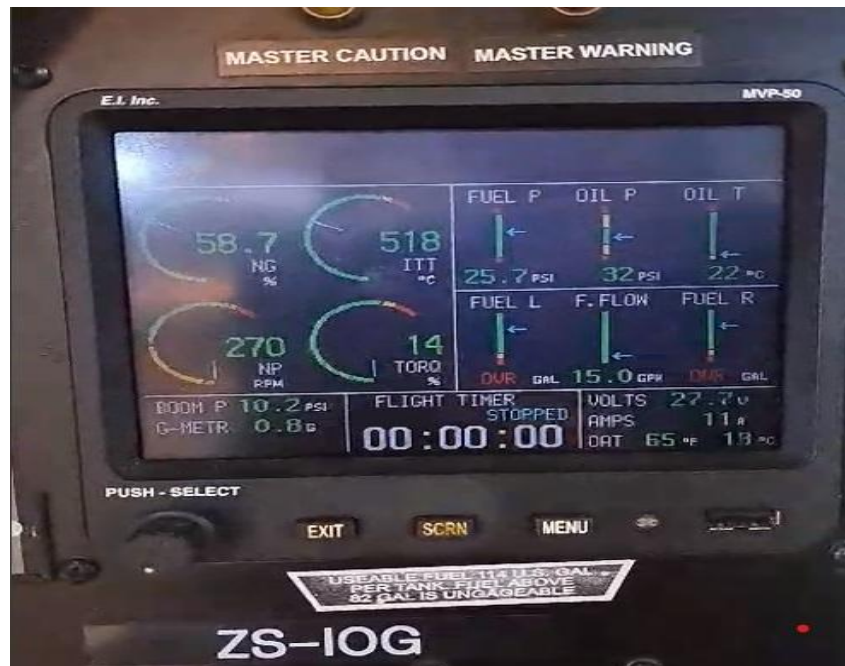
**Figure 4:** The MVP-50T screen indicates the engine parameters at idle: Normal start and the engine idled at 58.7%, prop revolutions per minute (RPM) at 270, torque at 14 pound per square inch (psi), fuel pressure at 25.7psi, oil pressure at 32psi, fuel flow at 15 gallons per hour (gph) and oil temperature at 22° (degrees) Celsius; all parameters were within limits. (Source: Operator)

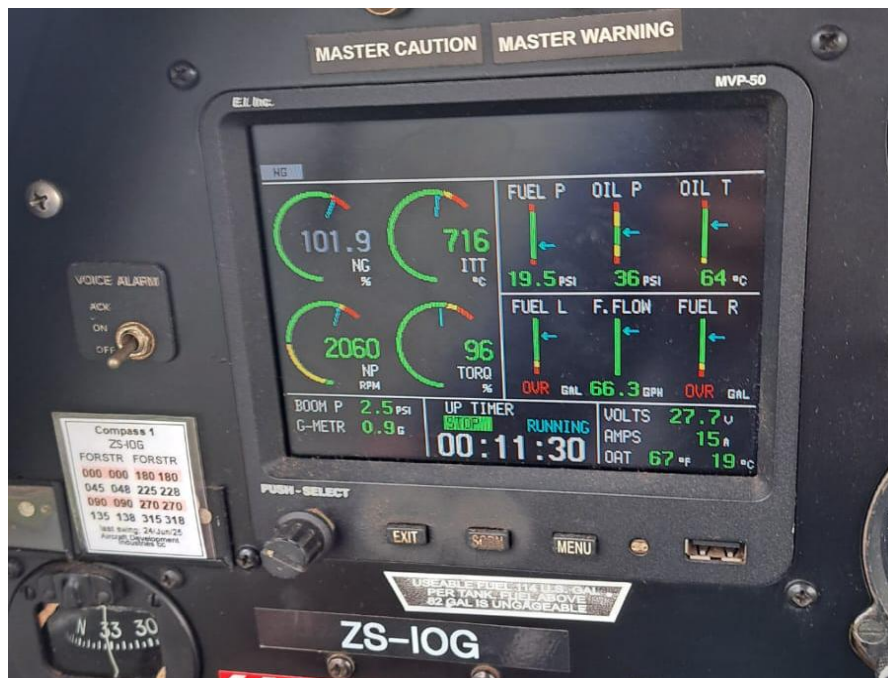
**Figure 5:** The MVP-50T screen indicates the engine parameters on take-off: interstage turbine temperature (ITT) at 716, prop RPM at 2 060, torque at 96psi, fuel pressure at 19.5psi, oil pressure at 36psi, fuel flow at 66.3gph and oil temperature at 64° Celsius; all parameters were within limits. (Source: Operator)

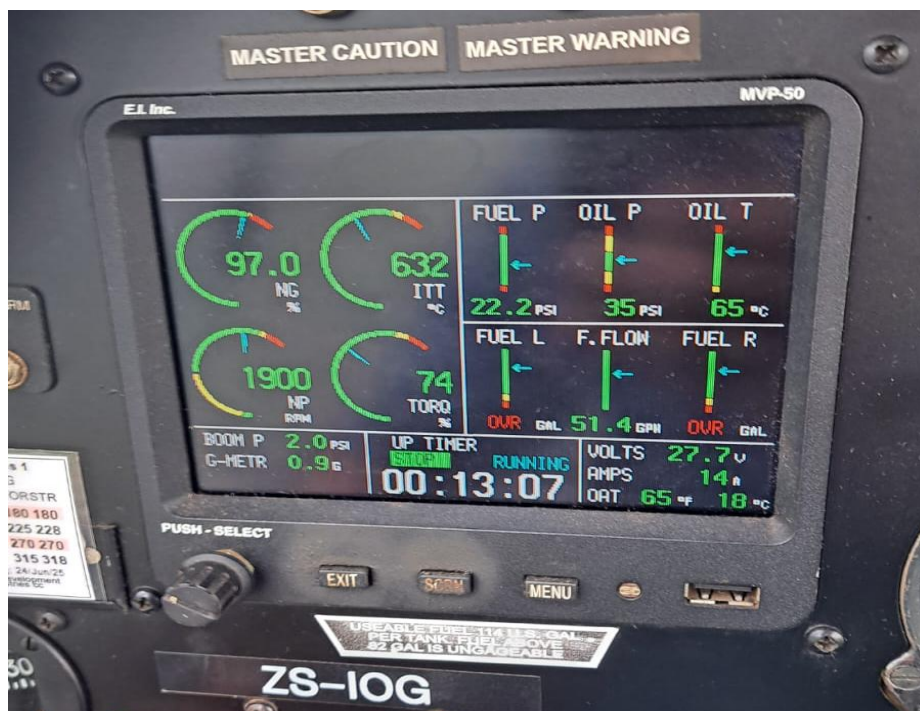
**Figure 6:** The MVP-50T screen indicates the engine parameters at cruise: ITT at 632, prop RPM at 1 900, torque at 74psi, fuel pressure at 22.2psi, oil pressure at 35psi, fuel flow at 51.4gph and oil temperature at 65° Celsius; all parameters were within limits. (Source: Operator)

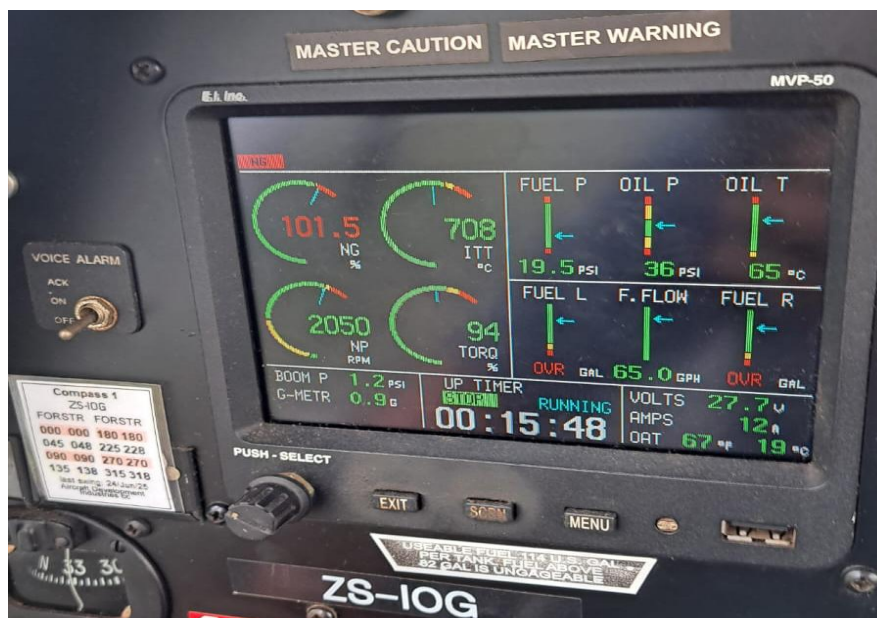
**Figure 7:** The MVP-50T screen indicates the engine parameters during emergency: ITT at 708, prop RPM at 2 050, torque at 94psi, fuel pressure at 19.5psi, oil pressure at 36psi, fuel flow at 65 gph and oil temperature at 65° Celsius; all parameters were within limits. (Source: Operator)
