**LIMITED OCCURRENCE INVESTIGATION REPORT – FINAL**

| <b>Reference Number</b> | CA18/2/3/10574 | | | | | | |
| <b>Registration</b> | ZS-KTA | | | | | | |
| <b>Make; Model; S/N</b> | Piper; PA28 RT-201T (Serial Number: 28R-8031163) | | | | | | |

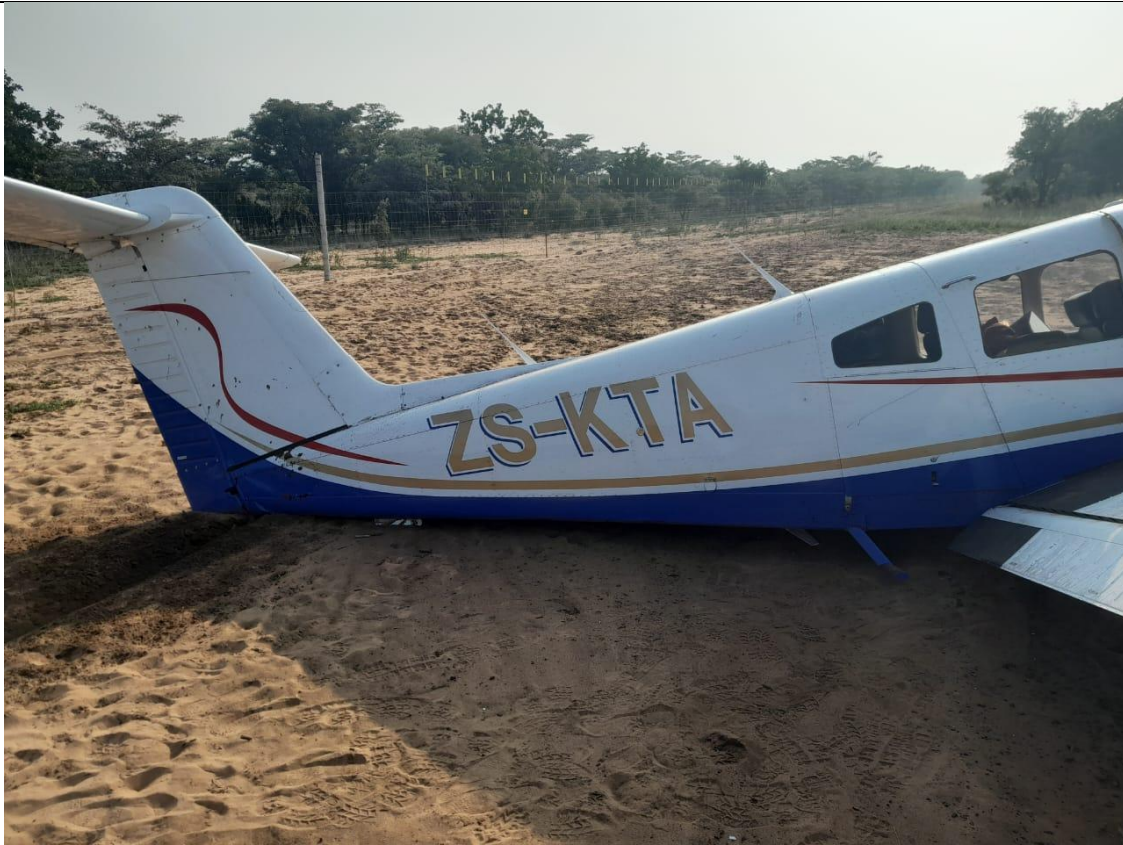
The aircraft sustained damage to the propeller, main landing gear and the underbelly. Both occupants disembarked from the aircraft uninjured.

**Figure 2:** The collapsed landing gear on the soft sand-covered runway. (Source: Pilot)

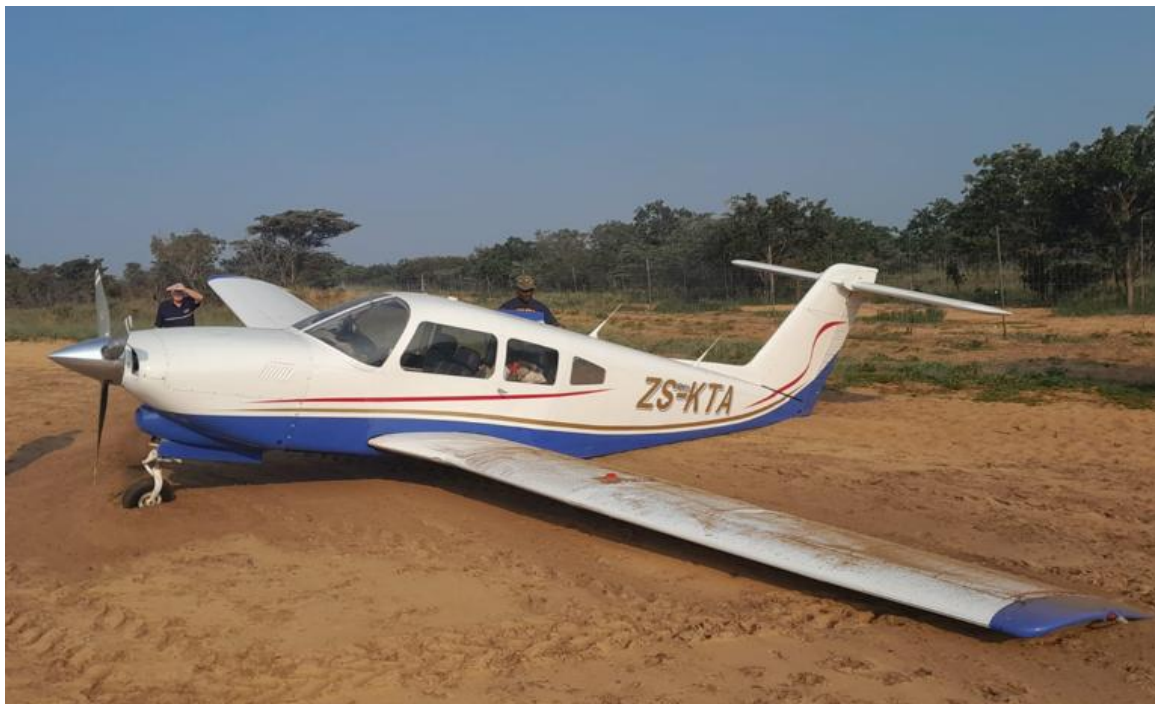
**Figure 3:** The left wing and the aft fuselage resting on the runway post-accident. (Source: Pilot)

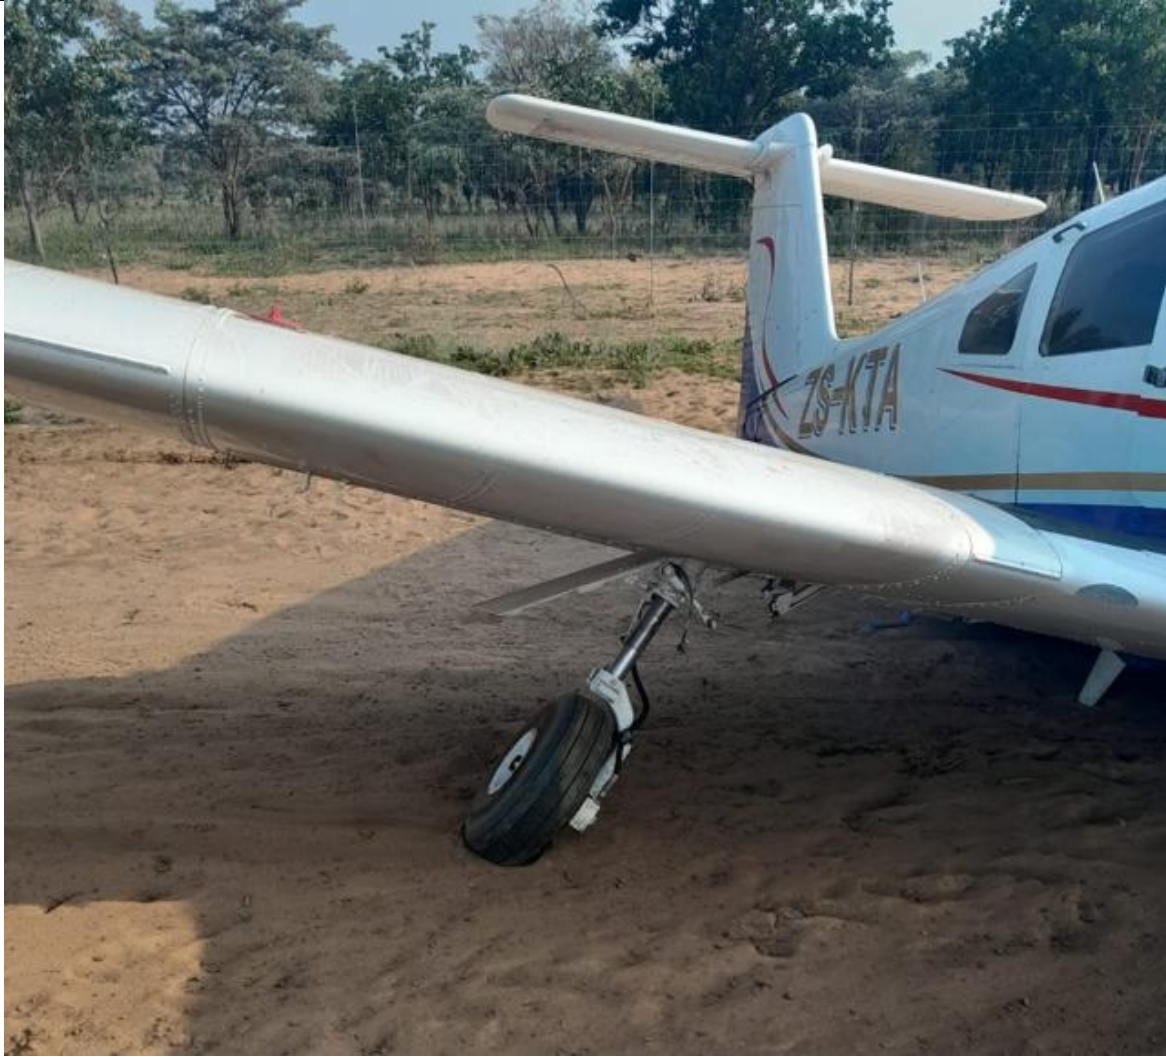
The pilot stated that during the landing roll, he applied aggressive braking to avoid impacting the obstacles ahead of the aircraft's path; the aircraft decelerated rapidly but he lost directional control. The nose landing gear pivoted on the ground which caused the aircraft's tail to swing sharply to the left. This motion caused the left main landing gear to pull inward and collapse (see Figure 3), whilst the right main landing gear was forced outward, damaging the oleo strut attachment points (see Figure 4). The aircraft came to rest with its left wing touching the ground.

**Figure 4:** The bent oleo after the accident. (Source: Pilot)
