LIMITED OCCURRENCE INVESTIGATION REPORT – FINAL

Reference Number	CA18/2/3/10576						
Classification	Accident	Date	10 April 2025	Time	1023Z		
Type of Operation	Training (Part 141)						
Location							
Place of Departure	Rand Airport (FAGM), Gauteng province		Place of Intended Landing	Rand Airport (FAGM), Gauteng province			
Place of Occurrence	Grass strip south-east of Runway 29 at Rand Airport (FAGM)						
GPS Co-ordinates	Latitude	26°14'33" S	Longitude	028°09'04" E	Elevation	5 483 ft	
Aircraft Information							
Registration	ZS-RVG						
Make; Model; S/N	Robinson; R44 Raven II (Serial Number: 10640)						
Damage to Aircraft	Destroyed			Total Aircraft Hours	7 331.0		
Pilot-in-command							
Licence Type	Student Pilot Licence (SPL)		Gender	Male		Age	36
Licence Valid	Yes	Total Hours	37.8		Total Hours on Type	37.8	
Total Hours 30 Days	12.3		Total Flying on Type Past 90 Days	35.2			
People On-board	1 + 0	Injuries	1	Fatalities	0	Other (on ground)	0
What Happened

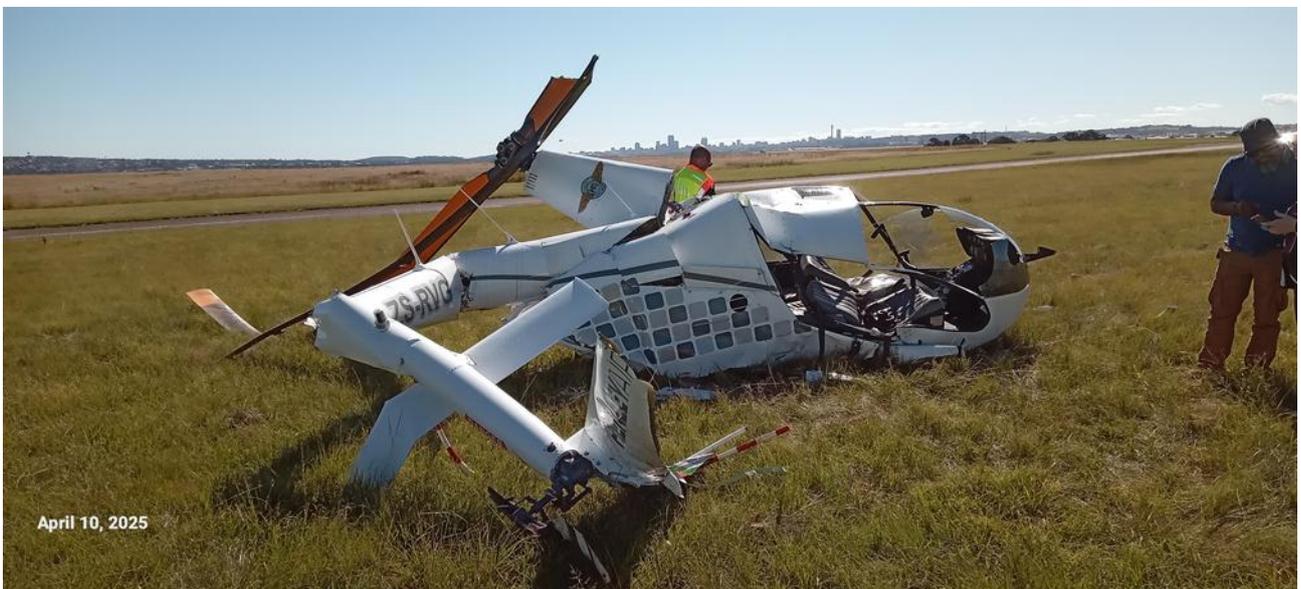
Figure 2: The helicopter after the accident.

The helicopter struck the ground tail first whilst rotating clockwise. One of the tail rotor blades sheared off and the tail boom bent at two points. One of the main rotor blades also bent, and the other sheared off near the root. The landing gear skids broke off and the main fuselage buckled after impact.

Post-investigation of the helicopter did not reveal any anomalies with the flight controls or the engine. All damage was attributed to the accident impact forces.
