**LIMITED OCCURRENCE INVESTIGATION REPORT – FINAL**

| <b>Reference Number</b> | CA18/2/3/10577 | | | | | | |
| <b>Registration</b> | ZU-OIL | | | | | | |
| <b>Make; Model; S/N</b> | Shadow Lite CC; Jabiru SP (Serial Number: 370) | | | | | | |

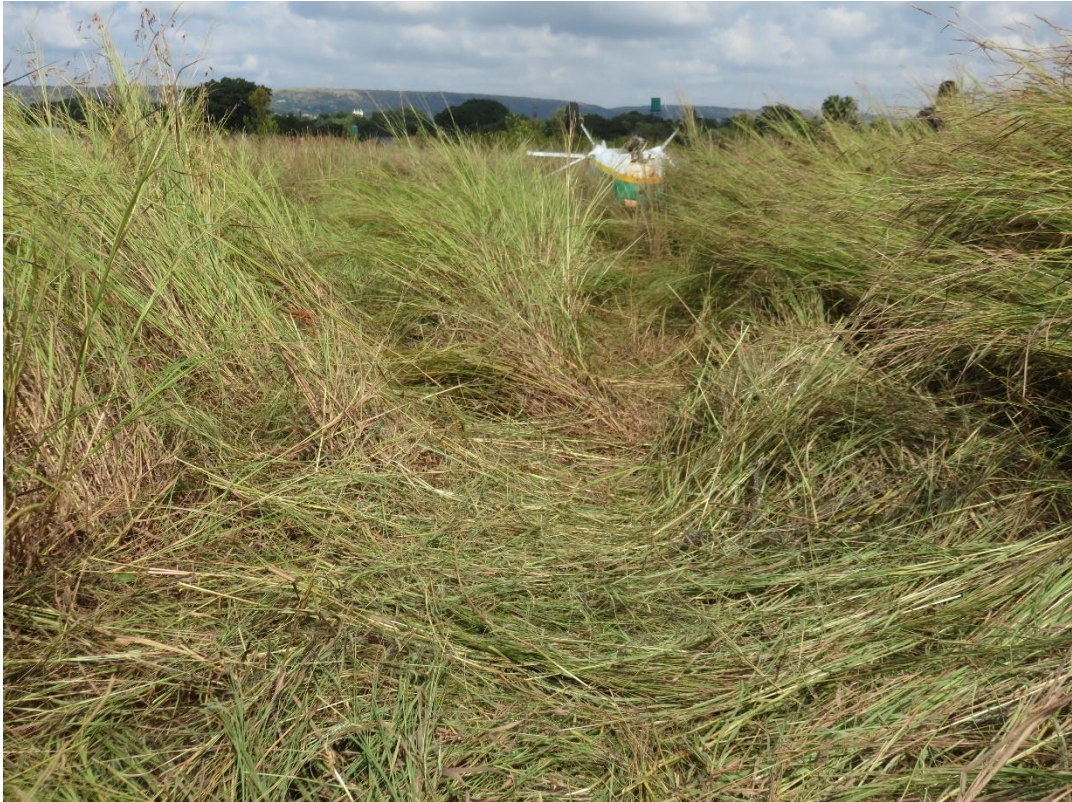
**Figure 2:** The landing path through the field before the aircraft nosed over.

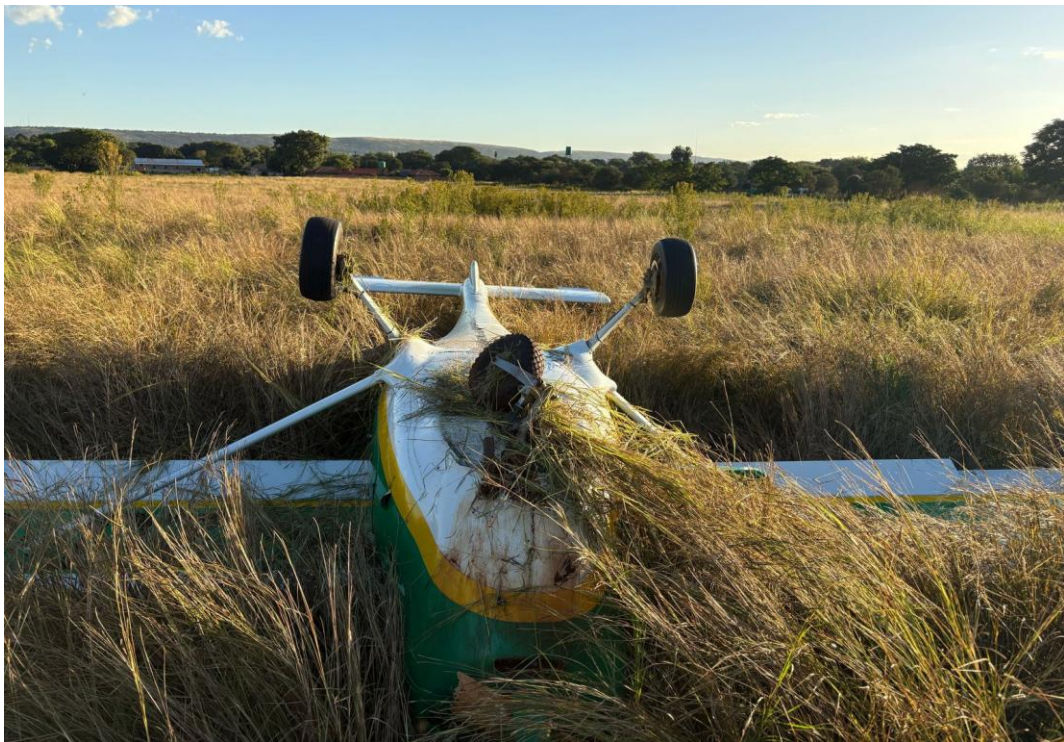
**Figure 3:** The aircraft as it came to rest. (Source: Pilot)

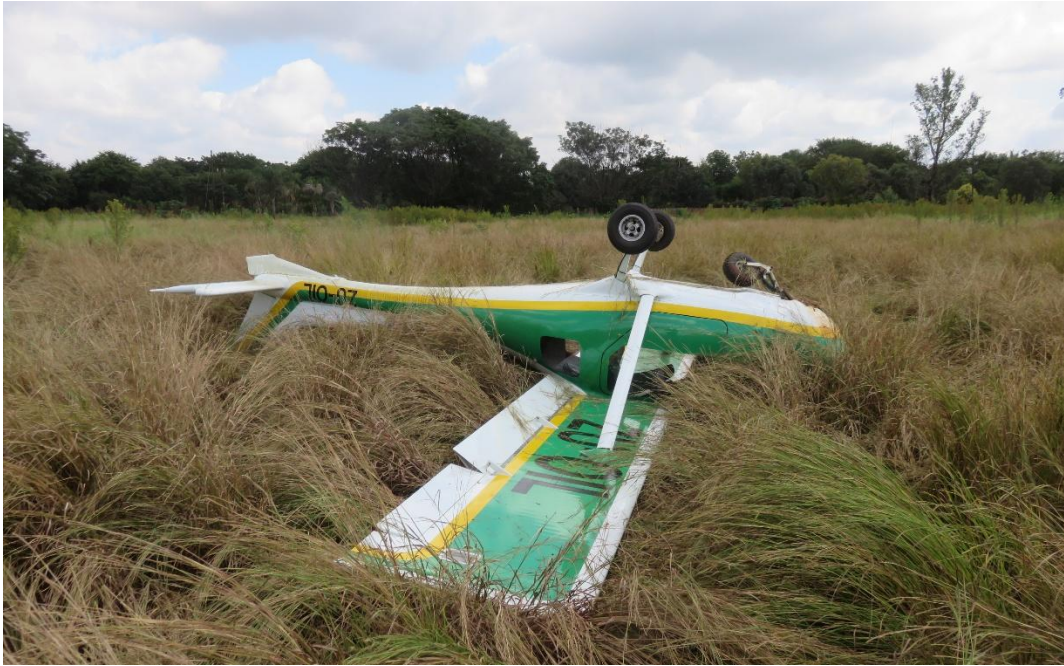
**Figure 4:** A side view of the aircraft after the accident.

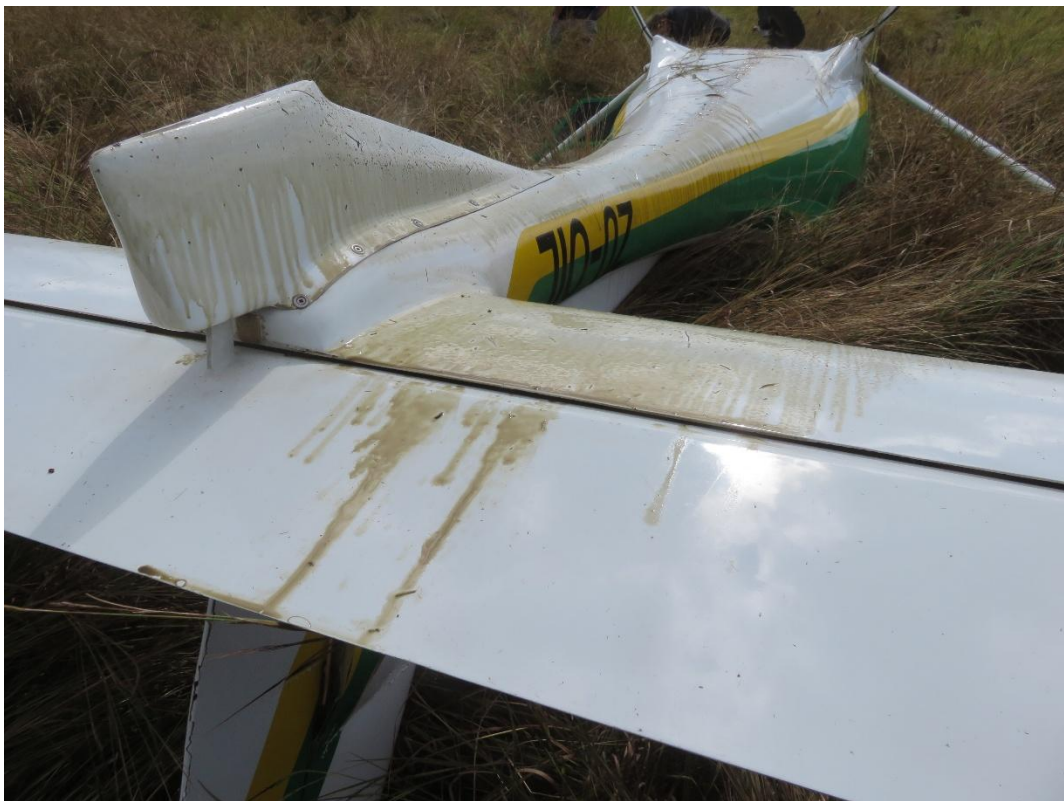
**Figure 5:** The lower fuselage and left horizontal stabiliser and elevator covered with engine oil.

- 2.10 The oil hose with part number PH089BN that connects to the oil cooler and oil filter was found burst which led to engine oil being pumped overboard; this corresponded with the low oil pressure indication in the cockpit as reported by the crew.

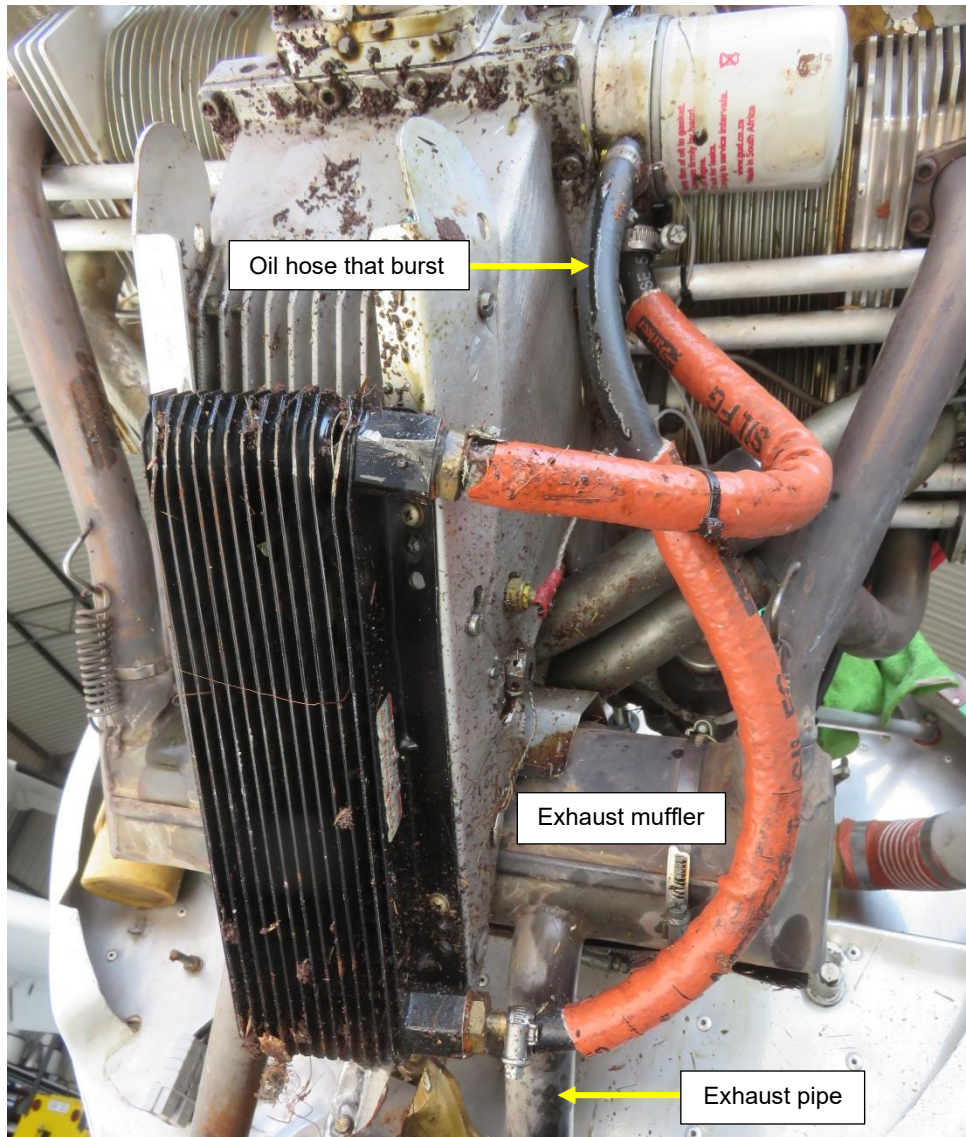
**Figure 6:** The burst oil hose, exhaust muffler and exhaust pipe.

The aircraft nosed over during a forced landing on a field after the engine had stopped operating. The cause of engine stoppage was attributed to the oil hose (P/N: PH089BN) fitted between the oil filter and the oil cooler that burst, resulting in engine oil being pumped overboard and, ultimately, the engine stoppage.

1. The oil hose was exposed to intense heat as it was in proximity to the exhaust assembly (approximately 30mm). The heat sleeve (orange in colour, which was fitted over the oil hose) did not cover the area where the hose attaches to the oil cooler (area where it burst), as presented in Figures 6 and 7.

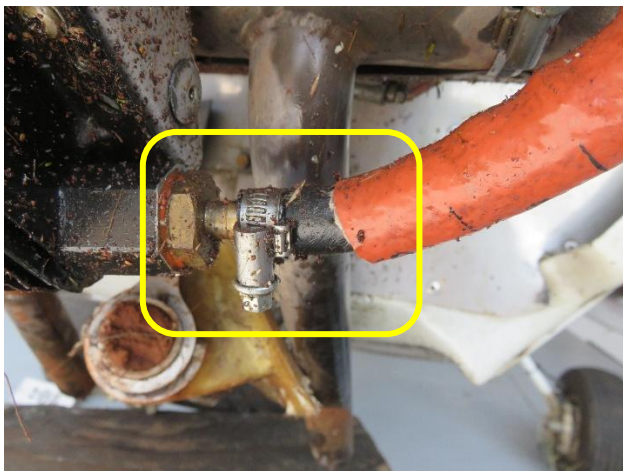
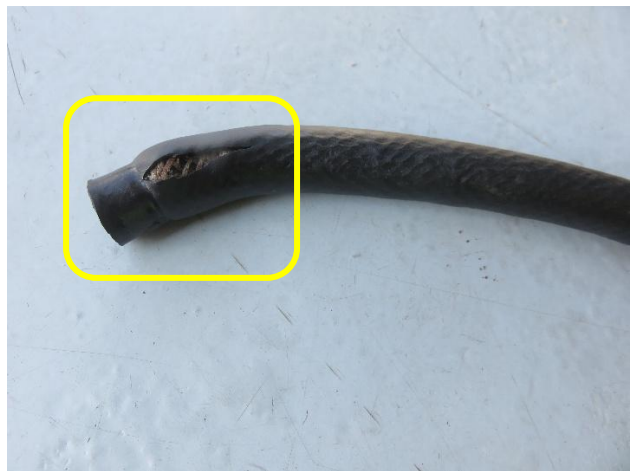
**Figure 7:** The oil hose still connected to the oil cooler (a). The hose was found burst (b).

*"Our hoses are not suitable for aircraft or vehicles. The maximum temperature that a PVC hose goes is up to 60 Degrees Celsius. These multipurpose hoses are ideal for air and water applications used in the mining, construction, agriculture, and landscaping environments."*

| It is recommended that the Director of Civil Aviation (DCA) publish an article in the General Aviation Skywatch magazine emphasising the importance of authorised hoses used for various applications to be fitted according to the maintenance requirements of non-type certified aircraft (NTCA). If an approved person or any maintenance personnel working on an NTCA aircraft has doubts about the fitment and/or replacement of the hose/s, they should consult the original equipment manufacturer (OEM) or the aircraft manufacturer regarding the appropriate hose(s) to be installed for different fluid applications. |

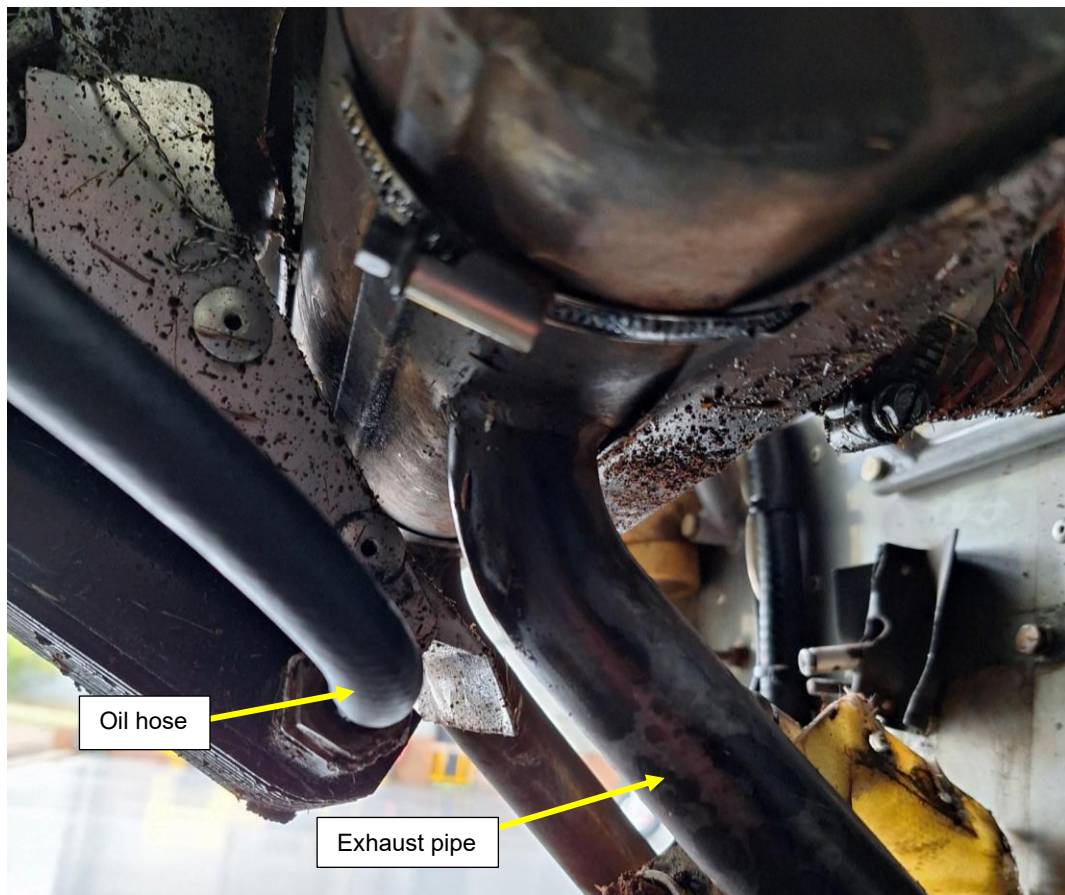
**Figure 8:** The oil hose connected to the oil cooler and the exhaust pipe in proximity to each other.

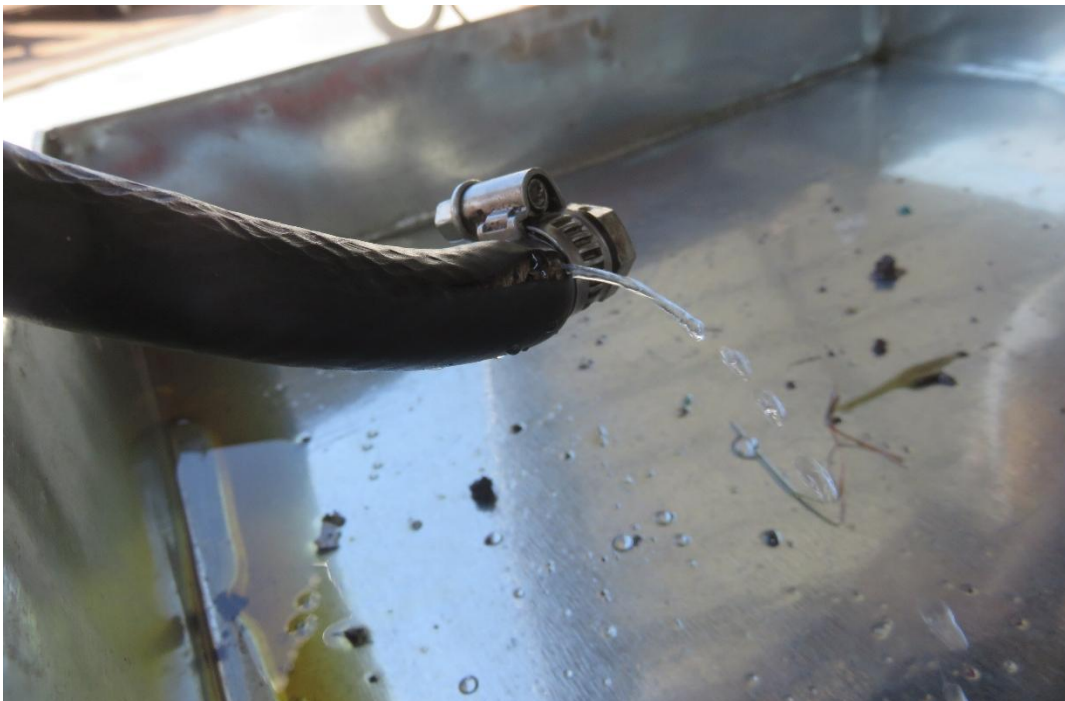
**Figure 9:** The burst hose was closed at one end; it was filled with water, and pressure was applied by blowing on the other end to identify the area where it had burst.
