AIRCRAFT ACCIDENT REPORT AND EXECUTIVE SUMMARY

Reference:		CA18/2/3/10578	
Aircraft Registration	ZU-TNT	Date of Accident	12 April 2025		Time of Accident	1417Z	
Type of Aircraft	Slick 540		Type of Operation		Private (Part 94)		
Pilot-in-command Licence Type		Private Pilot Licence (PPL) (Aeroplane)	Age	45	Licence Valid	Yes	
Pilot-in-command Flying Experience		Total Flying Hours		512.35	Hours on Type	1.6	
Last Point of Departure		Kitty Hawk Aerodrome (FAKT) near Pretoria, Gauteng Province					
Next Point of Intended Landing		Kitty Hawk Aerodrome (FAKT) near Pretoria, Gauteng Province					
Damage to Aircraft		Destroyed					
Location of the accident site with reference to easily defined geographical points (GPS readings if possible)							
On a private farm, approximately 2.8 nautical miles (nm) east of FAKT at Global Positioning System (GPS) co-ordinates determined to be 25°52'12.88"S 028°29'51.72"E							
Meteorological Information		Wind direction: 218°; wind speed: 3 kts; visibility: 10km; cloud cover: CAVOK; cloud base: 1 000ft; temperature: 23°C; dew point: 12°C; QNH: 1024

Synopsis

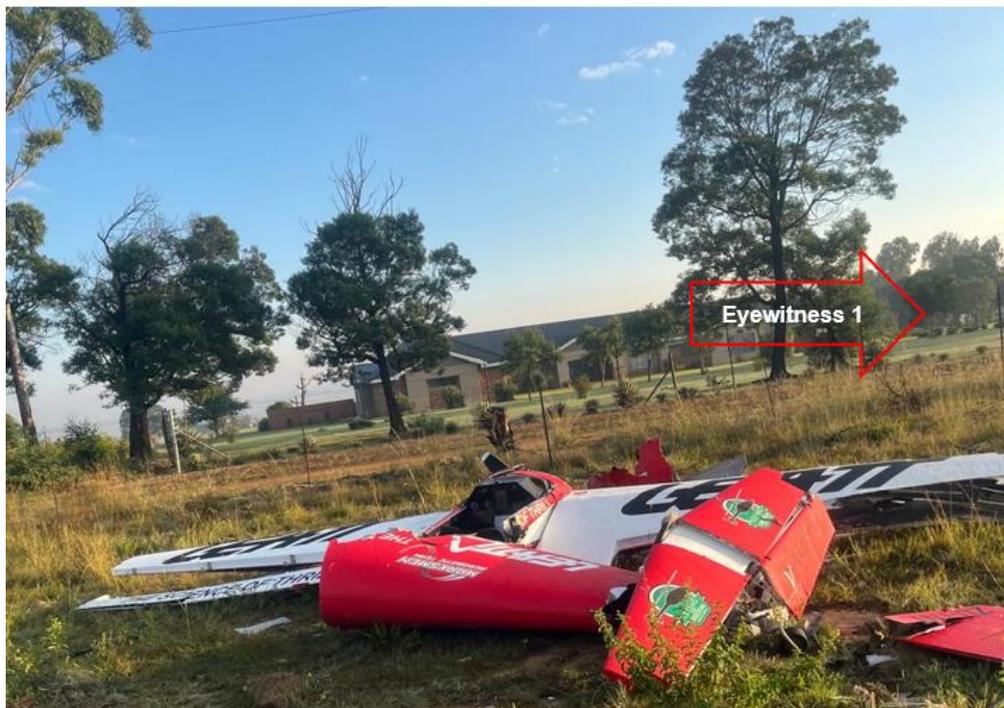
- 1.1.5. The first eyewitness was in a house across the road from the accident site. He reported that he saw the aircraft pitch up and down twice and, on the third pitch, it did not recover; instead, it entered a flat spin, lost height and crashed on a private farm's field. He stated that the

Figure 1: The aircraft at the accident site and the approximate location of the first eyewitness (red arrow).

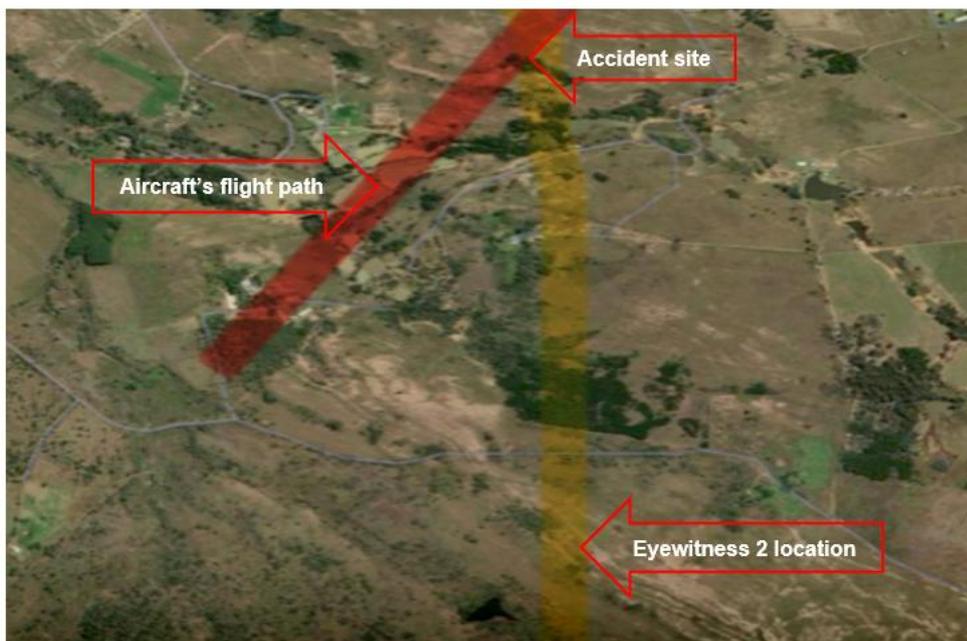
- 1.1.6. The second eyewitness was at Welbekend, a property located 2 nautical miles (nm) from the accident site. The second eyewitness reported that whilst inspecting his livestock (cattle), he observed an aircraft that was performing aerobatic manoeuvres north of his position. He noted that the aircraft commenced a right-side roll, followed by a series of additional rolls. He stated that initially, the manoeuvres appeared intentional and controlled; however, as the sequence progressed, the rolls appeared to lose structure and consistency. He later lost visual of the aircraft. Moments later, he heard a loud impact which he estimated to have originated approximately 4 kilometres (km) from his location. He then drove to the area from which the sound had emanated and discovered the crashed aircraft.

Figure 3: An aerial view of the approximate location of the second eyewitness and the accident site. The yellow line represents the second eyewitness' line of sight. (Source: Eyewitness)

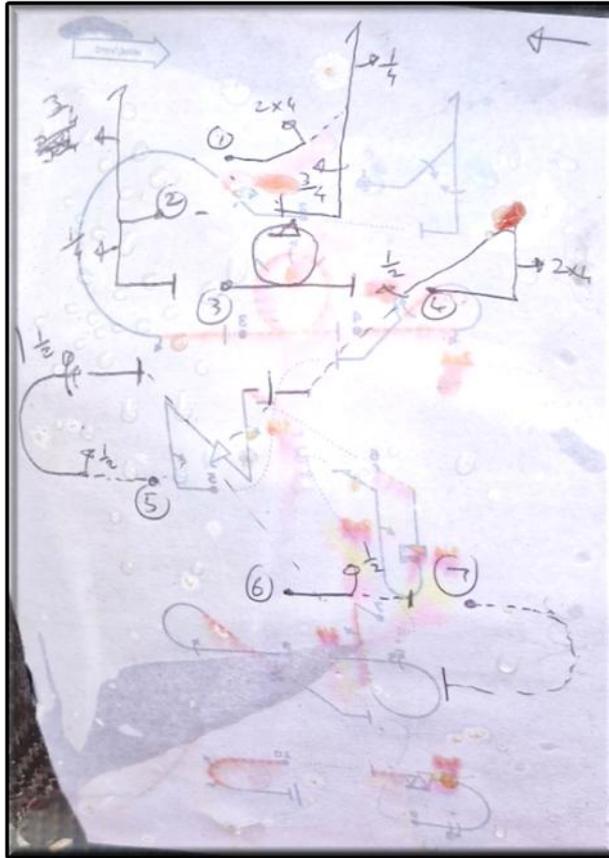
1.1.7. A copy of an aerobatic sequence was found in the aircraft. However, it was reported that the copy (aerobatic sequence) did not belong to the subject pilot because it depicted an advanced sequence used at competitions. It was later determined that it belonged to the first co-owner pilot who had used this sequence during his aerobatic training.

Figure 4: A copy of the aerobatic sequence found in the aircraft.

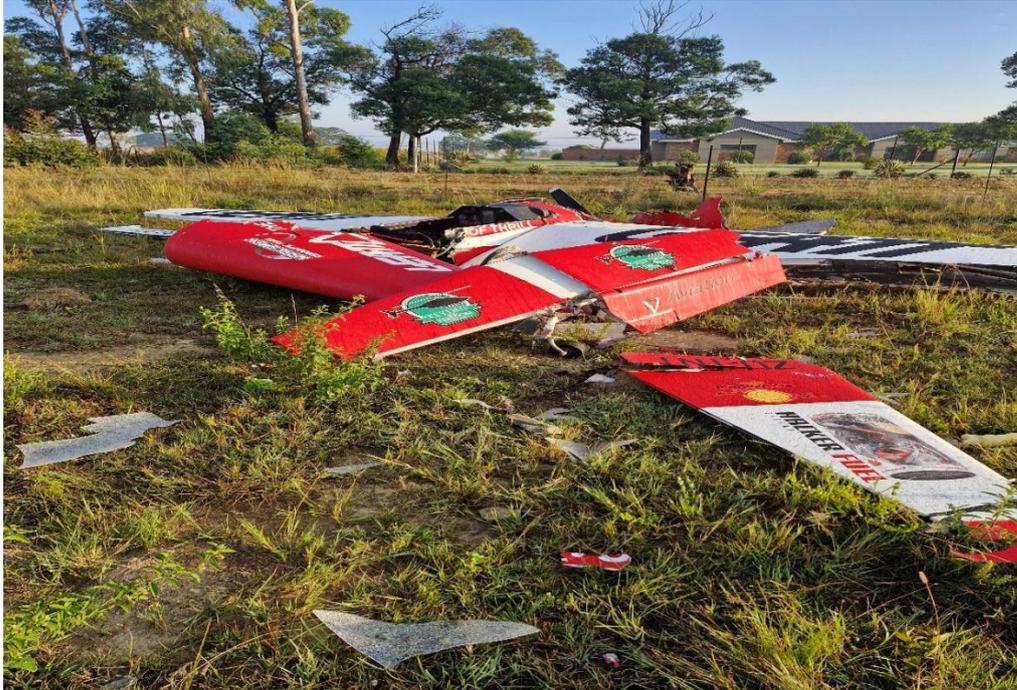
1.3.1. The aircraft was destroyed during the accident sequence.

Figure 5: The aircraft at the accident site.

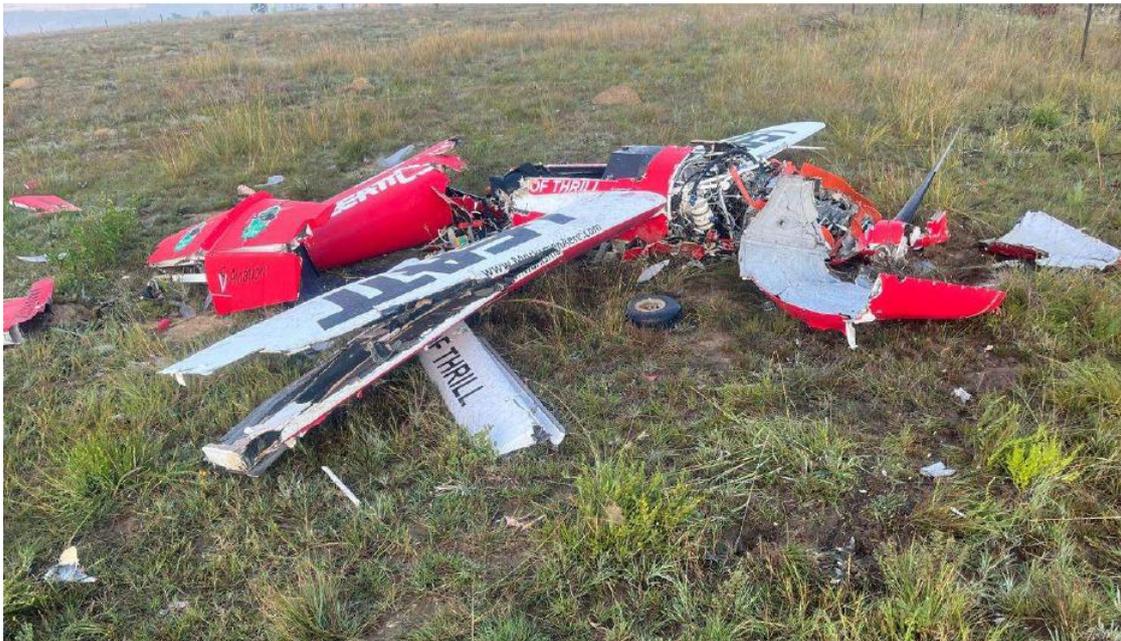
1.12.1. The accident site was on a field within a farm, approximately 2.8nm east of FAKT. The wreckage was confined to a compact area with a debris field diameter of approximately 23m, indicating a high-energy impact with the ground and with limited forward momentum. Initial ground contact appeared to have been made by the right-wing tip which separated from the main fuselage structure; it was located approximately 2m from the aircraft's final resting position. The left wing had remained intact. The empennage was destroyed. The canopy separated from the fuselage and was located 2.5m from the main wreckage. Analysis of the wreckage distribution and ground scarring suggested that the right wing impacted the ground first, followed by the nose section and the propeller blades. The deformation and fragmentation patterns observed on the wing structures were consistent with a high-velocity impact.

Figure 6: The wreckage was confined to a compact area.

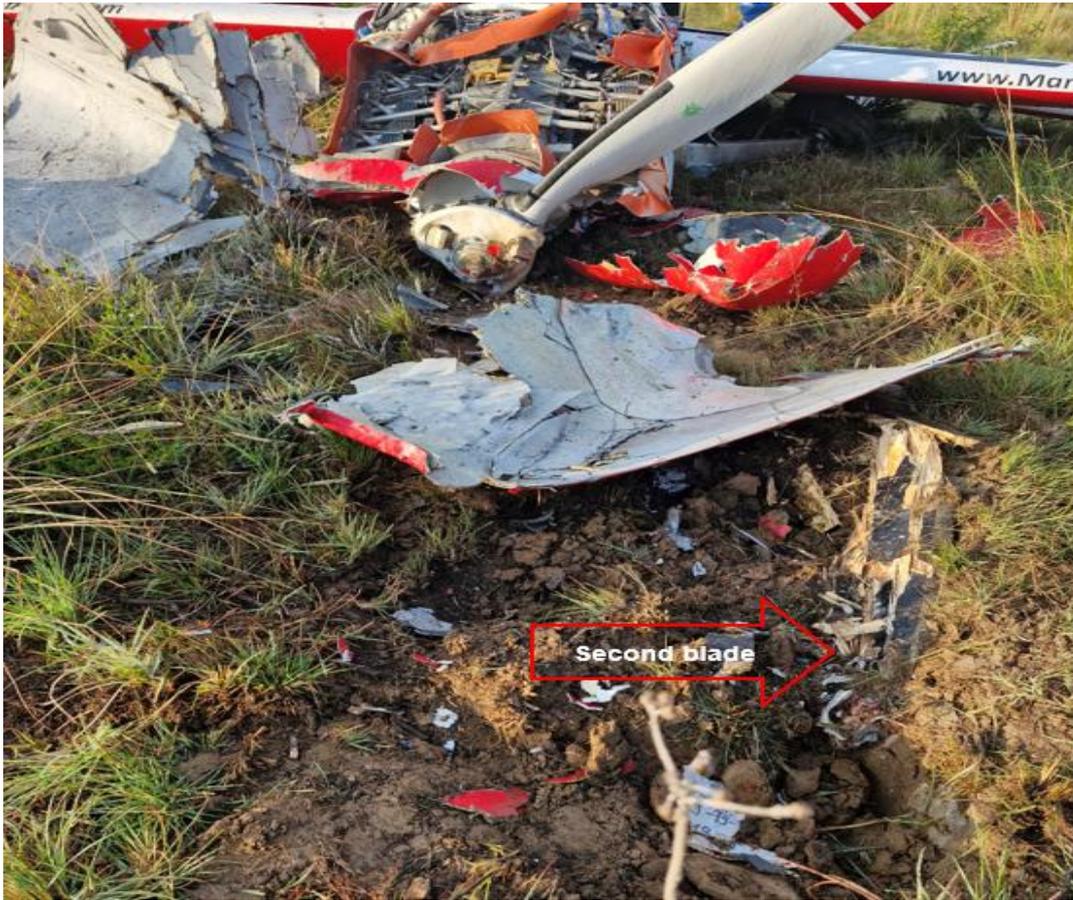
1.12.2. The propeller was examined at the accident site; one of the blades had remained intact whilst damage to the other two blades indicated that the engine was producing a substantial amount of power on impact. The amount of power that was produced could not be determined. Witness marks on the wreckage indicated that the aircraft entered an inadvertent spin from which the pilot could not recover, which rendered ground impact inevitable.

Figure 7: The propeller with one blade still intact; the other two blades were destroyed during the accident sequence.

- 2.2.6 The propeller was examined at the accident site; one blade had remained intact whilst damage on the other two blades indicated that the engine was producing a substantial amount of power on impact. The amount of power produced could not be determined. Witness marks on the wreckage/accident site indicated that the aircraft entered an inadvertent spin from which the pilot could not recover, which rendered ground impact inevitable.

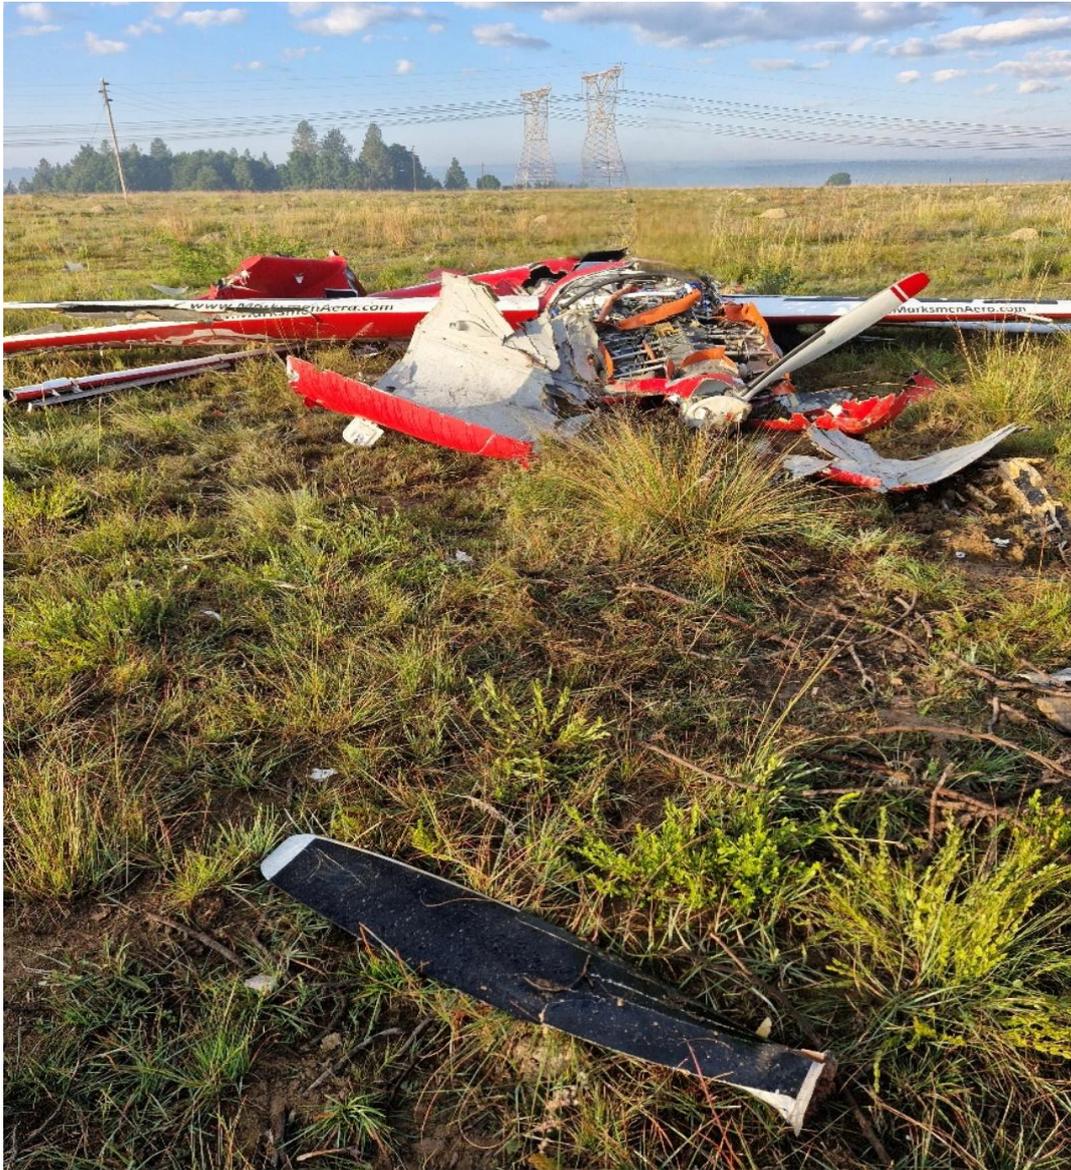
Figure 8: The third propeller blade at the accident site.

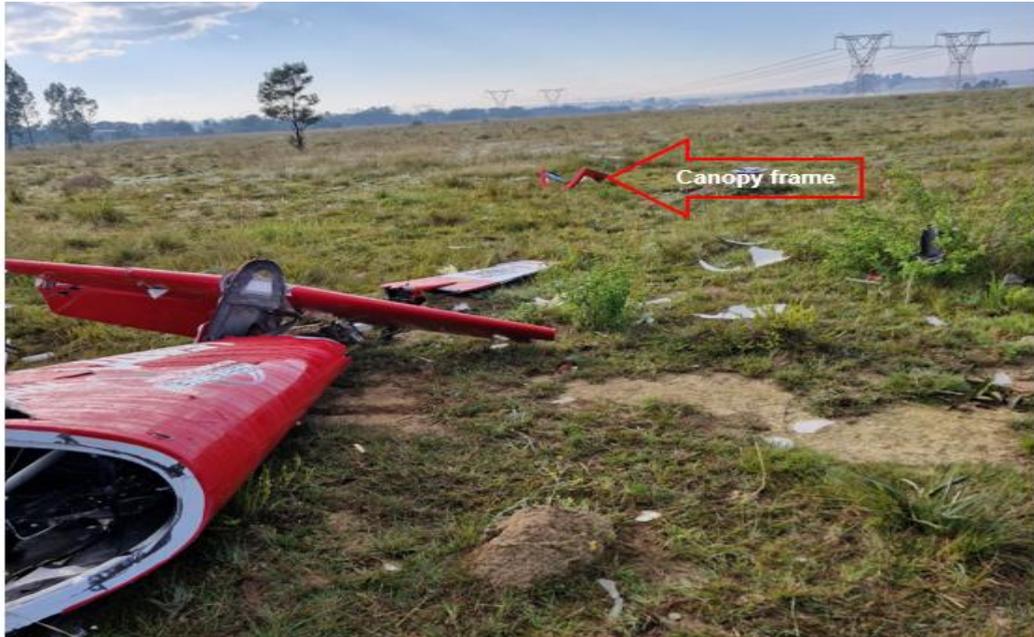
1.12.3. The empennage had separated from the forward fuselage. The upper portion of the rudder was discovered approximately 13m from the main wreckage whilst the remaining rudder structure was located 2m from the primary impact area; this suggested aerodynamic or structural separation during impact. The canopy was recovered 7m from the wreckage which indicated a possible in-flight detachment or ejection upon impact.

Figure 9: The empennage and canopy.

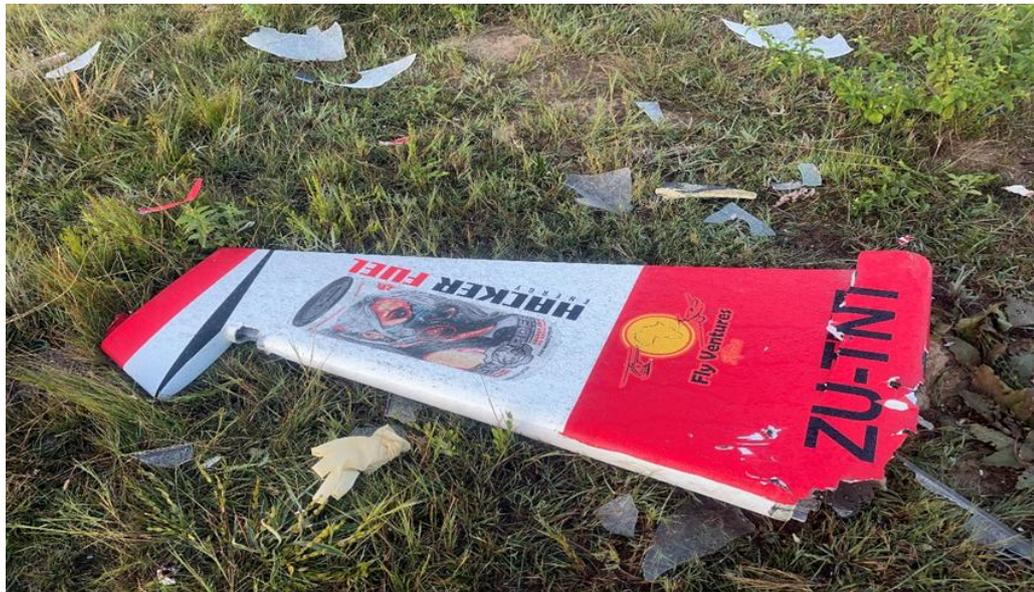
Figure 10: The broken rudder.

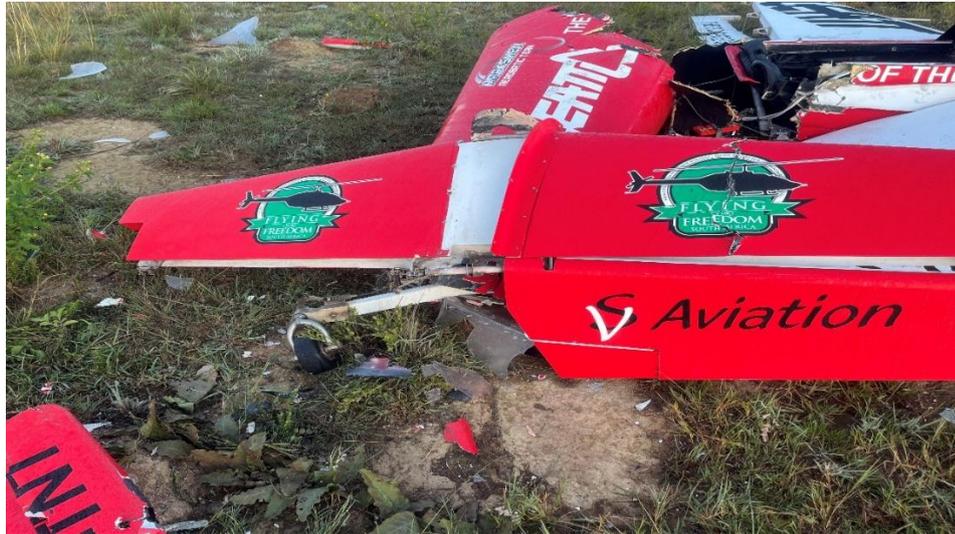
1.12.4. The seat restraints (seatbelts) in the cockpit had remained intact and secured, and the flight control linkages and control surfaces, although disturbed, were generally found to be continuous. The left aileron was located approximately 4m from the wreckage, whilst the right aileron had remained attached to the wing in a fully deflected downward position.

Figure 11: The elevator.

1.12.5. The tail wheel bar was found broken (Figure 11), likely due to secondary impact forces. The engine (Figure 12) had remained largely intact and secured to its mounts although it exhibited localised damage which was consistent with a nose-first impact force.

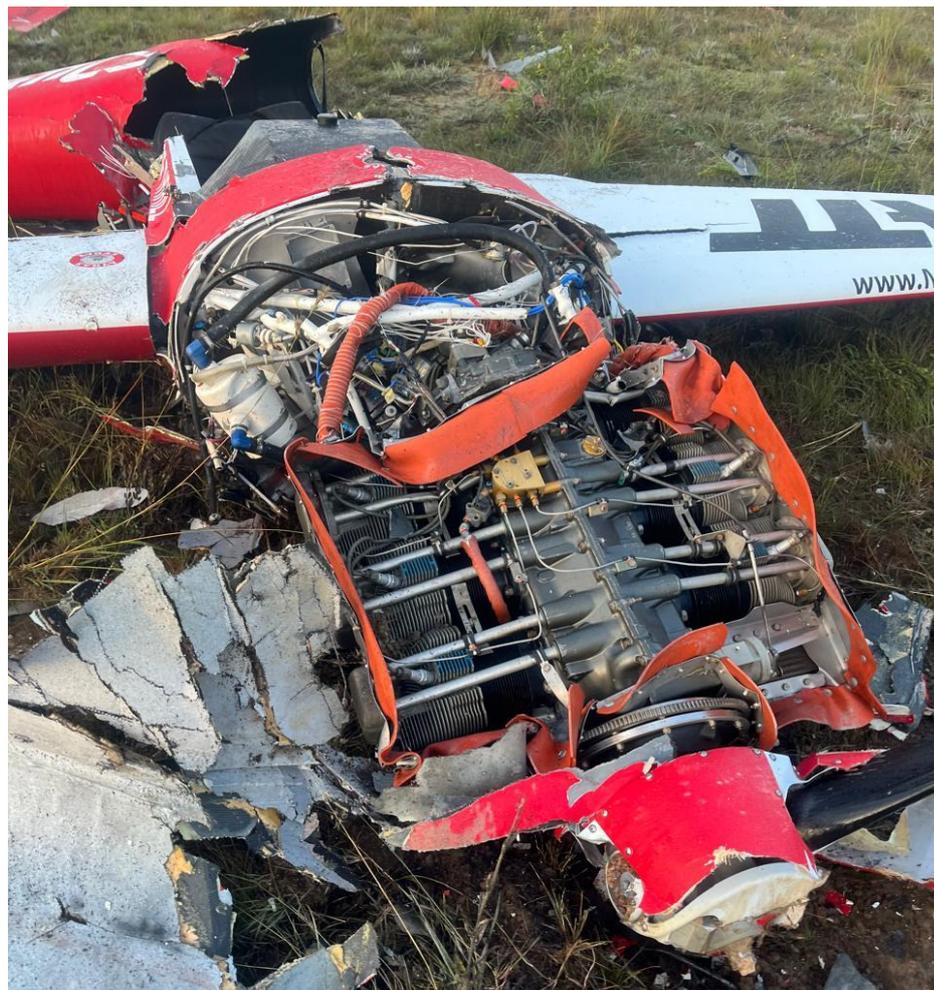
Figure 12: The engine post-impact.

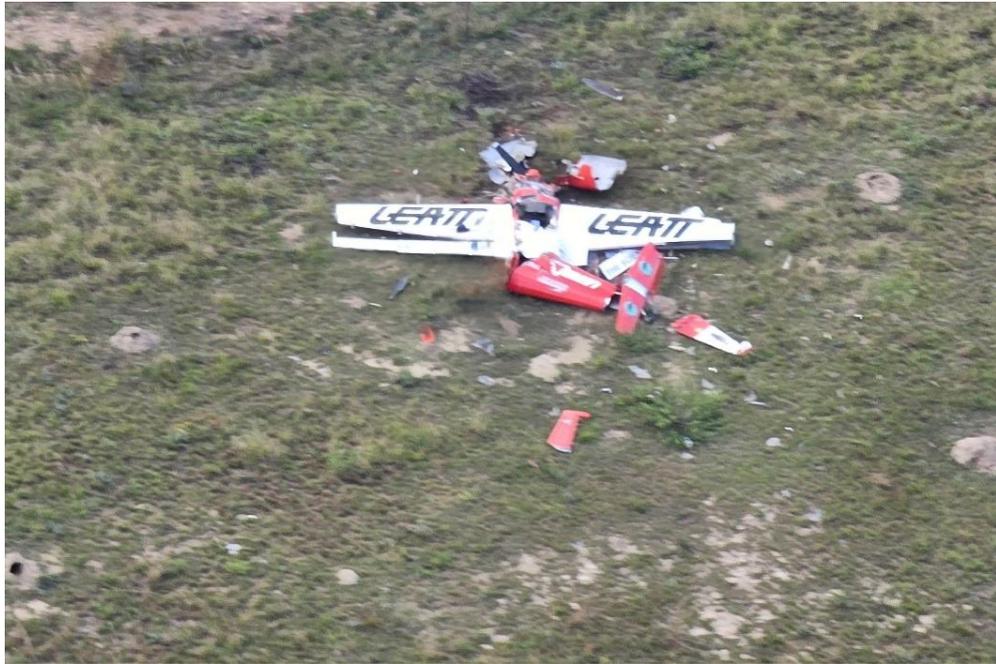
1.12.6. The condition of the wreckage and debris pattern suggested a flat spin with a limited forward speed.

Figure 13: The wreckage distribution at the accident site. (Source: EMS personnel)
