**LIMITED OCCURRENCE INVESTIGATION REPORT – FINAL**

| <b>Reference Number</b> | CA18/2/3/10580 | | | | | |
| Registration | ZS-KHR | | | | | |
| Make; Model; S/N | Piper Aircraft; PA-36-375 Pawnee Brave (Serial Number: 36-7802059) | | | | | |

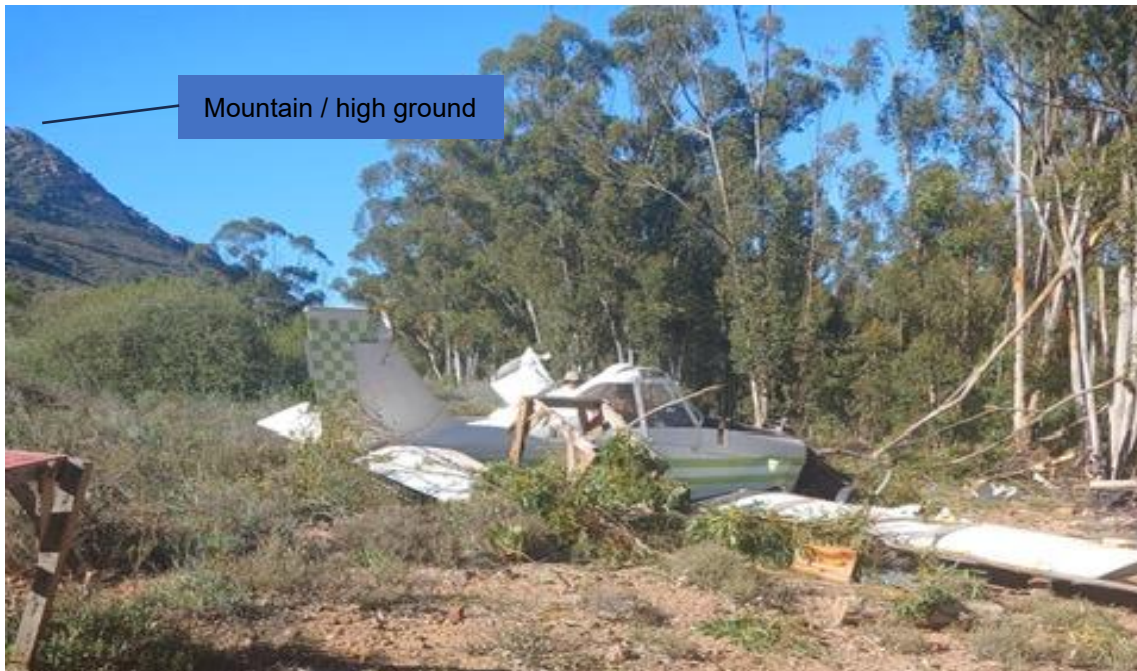
Upon arrival at the citrus farm, which was on the leeward side of the mountain, the pilot circled the area to scan for potential obstacles and hazards. Thereafter, he commenced with the first spray-run application. He reported that during this process, the aircraft lost lift due to a sudden downdraft from the mountain and struck the 30-feet (ft) tall citrus treetops with the main wheels and spray boom. Consequently, the aircraft pitched down. The pilot could not recover the aircraft and it crashed on the ground. After the crash, the pilot turned off the master and fuel switches and vacated the aircraft unassisted; he was not injured. The aircraft was substantially damaged.

**Figure 2:** The aircraft at the accident site. (Source: Pilot)

| Findings | |
|---|---|
| The aircraft struck the citrus treetops during the crop-spraying application on the leeside of the mountain after experiencing a downdraft which caused it lose height and crash on the ground. | |

| Operators and pilots should be aware of the dangers associated with mountain waves when operating in mountainous areas. |

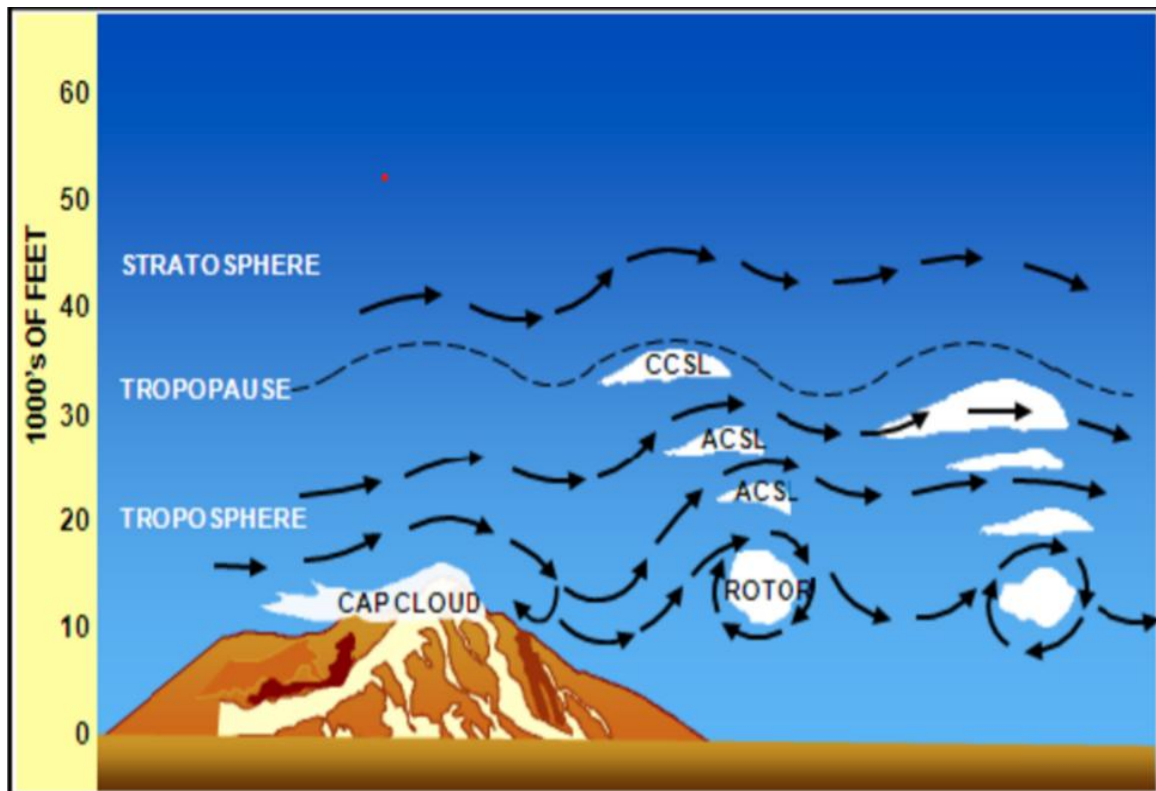
*A mountain wave is an atmospheric wave disturbance formed when stable air flow passes over a mountain or mountain ridge. Mountain waves are a form of mechanical turbulence which develop above and downwind of mountains. The waves remain nearly stationary while the wind blows rapidly through them. The waves may extend 600 miles (1 000km) or more, downwind from the mountain range. Mountain waves often produce violent downdrafts on the immediate leeward side of the mountain barrier. Sometimes the downward speed exceeds the maximum climb rate of an aircraft and may drive the aircraft into the mountainside.*

**Figure 3:** AC 00-06B mountain wave conditions.

| Findings | |
|---|---|
| 3.1 | The aircraft was flown on the lee-side of the mountain where mountain wave activity was prevalent and had, thus, contributed to this accident. |
