AIRCRAFT ACCIDENT REPORT AND EXECUTIVE SUMMARY

Reference:		CA18/2/3/10585	
Aircraft Registration		ZS-WXE	Date of Accident		18 May 2025	Time of Accident	1330Z
Type of Aircraft		RANS S-10 Sakota		Type of Operation		Private (Part 94)	
Pilot-in-command Licence Type		Commercial Pilot Licence		Age	39	Licence Valid	Yes
Pilot-in-Command Flying Experience		Total Flying Hours		5956.4	Hours on Type	±2.6	
Last Point of Departure		Middleburg Aerodrome (FAMB), Mpumalanga Province					
Next Point of Intended Landing		Middleburg Aerodrome (FAMB), Mpumalanga Province					
Damage to Aircraft		Destroyed					
Location of the accident site with reference to easily defined geographical points (GPS readings if possible)							
Approximately 200m left of Runway 32 at Middleburg Aerodrome (FAMB) at GPS position: 25°41'25.94" South 029°26'39.04" East, an elevation of 4 860 feet (ft)							
Meteorological Information		Surface wind: 360°/5kt, temperature: 22°C, dew point 17°C, visibility: 9999m; QNH: 1022hPa

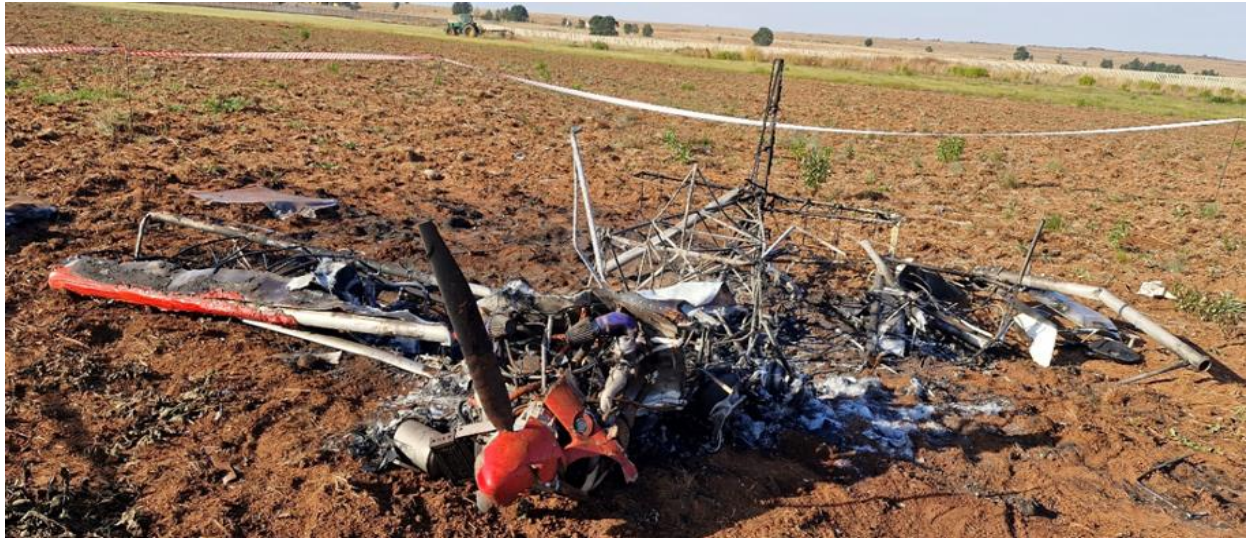
1.3.1. The post-impact fuel-fed fire destroyed the aircraft.

Figure 2: The wreckage at the accident site. (Source: Emergency Medical Services [EMS])

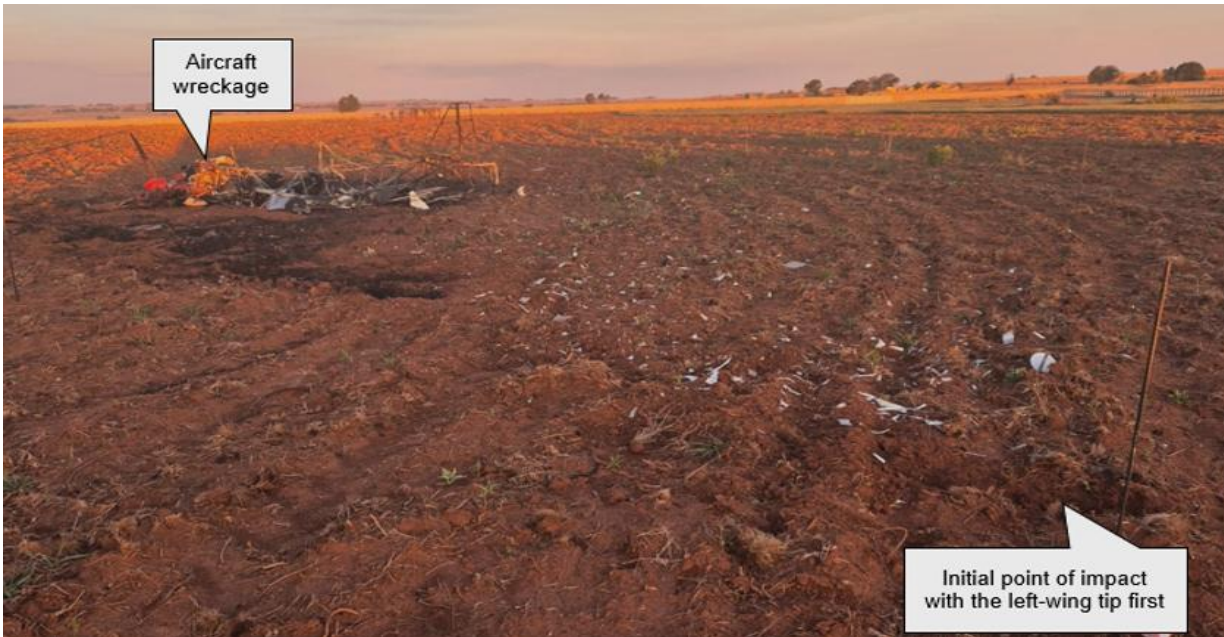
1.12.1. The accident site was confined to a radius of approximately 15m, about 200m left of RWY 32. The aircraft was destroyed by a post-impact fuel-fed fire. The wreckage was found facing east. Fragments of composite material were scattered on the ground from the point of impact to the resting position.

Figure 5: The wreckage.

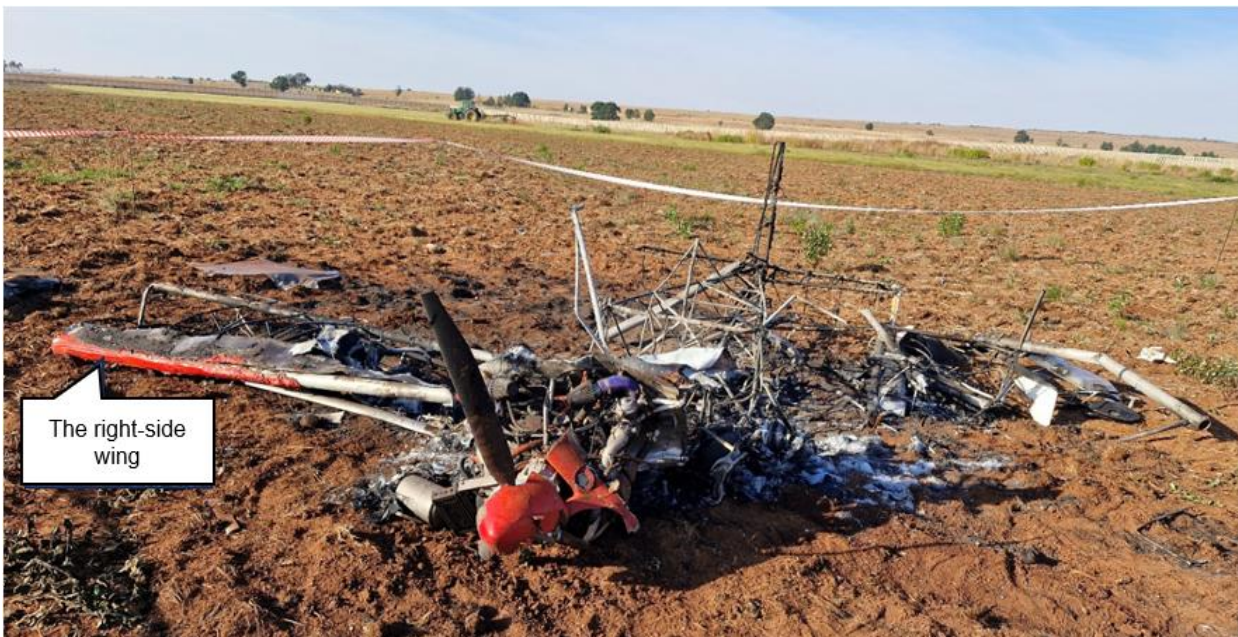
1.12.2. The left wing was deformed from the wing tip with more damage on the leading edge, associated with the initial impact with the ground; its fragments had scattered as the wreckage propelled forward during the sequence of events (see Figure 4) and later impacted the engine's left side. The right-side wing sustained minimal damage during the accident sequence.

Figure 6: The condition of the right-side wing.

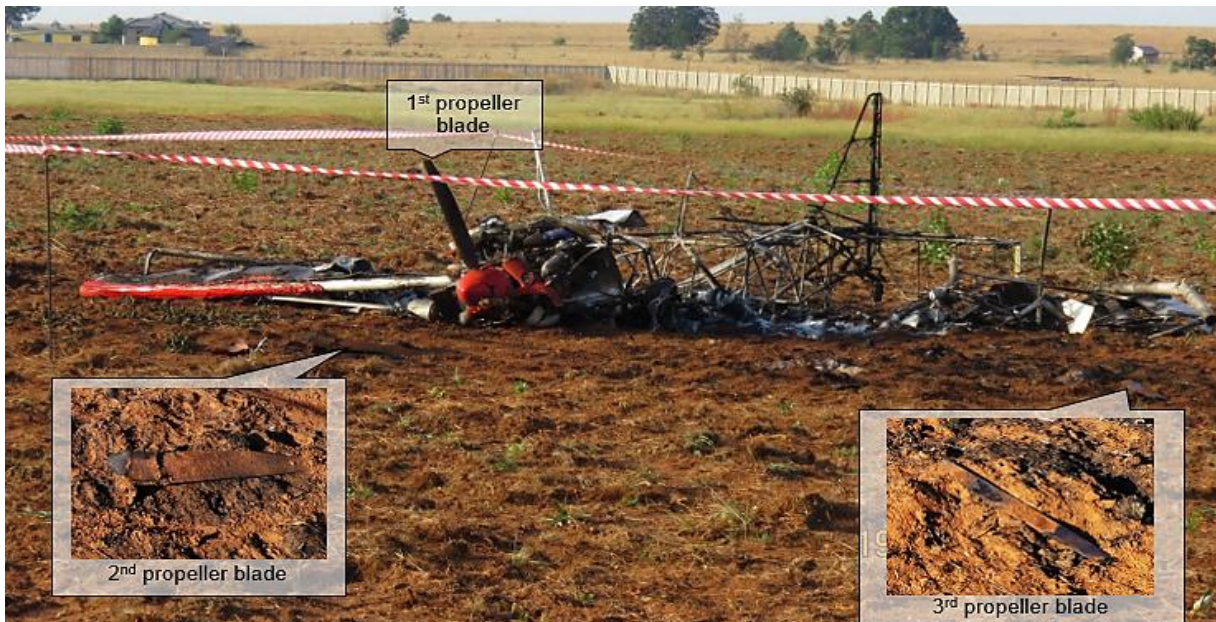
Figure 7: The positions of the broken propeller blades after the accident.

1.12.4. Two of the three propeller blades were located near the engine; the third propeller blade was still attached to the engine and intact (see Figures 7 and 8). All engine controls and flight surface cable controls were accounted for and tested for continuity on site, and no anomalies observed.

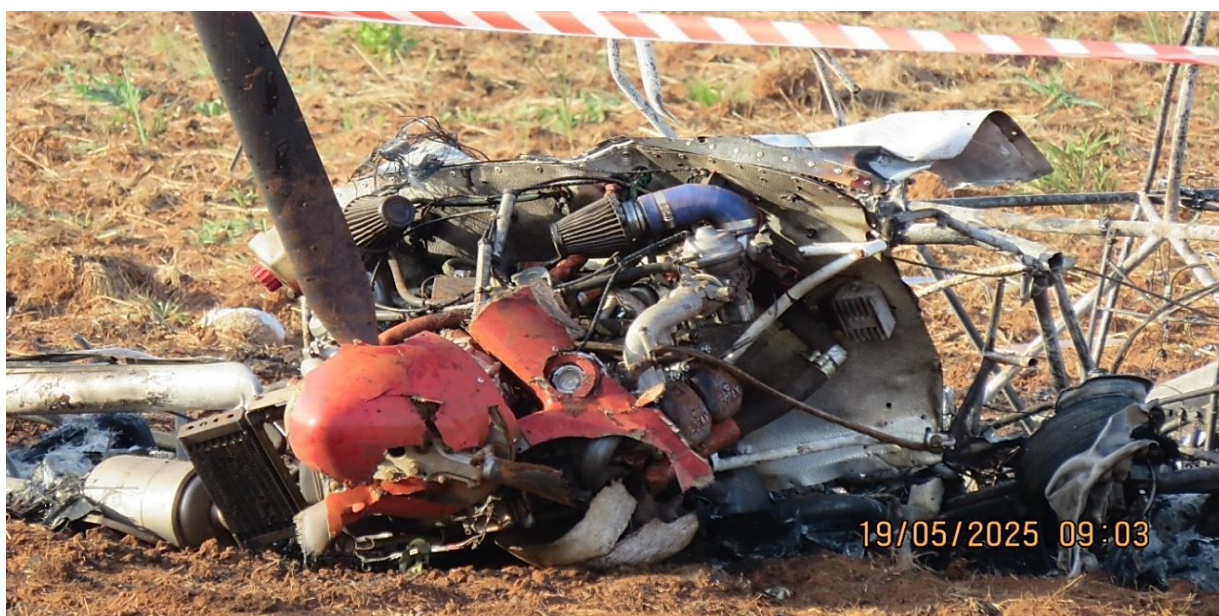
1.12.3. The wreckage was cut open by Emergency Medical Services (EMS) and the South African Police Service (SAPS) Forensic personnel during the removal of the two occupants. The engine appeared intact with damage only observed on the bottom side of the propeller spinner; two of the three propeller blades had broken off during the accident sequence.

Figure 8: The damaged engine.

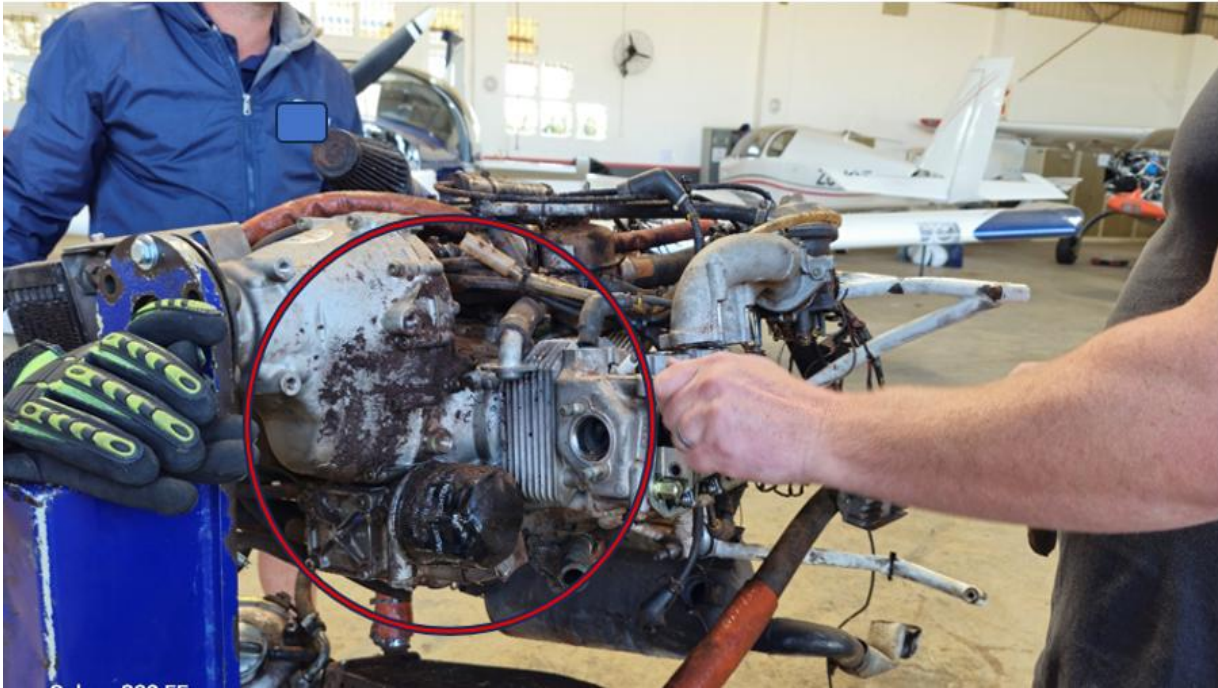
- *The engine was intact with visible fire damage on the electrical cables.*
- *The engine was turning freely with no restrictions.*
- *There was evidence of impact damage on the front left side of the engine, which caused damage to the left-side exhaust manifold and oil filter.*
- *The propeller spinner and the propeller hub sustained impact damage.*
- *Both carburetors were intact with no anomalies.*

Figure 9: Damage on the left side of the engine.

The magnetic chip detector on the gearbox was clean (no metal particles). There was sufficient oil in the separate engine oil tank (dry-samp). There was no evidence of a mechanical failure on the engine that could have contributed or have caused an engine stoppage/failure.
