LIMITED OCCURRENCE INVESTIGATION REPORT – FINAL

| Reference Number | CA18/2/3/10586 | | | | | | |
| Registration | ZU-DMU | | | | | | |
| Make; Model; S/N | Micro Wings Cubby; Tri Cubby (Serial Number: AK0405) | | | | | | |

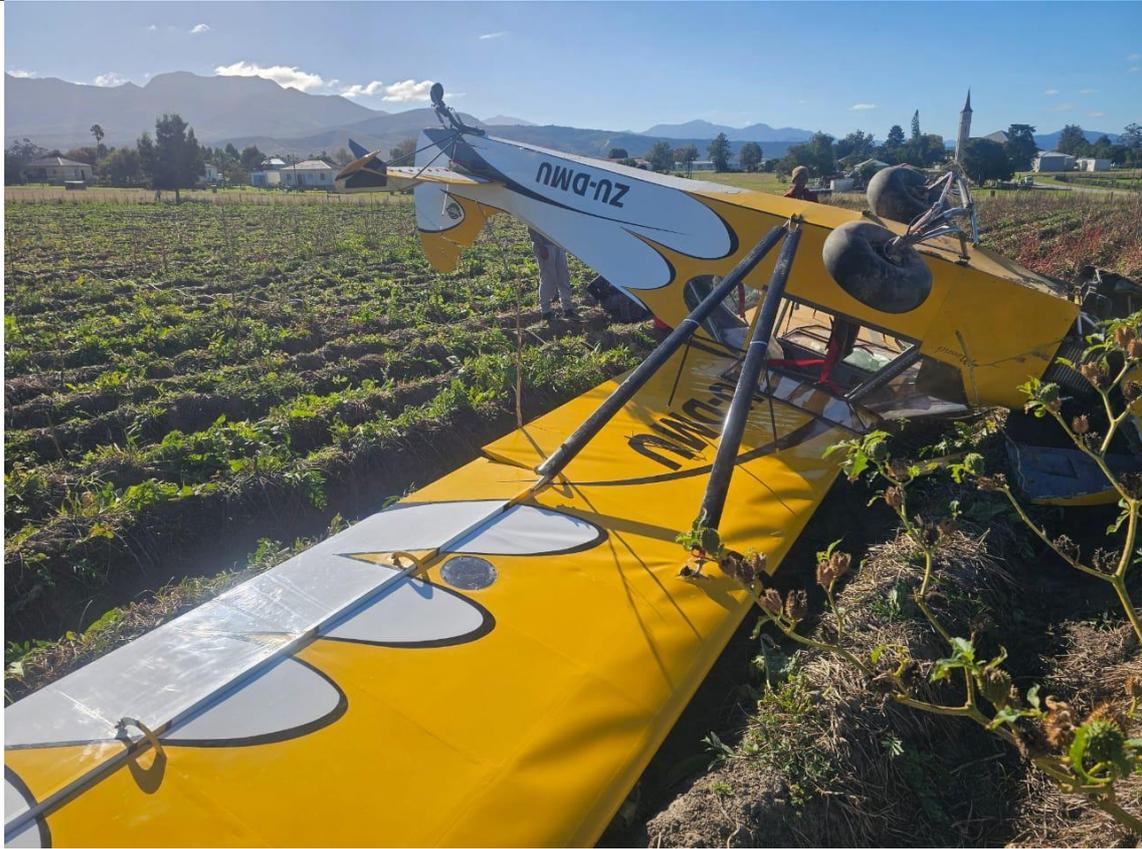
touch down, the main landing gear collapsed (see Figure 2) and the aircraft nosed over; it rested in an inverted attitude. The aircraft sustained substantial damage to the landing gear, propeller, wings and empennage. The pilot was not injured during the accident sequence.

Figure 2: The aircraft as it came to rest. (Source: Pilot)

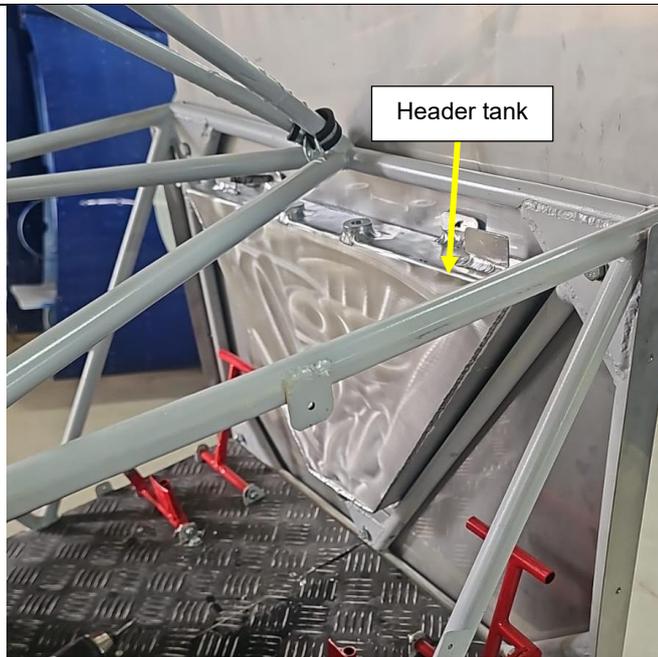
The aircraft is equipped with two fuel tanks, located in each wing. Each tank has a fuel capacity of 45 litres, with 7.5 litres per tank being unusable. The fuel from the respective tanks feeds a header tank under gravity. The header tank, which is in the shape of a triangle (see Figure 3), has a capacity of approximately 5 litres. The header tank is located on the cockpit side of the forward bulkhead in the area above the rudder pedals. Fuel supply to the engine is via the header tank, which has a vent line that feeds back to the fuel tanks. A purge valve is installed at the bottom of the header tank where fuel can be drained by the pilot before each flight to ensure it is free of contamination. The aircraft is fitted with two electric fuel pumps. Both pumps are in the ON position during start, taxi, and take-off phases. Once airborne, one of the fuel pumps is switched off. The fuel passes through a fuel filter to a fuel divider/regulator that feeds fuel to the two carburetors. Each fuel tank has a fuel shut-off valve that is located in the cockpit (see Figure 4). During flight, both shut-off valves are in the open position.

Figure 3: The position of the header fuel tank. (Source: Aircraft owner)

| <p>Contributing Factor(s)</p> <p>The possibility of a fuel vapor lock that could have formed in the fuel lines from the main tanks to the header tank could have caused the header tank to run dry and starve the fuel supply to the engine. Hence, the pilot was unable to perform an engine restart in-flight.</p> <p>Although the actual fuel quantity could not be determined, the aircraft had approximately 30 to 40L of fuel on-board as the pilot indicated a fuel endurance of 1 hour and 30 minutes before take-off. Should the pilot have made any excessive manoeuvres in-flight, it could have contributed to or have caused an inconsistent flow of fuel from the main tanks to the header tank (which contained insufficient fuel) to ensure a constant fuel supply to the engine. Any excessive manoeuvres are prohibited with 30L of fuel or less as per the POH.</p> |

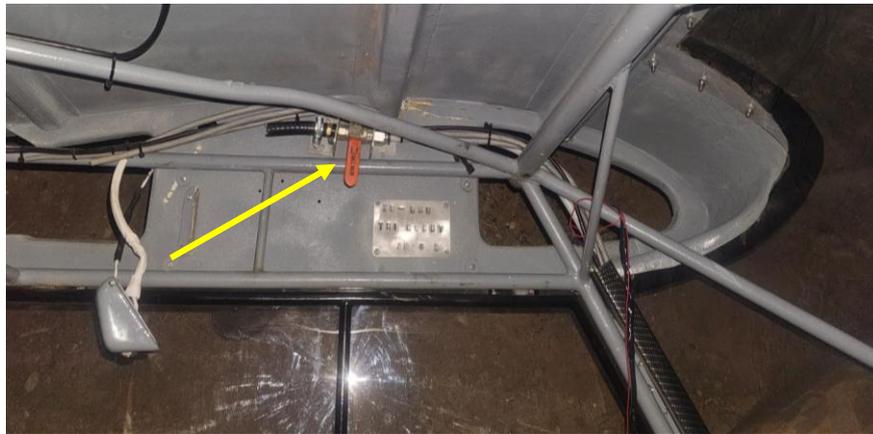
Figure 4: Fuel shut-off valve positioned inside the cockpit. (Source: Aircraft owner)

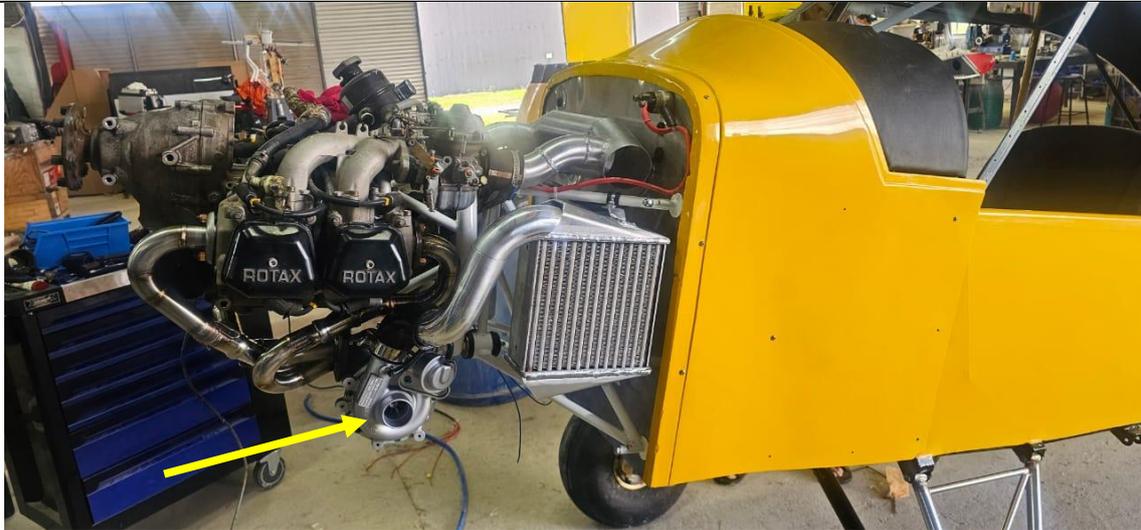
The aircraft was equipped with a Rotax 912 UL engine, which featured a turbocharger. The engine, Serial Number 4409607, was previously fitted to a Xenon 2 RST gyrocopter; it had accumulated 461.0 hours. The turbocharger that was fitted to the engine was an aftermarket conversion as it was not factory fitted with a turbocharger. The aircraft owner opted to install the engine which produced 90 kilowatts (kW) (122 horsepower), indicated by the yellow arrow in Figure 5. The engine ran on Motor Gasoline (MOGAS) which has a higher water content.

Figure 5: The engine installed in the aircraft. (Source: Aircraft owner)

2.7 The engine started and met all normal operating parameters during the post-accident ground run. The engine was fitted with a turbocharger and two carburettors. The turbocharger compresses the intake air before it enters the carburettors. The compressed air temperature is significantly higher than the ambient air temperature. These engines are, therefore, not prone to encountering carburettor icing.
