AIRCRAFT ACCIDENT REPORT AND EXECUTIVE SUMMARY

Reference:		CA18/2/3/10588	
Aircraft Registration	ZS-CZU	Date of Accident	8 June 2025		Time of Accident	1630Z	
Type of Aircraft	Piper PA-28-180		Type of Operation		Private (Part 91)		
Pilot-in-command Licence Type	Private Pilot Licence		Age	22	Licence Valid	Yes	
Pilot-in-command Flying Experience	Total Flying Hours		139.8		Hours on Type	118.5	
Last Point of Departure	Virginia Aerodrome (FAVG), KwaZulu-Natal Province						
Next Point of Intended Landing	Ladysmith Aerodrome (FALY), KwaZulu-Natal Province						
Damage to Aircraft	Substantial						
Location of the accident site with reference to easily defined geographical points (GPS readings if possible)							
Bloemhof Farm near Greytown (GPS position: 29°06'13.60" South 030°32'13.22" East)							
Meteorological Information	Instrument meteorological conditions prevailed with no reference to the ground						
Number of People On-board	2 + 0	Number of People Injured	1	Number of People Killed	0	Other (On Ground)	0

Synopsis							
<p>A Piper PA-28-180 aircraft with registration ZS-CZU was one of three aircraft that took off on a private flight from Virginia Aerodrome (FAVG) in KwaZulu-Nata

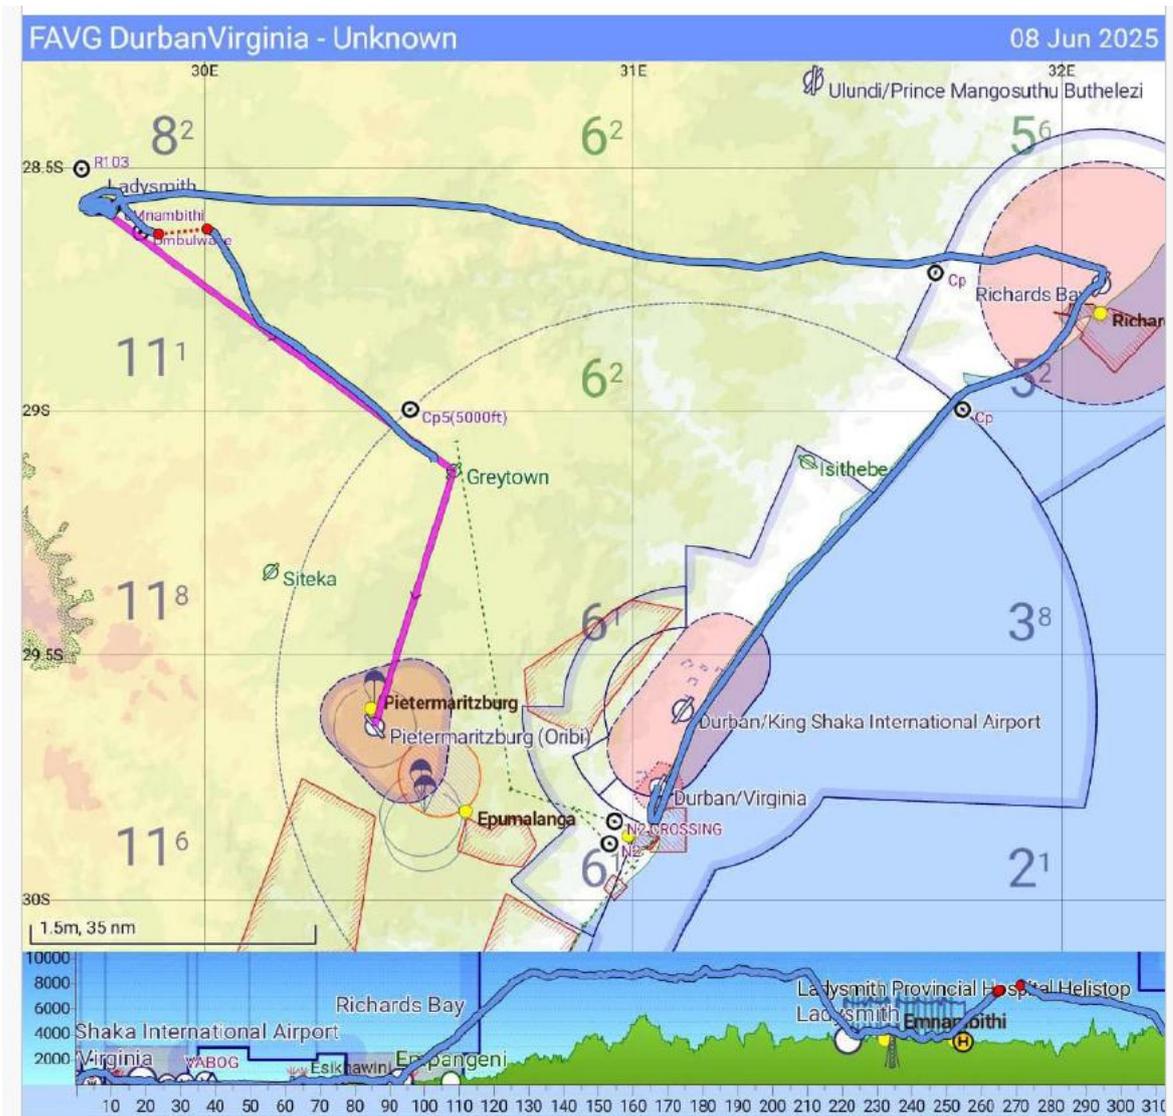
1.1.5 Figure 1 shows the iPad software application flight track (blue line). The software application, however, stopped recording when the aircraft was a few miles towards north-west of Greytown. The accident site was approximately 3 nautical miles (nm) south-west of Greytown.

Figure 1: The flight track that was downloaded from the iPad.

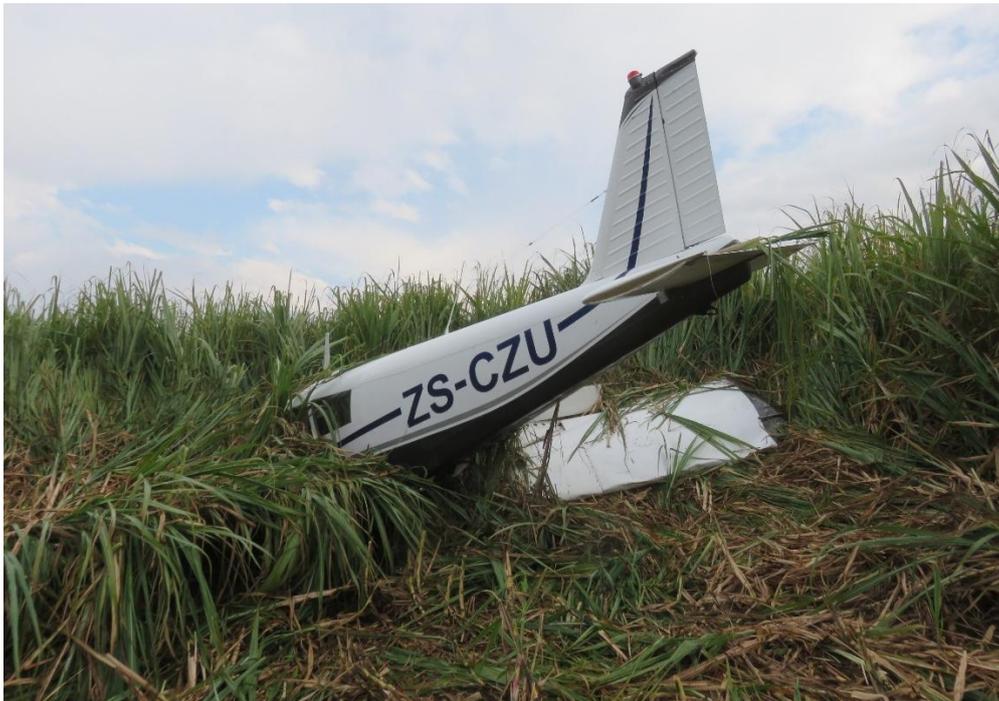
1.12.1 The aircraft impacted the sugarcane crops that were ready for harvesting at Bloemhof Farm. It came to a stop in a nose-down, wings-level attitude, approximately 30 metres (m) from the first contact with the sugarcane crops which acted as an arresting medium. The right wing separated where it attaches to the fuselage and twisted approximately 120°. The access door on the right side of the aircraft could be easily opened after the accident. The left wing, propeller and part of the engine nacelle were covered under the sugarcane crops. It was possible to ascertain that a substantial amount of fuel was still in the left-wing tank; the fuel selector in the cockpit was selected to the left tank. The aircraft came to rest 2.8nm west of FAGY and 220m from the high-tension powerlines that diagonally crossed their flight path.

Figure 4: The aircraft as it came to rest.

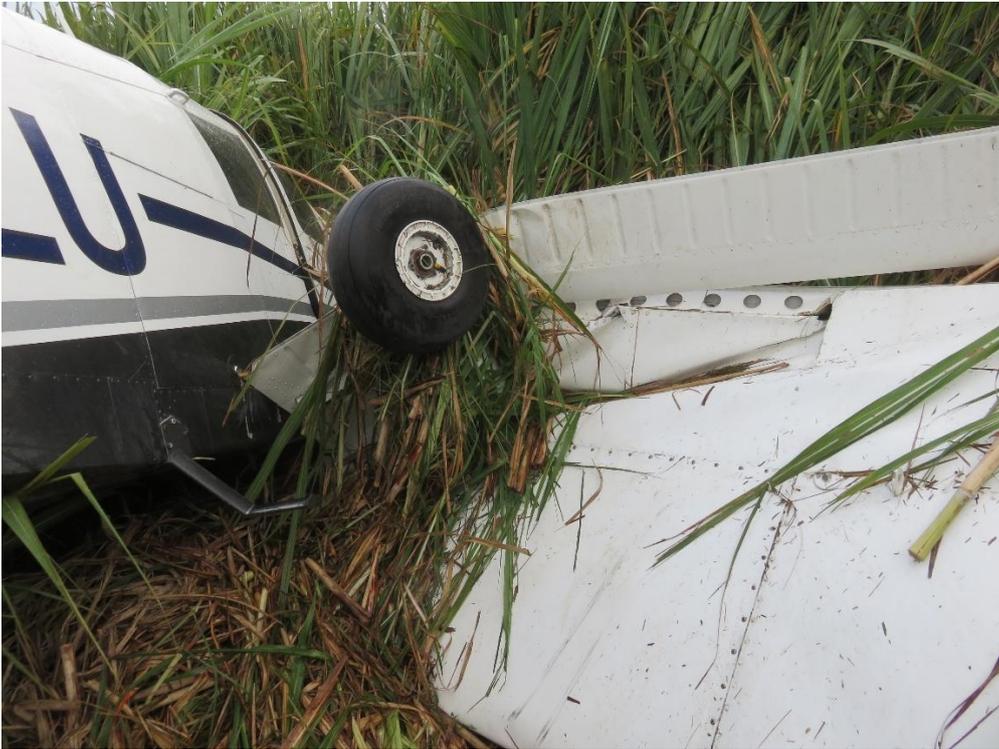
1.3.1 The aircraft sustained substantial damage to the right wing, which twisted approximately 120° and partially separated from the fuselage.

Figure 5: The twisted right wing with the main landing gear still attached.

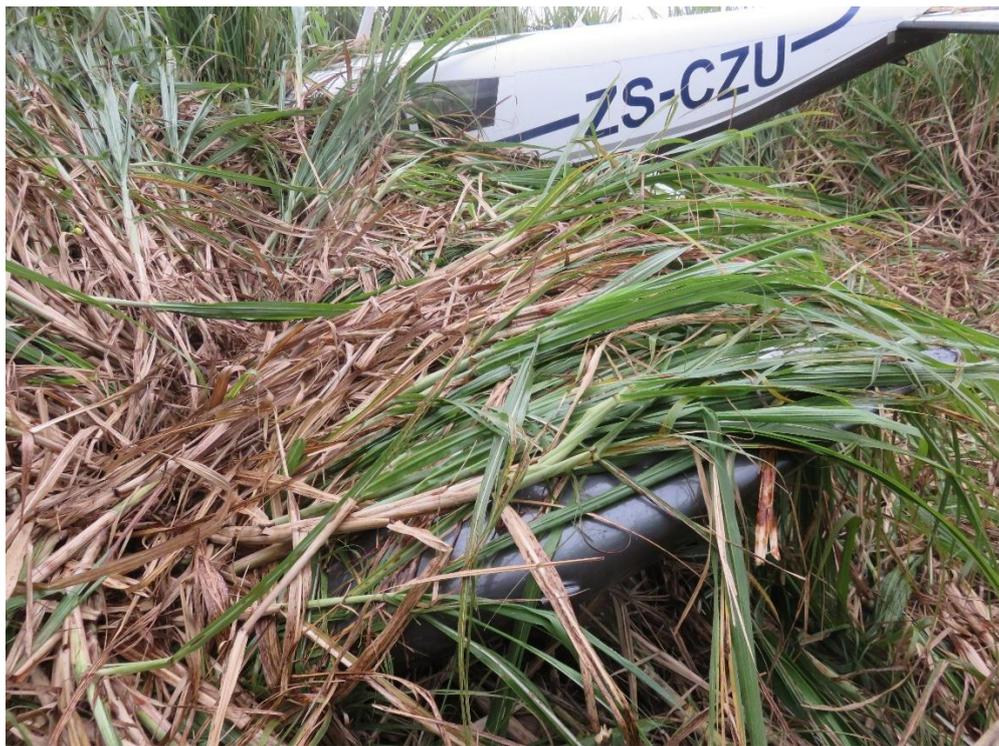
Figure 6: The left-wing tip is almost buried underneath the sugarcane crops.

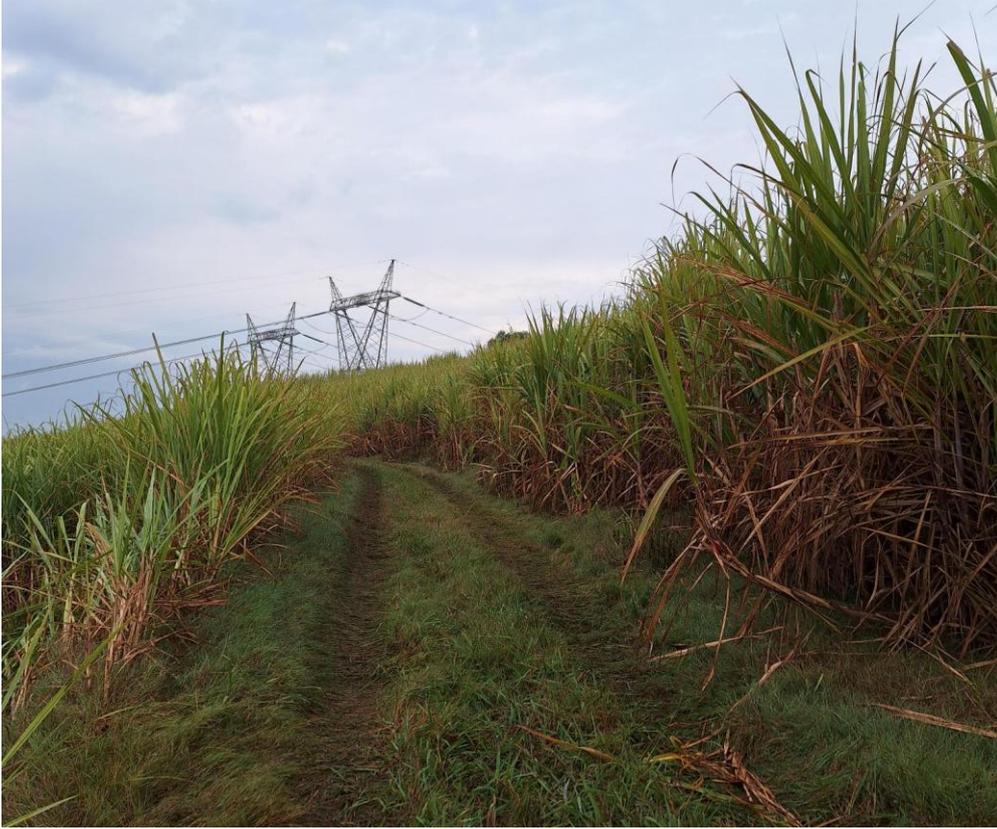
Figure 7: The high-tension power lines were 220m from the crash site.

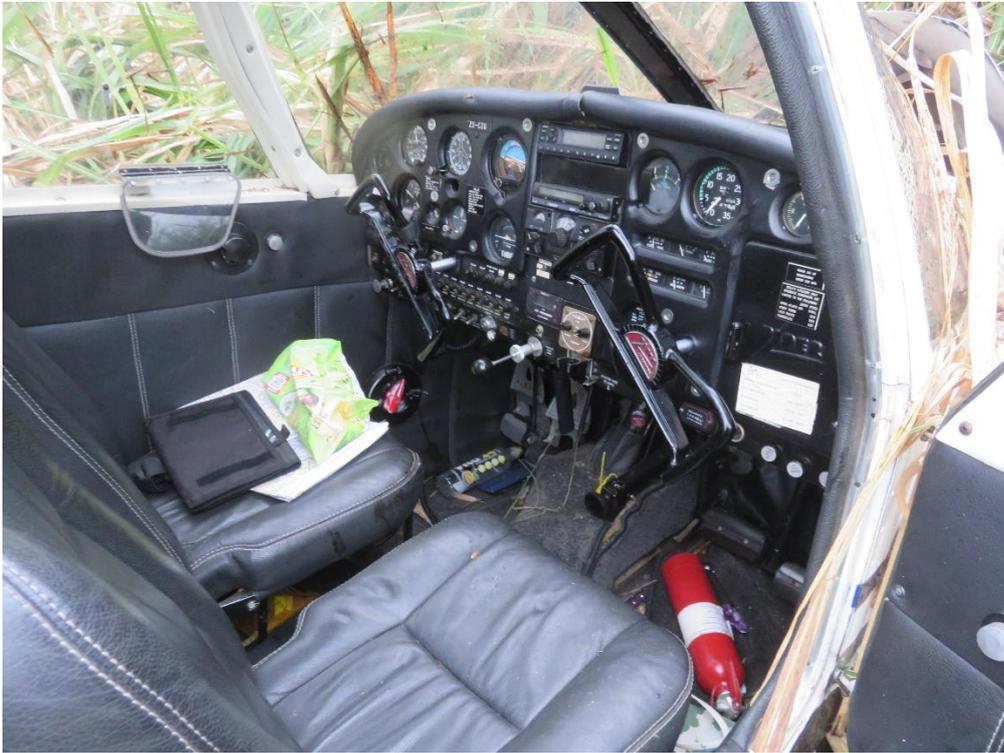
1.15.2 The two occupants had made use of the aircraft's equipped safety harnesses. The PIC sustained minor facial injuries as she impacted the instrument panel during the accident sequence; the PF was not injured.

Figure 8: The cockpit remained intact.
