AIRCRAFT ACCIDENT REPORT AND EXECUTIVE SUMMARY

Reference:		CA18/2/3/10589	
Aircraft Registration	ZS-KFB	Date of Accident	08 June 2025		Time of Accident	Unknown	
Type of Aircraft	Piper 28-181 Archer II		Type of Operation		Private (Part 91)		
Pilot-in-command Licence Type	Private Pilot Licence (PPL)		Age	22	Licence Valid	Yes	
Pilot-in-command Flying Experience	Total Flying Hours		94.3	Hours on Type	88.3		
Last Point of Departure	Virginia Aerodrome (FAVG), KwaZulu-Natal Province						
Next Point of Intended Landing	Ladysmith Aerodrome (FALY), KwaZulu-Natal Province						
Damage to Aircraft	Destroyed						
Location of the accident site with reference to easily defined geographical points (GPS readings if possible)							
Approximately 3.6 nautical miles (nm) north-east of Hylton in KwaZulu-Natal Province (GPS position 29°12'07.2" South 030°22'32.4" East)							
Meteorological Information	Wind direction: 240° at 07 kts; visibility: 5000m; temperature: 14°C; dew point: 10°C; QNH: 1016 hPa

Synopsis

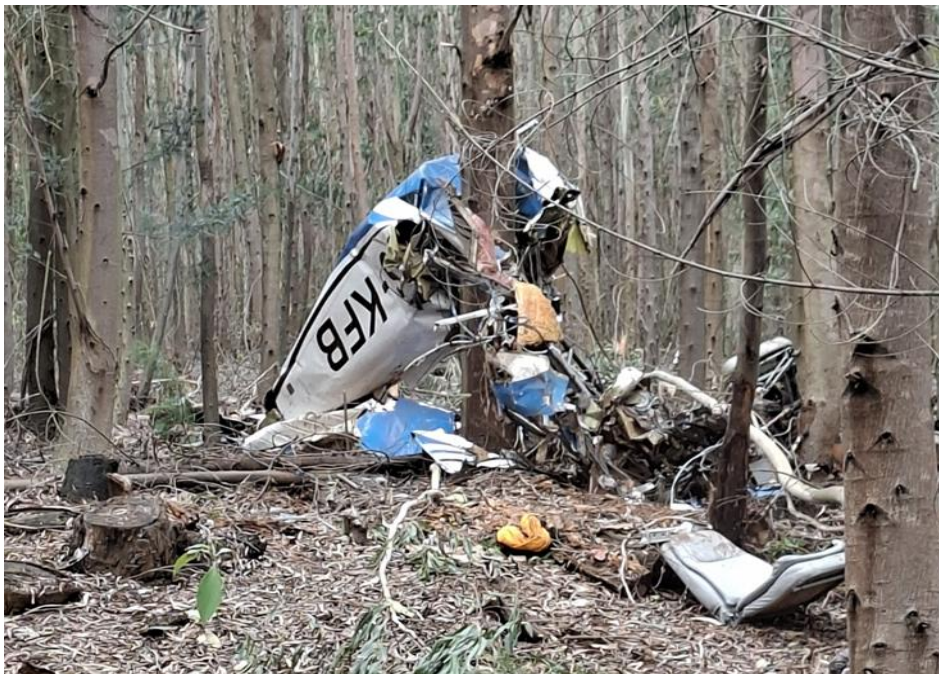
1.3.1. The aircraft was destroyed.

Figure 1: The wreckage of ZS-KFB in an inverted position at the accident site.

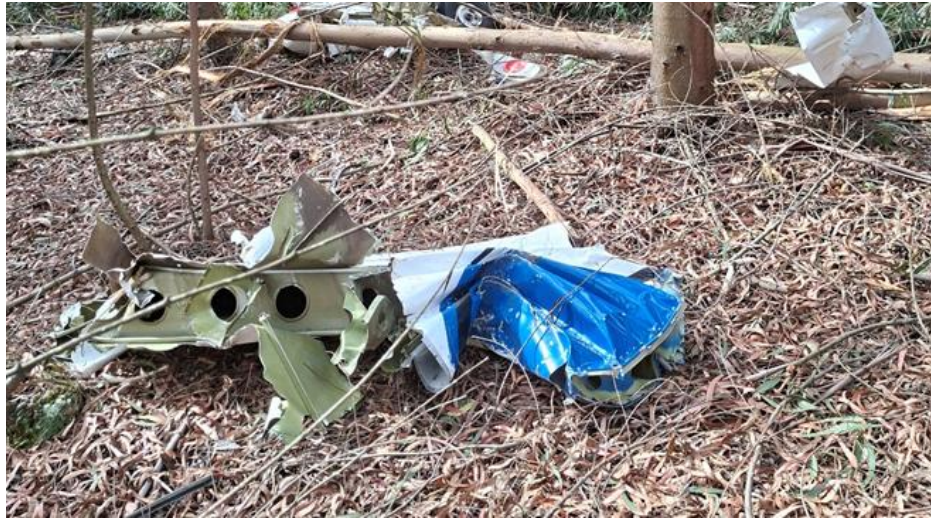
Figure 5: Exposed spar and a portion of the severed wing.

1.12.2. Upon arrival, two days after the accident, the investigation team noticed that the fuel tanks had ruptured during the accident sequence. No fuel odour was present due to persistent rain in the area. The debris was spread over an area larger than 20m x 65m. The wings had broken off from the fuselage due to impact with several trees. Damage to aircraft and the trees indicated blunt forces that were greater than their material strength. The left wing was found shattered (in pieces), and the leading-edge metal skin was pushed all the way to the spar. The landing gear was severed. The horizontal and vertical stabilisers were also severed from the airframe.

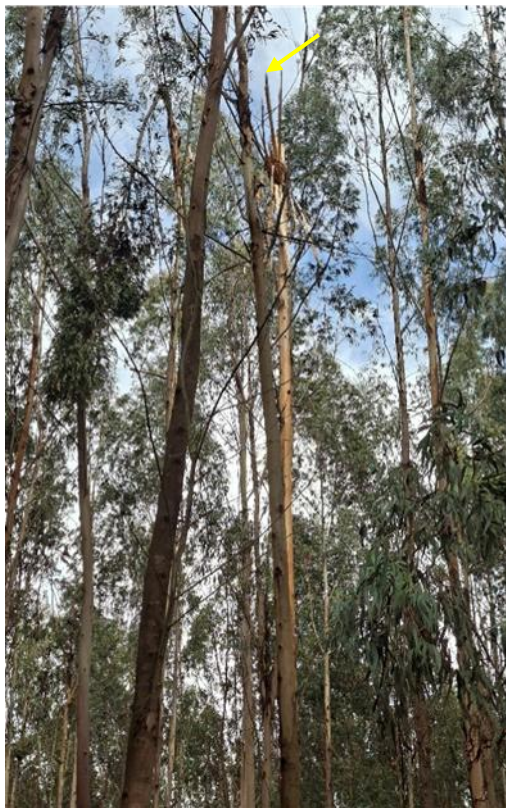
1.12.1. The impact marks at the accident site indicated that the aircraft entered the gum tree forest in a steep angle and in a south heading, severing several tree-tops of different heights in its wake, before it stopped in an inverted attitude.

Figure 6: Tree tops showing impact signs (yellow arrow). **Figure 7:** Some of the tree stems that were flattened.

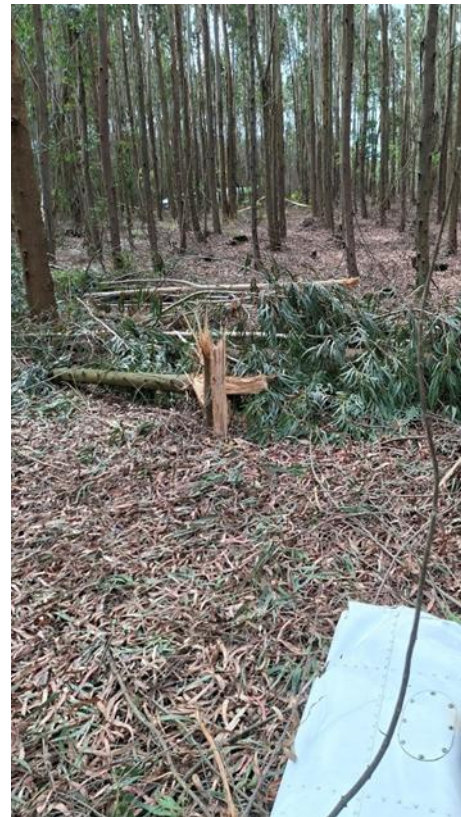
1.12.4. The main wreckage (from the back of the cabin) rested against a tree in an inverted position. This indicated that the wings were not level when it crashed. The second wing (right) was found during recovery under a cluster of trees that were flattened by the aircraft; eight trees covered the second wing.

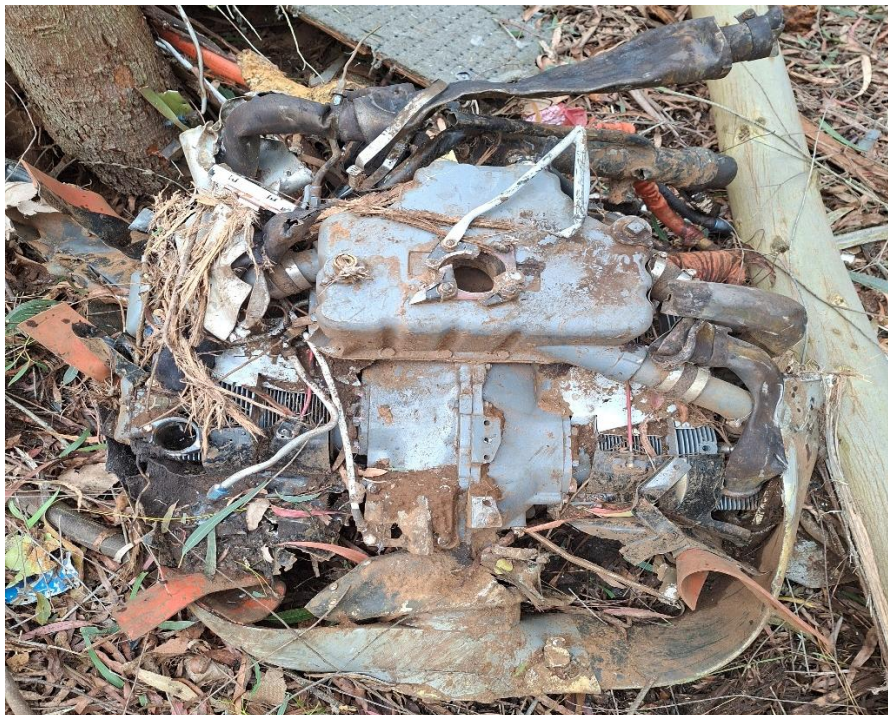
1.12.3. The cockpit area and the engine fire wall sustained substantial damage. The seats were found scattered; the cabin floor and instrument panel were unidentifiable; no instruments remained intact in the aircraft. The aircraft doors were found detached on both sides of the main wreckage. The engine was located a few metres from the main wreckage, it was inverted; the propeller blade tips coned backward.

Figure 8: The inverted engine with the propeller blade tip that was severed.

1.16.1. The propeller showed that the engine was producing substantial amount of power at the time of the accident.
