AIRCRAFT ACCIDENT REPORT AND EXECUTIVE SUMMARY

Reference:		CA18/2/3/10590	
Aircraft Registration	ZS-HFH	Date of Accident	22 June 2025		Time of Accident	0202Z	
Type of Aircraft	Robinson R44, Raven II		Type of Operation		Agricultural Operations (Part 137)		
Pilot-in-command Licence Type	Commercial Pilot Licence		Age	39	Licence Valid	Yes	
Pilot-in-command Flying Experience	Total Flying Hours		1 908.0		Hours on Type	Unknown	
Last Point of Departure	Metsi Berries Farm, Modimolle-Mookgopong, Limpopo Province						
Next Point of Intended Landing	Metsi Berries Farm, Modimolle-Mookgopong, Limpopo Province						
Damage to Aircraft	Destroyed						
Location of the accident site with reference to easily defined geographical points (GPS readings if possible)							
In a flooded ditch, approximately 600 metres (m) from the berries field at Global Positioning System (GPS) co-ordinates determined to be S24° 16'.40" E28° 39'.38", at an elevation of approximately 4 067ft

Occurrence Details

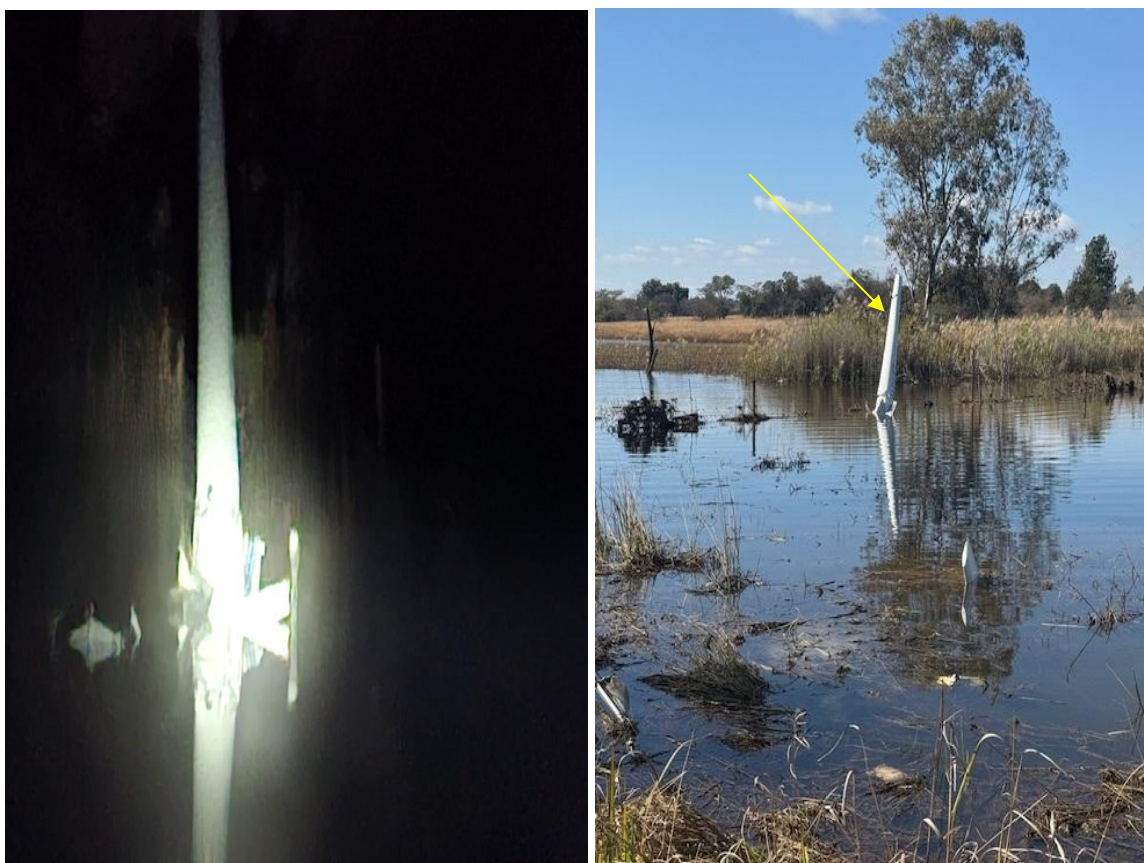
Figures 3 and 4: A picture of the helicopter taken whilst still dark (left picture). Another picture of the helicopter taken in the morning showing the helicopter almost fully submerged in a flooded ditch with the tail boom tilted high (right picture). (Source: Farm manager)

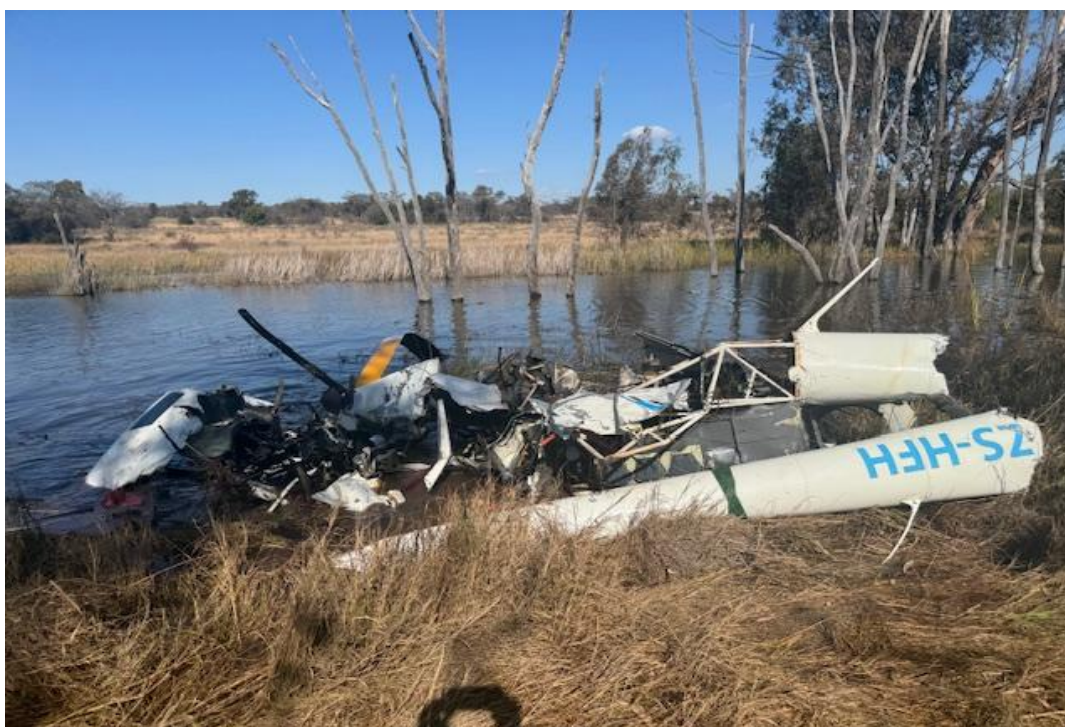
1.3.1 The helicopter was destroyed during the accident sequence.

Figure 5: The wreckage after it was recovered from the flooded ditch.

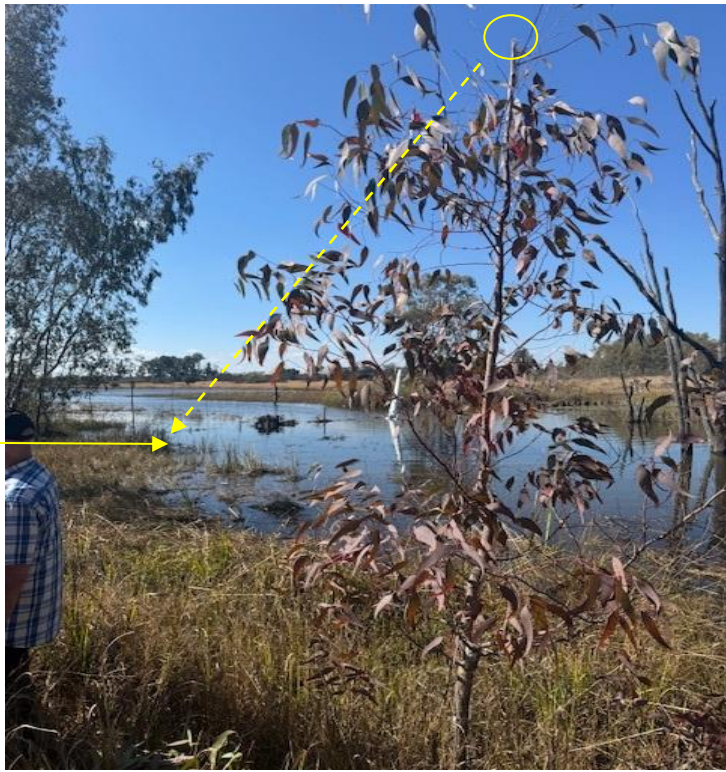
1.12.1 The accident occurred in a flooded ditch on the border of Metsi Berries Farm in Modimolle-Mookgophong, approximately 600m from the lift-off point which was at an elevation of 4 067ft. The wreckage was contained within a relatively small area, and all the helicopter's major components were identified at the accident site. Evidence at the accident site showed that the helicopter was in a nose-down attitude before the accident. The helicopter first clipped the top of a tree which was approximately 6m high with the main rotor blade before it crashed into the water on the side of the flooded ditch and at a heading of approximately 147°. The skid landing gears broke during the accident sequence. It was evident that a significant amount of energy at impact was absorbed by the skid landing gears. The stabiliser was severed by one of the main rotor blades during the accident sequence and was found close to a tree that was struck by the main rotor blade.

Figure 7: The approximate first impact area and a tree that the helicopter clipped with the main rotor (yellow circle).

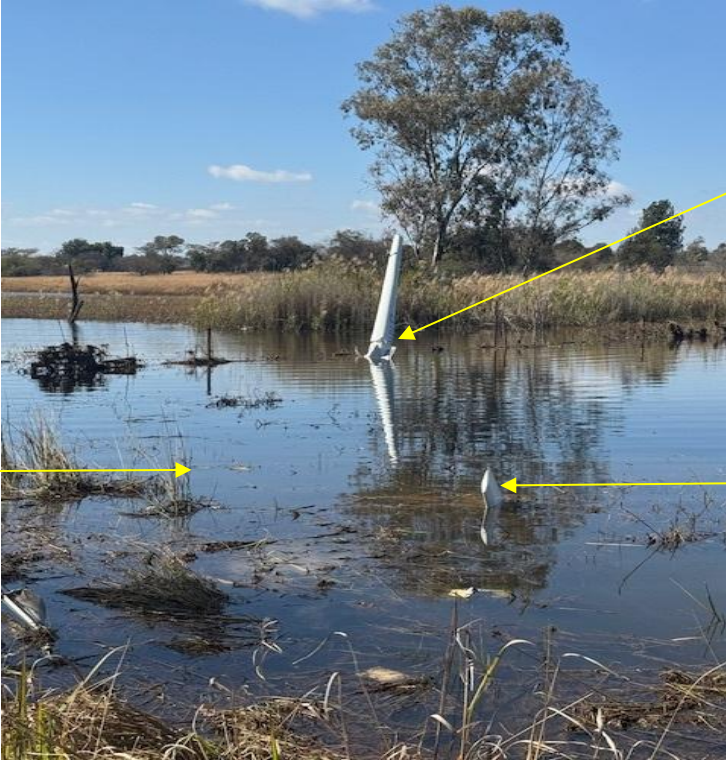
1.12.3 The cockpit cabin area was submerged, and the tail boom was tilted up. The tail boom structure showed compression damage just aft of the main fuselage attachment point. The engine compartment revealed no sign/s of catastrophic failures. It was clean and free of oil and hydraulic fluid. The drive V-belts were all intact with no sign of rolling or chafing. The upper and lower sheaves were displaced longitudinally, and the belts were not in place in the sheave grooves. The belt tension actuator had broken into several pieces. The clutch centring strut had rotational scoring running in the direction of rotation of the upper sheave.

Figure 8: The approximate first point of impact, the main wreckage and the stabiliser that separated during the accident sequence.

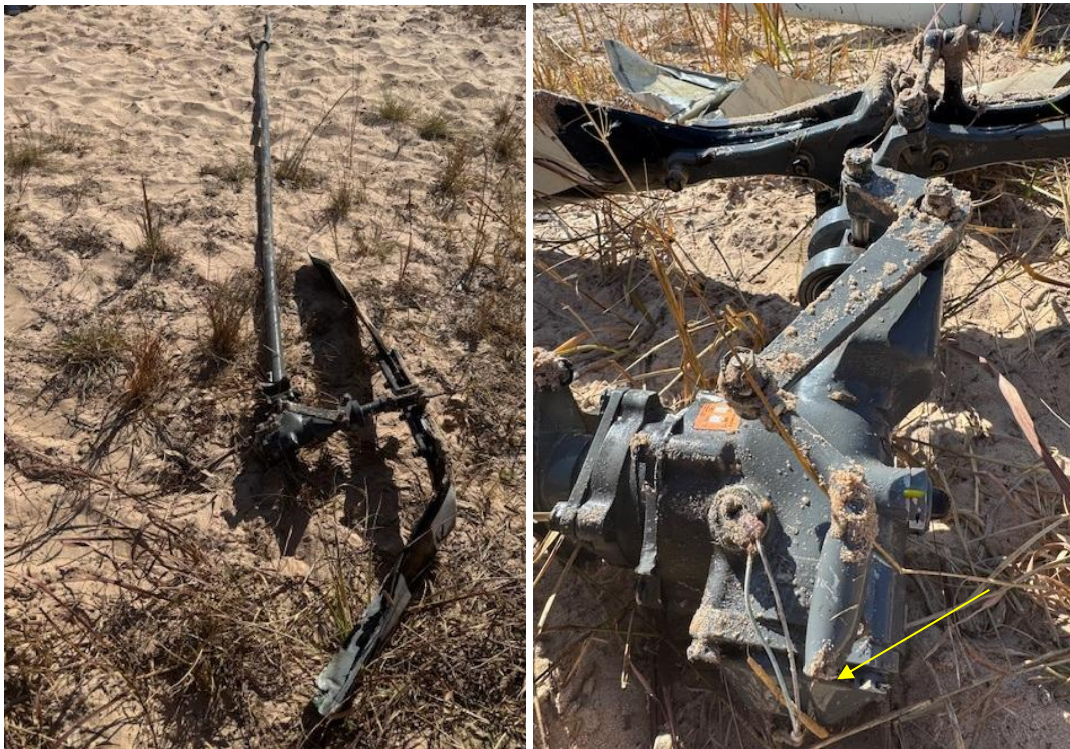
1.12.4 The tail rotor drive shaft separated from the tail rotor and the gearbox/transmission was found still attached to it. The tail rotor gearbox rotated freely with no abnormal noise, and the gear output shaft indicated normal operation and was undamaged. The tail rotor blades showed signs of rotation. None of the flex plates on the tail rotor drive shaft failed. The pitch change bellcrank broke off during the accident sequence. The flight controls had several disconnects between the cyclic, collective pitch control levers and swashplate. All fractures exhibited signatures consistent with overload. The tail rotor flight controls had several disconnects from the pedals and tail rotor, and all separations exhibited overload signatures.

Figures 9 and 10: The separated tail rotor drive shaft and blades (left picture); and the broken pitch change bellcrank (right picture).

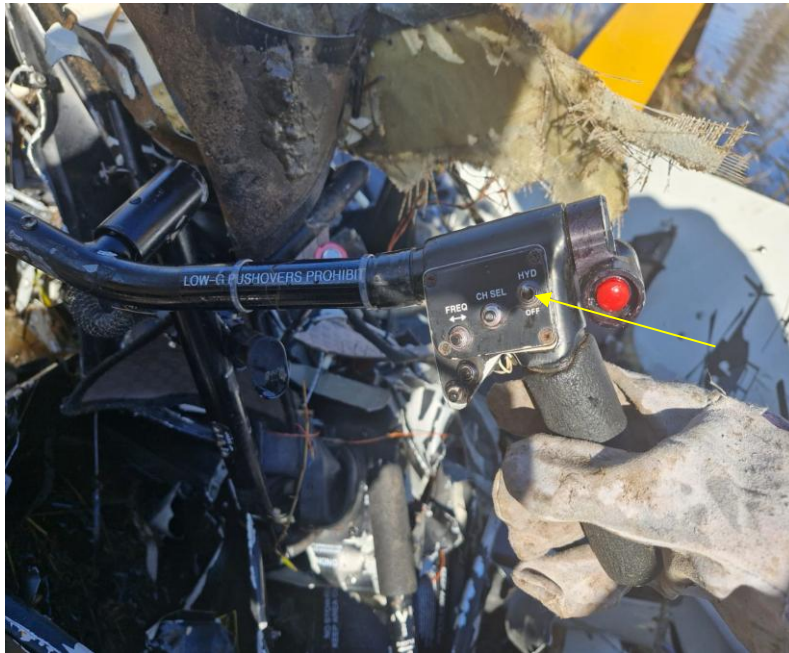
Figure 11: The cyclic pitch control lever indicating the hydraulic switch in the ON position.

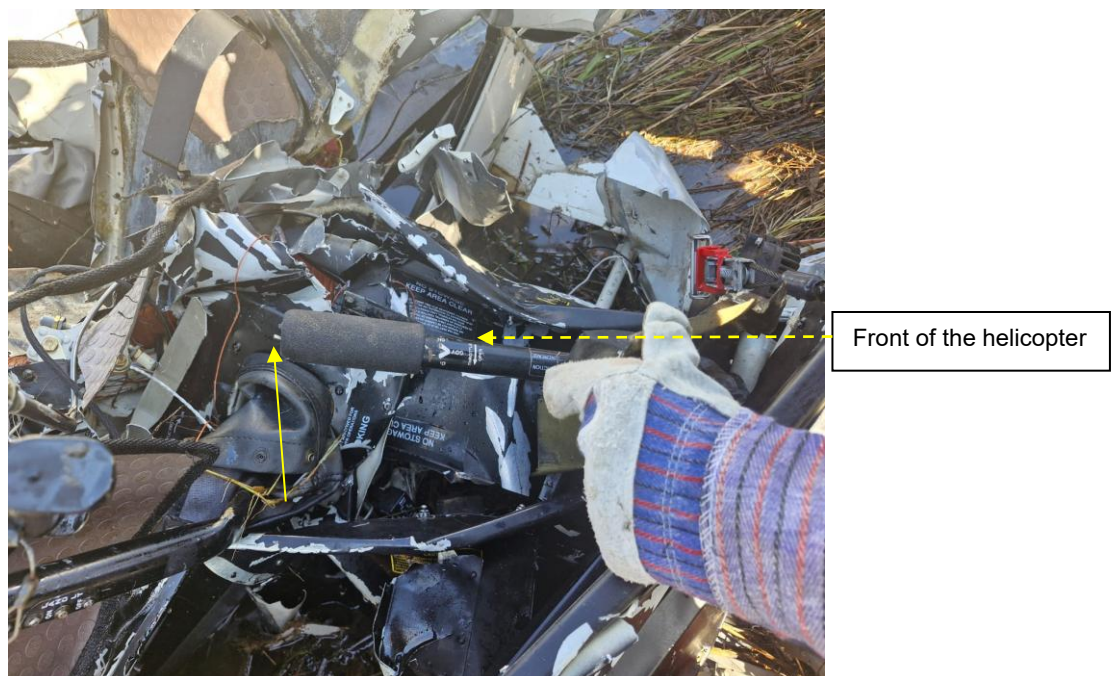
Figure 12: The collective pitch control lever near the full UP position and the engine governor in the ON (UP) position (yellow arrow).
