LIMITED OCCURRENCE INVESTIGATION REPORT – FINAL

Reference Number	CA18/2/3/10591					
Classification	Accident		Date	13 June 2025	Time	0839Z
Type of Operation	Private (Part 91)					
Location						
Place of Departure	Private Airstrip, Koppieskraal Pan, Northern Cape Province		Place of Intended Landing	Private Airstrip, Koppieskraal Pan, Northern Cape Province		
Place of Occurrence	Private Airstrip in Koppieskraal Pan, Northern Cape Province					
GPS Co-ordinates	Latitude	26°56'52.12"S	Longitude	20°18'32.27"E	Elevation	2 674 ft
Aircraft Information						
Registration	ZS-OYW					
Make; Model; S/N	Piper; PA-32R-301T (Serial No: 3257319)					
Damage to Aircraft	Substantial		Total Aircraft Hours	808.9		
Pilot-in-command						
Licence Type	Private Pilot Licence (PPL)		Gender	Male		Age 69
Licence Valid	Yes	Total Hours	746.1		Total Hours on Type	694.8
Total Hours 30 Days	6.4		Total Flying on Type Past 90 Days		6.4	
People On-board	1+2		Injuries	0		Fatalities 0 Other (on ground) 0

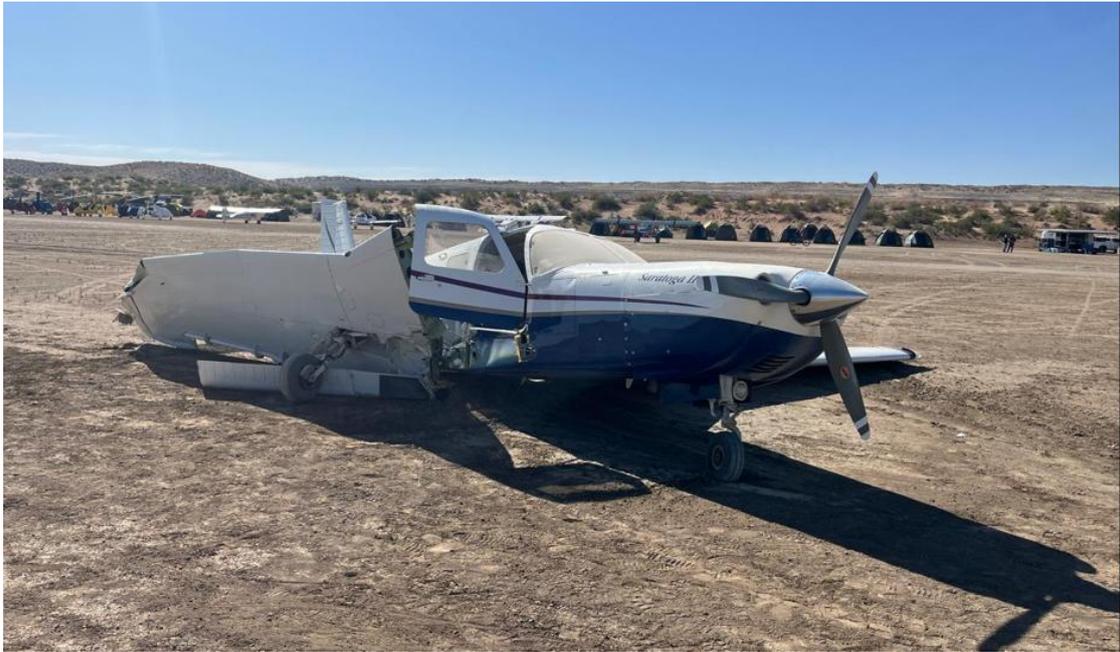
According to the ZS-OYW pilot, during the take-off roll whilst the aircraft was approximately 400 metres (m) from the threshold, he spotted the fuel bowser as it entered the runway from the right. The pilot attempted to avoid the vehicle by veering slightly to the left but despite the manoeuvre, the aircraft's right wing struck the truck and the aircraft's wing detached from the fuselage. Moreover, the left main landing gear collapsed, and the aircraft skidded on the ground before it stopped on the runway.

The occupants were unable to open the aircraft doors from the inside, thus, the bystanders at the scene forced the doors open from the outside for the pilot and the two passengers to disembark; they were not injured. The aircraft sustained substantial damage.

Figure 2: The aircraft post-accident. (Source: Pilot)

The aircraft impacted the fuel bowser truck due to inadequate communication and co-ordination of ground vehicle movement on the active runway.

1. It is recommended that organisers of temporary airstrip events equip all ground vehicles, including fuel bowzers, with operational very high frequency (VHF) radios tuned to the event frequency to enable drivers to monitor and co-ordinate with aircraft and ground personnel. A simple, written event safety plan should be developed to define responsibilities, communication channels and operational procedures with all pilots and ground staff briefed before operations begin.
2. It is recommended that designated runway crossing points be established at temporary airstrip events, controlled by a trained marshal in direct radio contact with airborne and taxiing aircraft. Vehicle crossings should only be permitted once the marshal confirms the runway is clear, ensuring safe separation between aircraft operations and ground vehicle movements.

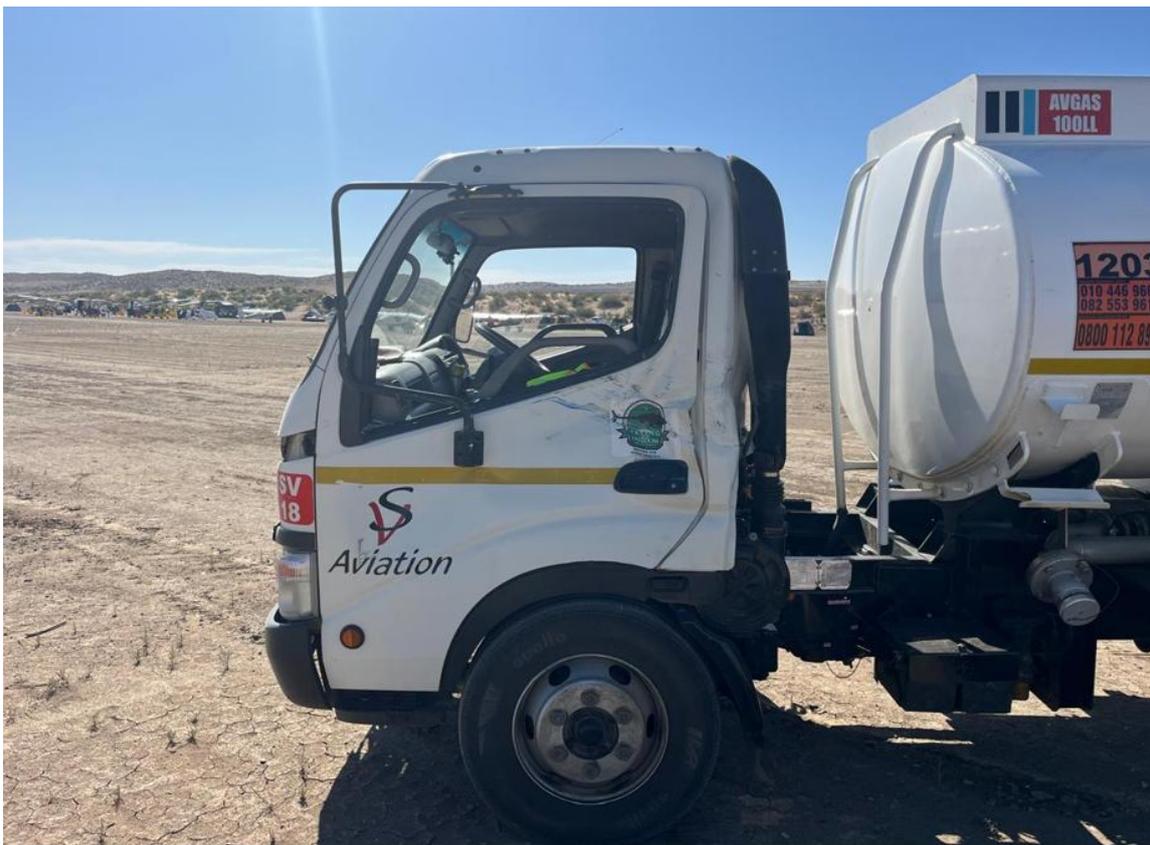
Figure 3: The impacted fuel truck. (Source: Pilot)

The driver stated that he was qualified and certified to operate a handheld radio for aerodrome operations. However, on the day of the accident, he did not have access to either a vehicle-mounted or handheld radio tuned onto the frequency in use at the event.

8. There were no existing systems to manage or co-ordinate movement of ground vehicles on the active runway. The fuel truck driver was contacted via a cellular phone as he was not issued a handheld radio or a vehicle with a radio to communicate with the pilots/organisers on the frequency that was used at the event. Although the fuel bowser had a designated area, the driver was requested to cross over the active runway to enable the aircraft on the other side to refuel.
9. The truck driver relied on physical observation with limited view due to blind spots around the area to cross over the active runway.

1. Absence of radio communication between aircraft and ground vehicles.
2. Lack of designated person or procedures to control vehicle movement crossing the runway.
