**LIMITED OCCURRENCE INVESTIGATION REPORT – DRAFT**

| <b>Reference Number</b> | CA18/2/3/10592 | | | | | | |
| Registration | ZU-ORG | | | | | | |
| Make; Model; S/N | Vans; RV-9 (Serial Number: 91013) | | | | | | |

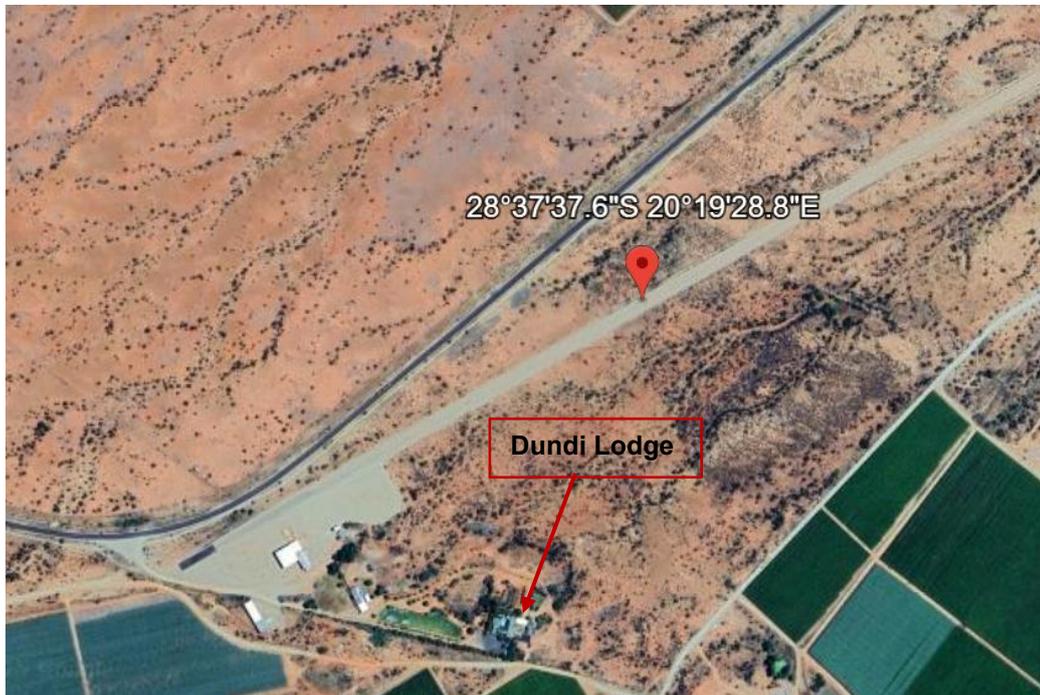
| <p>On Saturday, 14 June 2025, a pilot and a passenger on-board a Vans RV-9 aircraft with registration ZU-ORG intended to take-off from Dundi Lodge Private Airstrip in Northern Cape province to Morningstar Airfield in Western Cape province when the accident occurred. The flight was to be conducted under visual meteorological conditions (VMC) by day and under the provisions of Part 94 of the Civil Aviation Regulations (CAR) 2011 as amended.</p> <p>The pilot reported that a pre-flight inspection of the aircraft was conducted, and no anomalies were observed. The aircraft had approximately 136 litres (L) of Aviation Gasoline (Avgas) 100LL fuel in the tanks. It departed from Runway (RWY) 08 at Dundi Lodge Private Airstrip at approximately 0530Z with the engine power set at 2 700 revolutions per minute (RPM).</p> <p>During the take-off roll on the paved runway, the pilot lost directional control of the aircraft. He then applied the right rudder to regain control but was unsuccessful. The aircraft veered off to the left of the runway and exited the paved surface; it impacted some trees before it came to a stop approximately 500 metres (m) to the left of RWY 08.</p> | | | | | | | |

**Figure 1:** Aerial view of the accident site and Dundi Lodge. (Source: Google Earth)

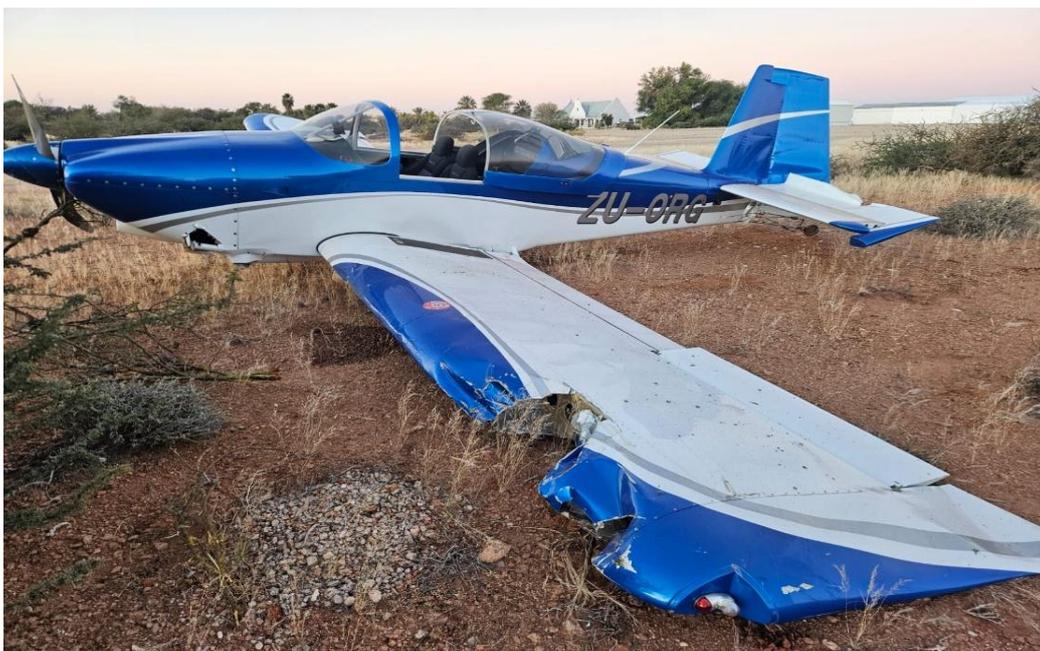
The pilot and the passenger were not injured after the accident sequence. The aircraft sustained substantial damage to the undercarriage, fuselage, left-wing leading edge and tailwheel, as well as horizontal and vertical stabilisers.

**Figure 2:** The aircraft in its resting position after the accident. (Source: Pilot)

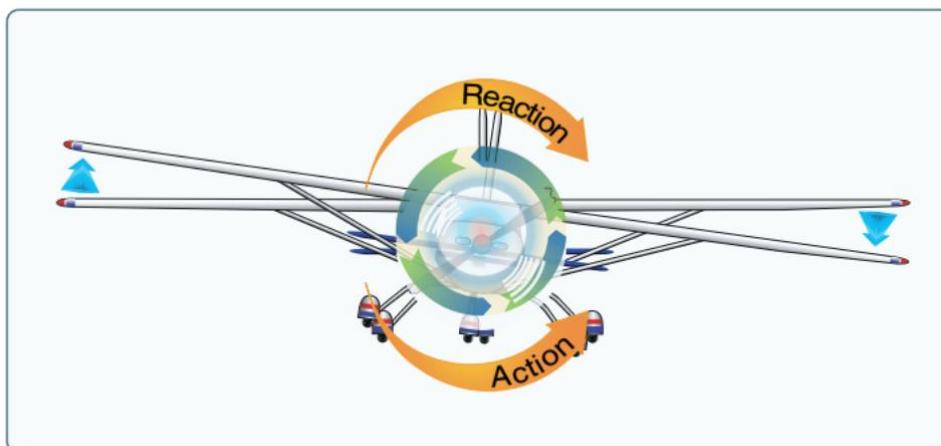
**Figure 5-47.** *Torque reaction.*

*Torque reaction involves Newton's Third Law of Physics—for every action, there is an equal and opposite reaction. As applied to the aircraft, this means that as the internal engine parts and propeller are revolving in one direction, an equal force is trying to rotate the aircraft in the opposite direction see Figure 5-47.*

*When the aircraft's wheels are on the ground during the take-off roll, an additional turning moment around the vertical axis is induced by torque reaction. As the left side of side of the aircraft is being forced down by torque reaction, more weight is being placed on the left main landing gear. This results in more ground friction, or drag, on the left tyre than on the right, causing a further turning moment to the left. The magnitude of this moment is dependent on many variables. Some of these variables are:*

4. The pilot lost directional control of the aircraft during the take-off roll on RWY 08 because of the failure to compensate for engine torque effect. This resulted in the aircraft drifting to the left before it exited to the left side of the runway and impacted some trees.

*This yawing moment on the take-off roll is corrected by the pilot's proper use of the rudder or rudder trim.*
