LIMITED OCCURRENCE INVESTIGATION REPORT – FINAL

Reference Number		CA18/2/3/10593					
Classification	Accident	Date	15 July 2025			Time	1820Z
Type of Operation	Private (Part 91)						
Location							
Place of Departure		Wonderboom Aerodrome (FAWB), Gauteng Province		Place of Intended Landing		Wonderboom Aerodrome (FAWB), Gauteng Province	
Place of Occurrence		On a bushy terrain approximately 3 nautical miles north-east of FAWB					
GPS Co-ordinates	Latitude	25°38'10.9" S	Longitude	28°16'03.8" E	Elevation	4018 ft	
Aircraft Information							
Registration		ZS-EAD					
Make; Model; S/N		Cessna; 172F (Serial Number 172-52464)					
Damage to Aircraft		Minor		Total Aircraft Tachometer Hours		4730.71	
Pilot-in-command							
Licence Type		Private Pilot Licence (PPL)		Gender		Male	
Age		22		Total Hours		123.7	
Licence Valid		Yes		Total Hours on Type		19	
Total Hours Past 30 Days		1		Total Flying on Type Past 90 Days		1	
People On-board		1+2		Injuries		0	
Fatalities		0		Other (on ground)		0

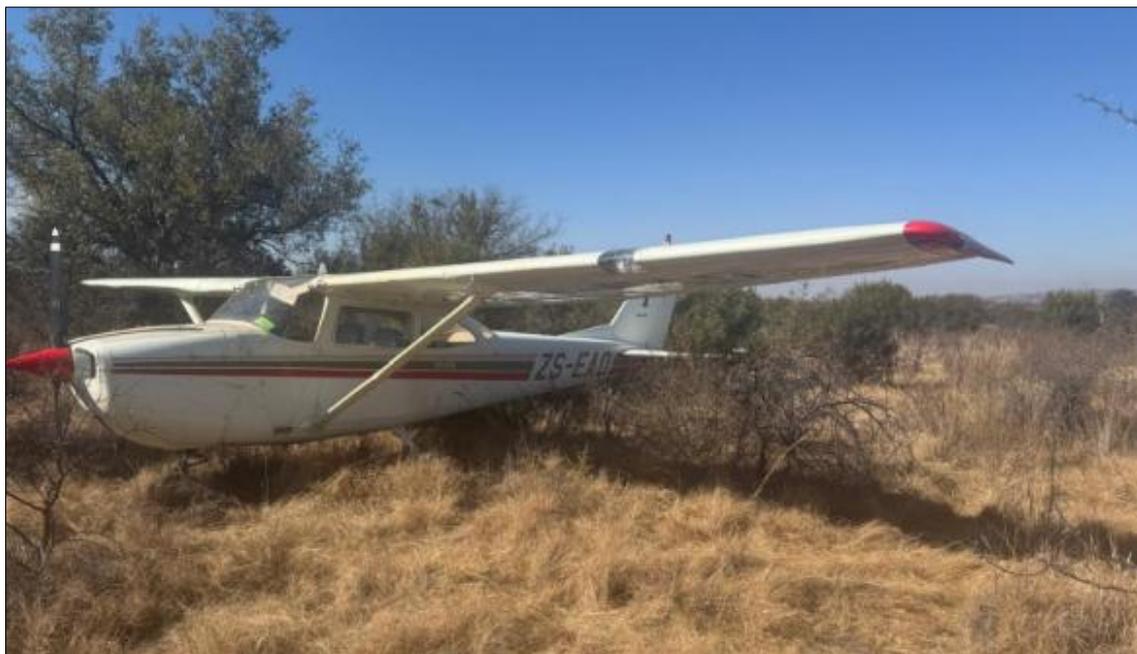
The pilot and the two passengers were not injured during the accident sequence. The aircraft sustained minor damage to the right horizontal stabiliser, right-wing leading edge, windscreen and right-wing strut mount.

Figure 1: The aircraft at the scene of the accident.
