LIMITED OCCURRENCE INVESTIGATION REPORT – FINAL

Reference Number	CA18/2/3/10594						
Classification	Accident		Date	3 August 2025		Time	0932Z
Type of Operation	Private (Part 94)						
Location							
Place of Departure	Worcester Airport (FAWC), Western Cape Province		Place of Intended Landing	Worcester Airport (FAWC), Western Cape Province			
Place of Occurrence	Theewaterskloof Local Municipality, Western Cape Province						
GPS Co-ordinates	Latitude	34° 08' 33.10" S	Longitude	19° 03' 06.41" E	Elevation	650 ft	
Aircraft Information							
Registration	ZT-GAE						
Make; Model; S/N	DG Flugzeugbau; DG800B (S/N: 8-87B23)						
Damage to Aircraft	Substantial			Total Aircraft Hours	1985		
Pilot-in-command							
Licence Type	Glider Pilot Licence (GPL)		Gender	Male		Age	73
Licence Valid	Yes	Total Hours	1983.4		Total Hours on Type	1068	
Total Hours 30 Days	8.2		Total Flying on Type Past 90 Days	16.7			
People On-board	1+0	Injuries	0	Fatalities	0	Other (on ground)	0

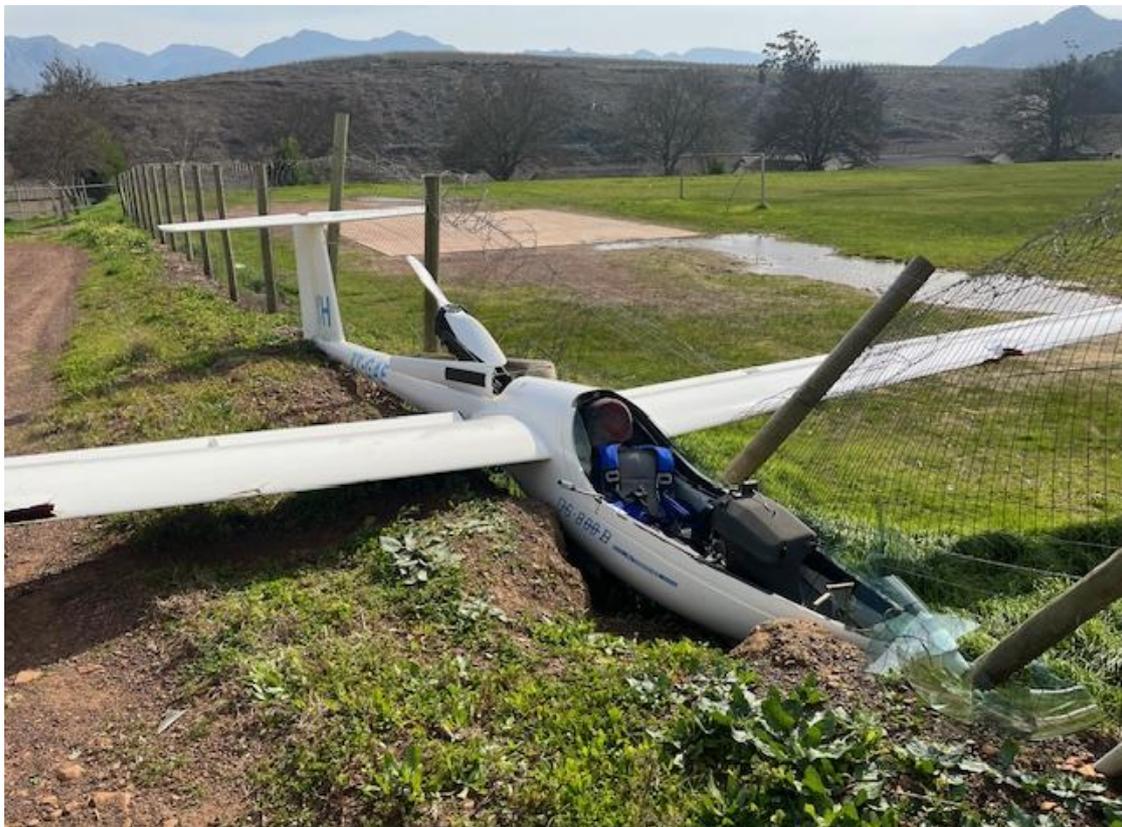
The pilot was not injured after the accident. The glider sustained damage to the wings, canopy (which broke off) and the fuselage.

Figure 2: The aircraft after impact. (Source: Pilot)

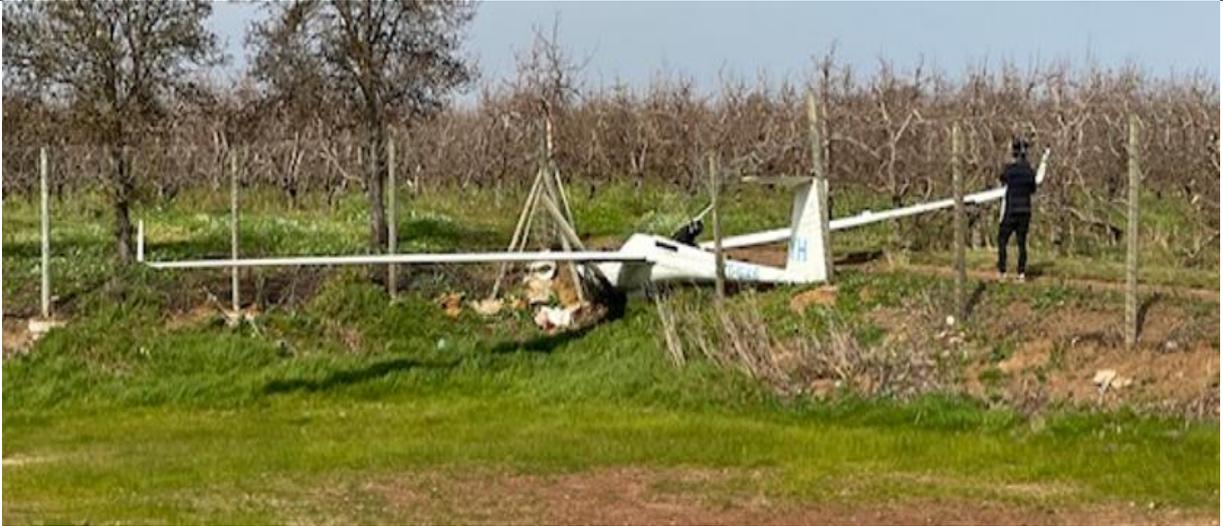
Figure 3: The rear view of the aircraft post-accident. (Source: Pilot)
