LIMITED OCCURRENCE INVESTIGATION REPORT – FINAL

Reference Number		CA18/2/3/10596					
Classification	Accident	Date	14 August 2025			Time	0730Z
Type of Operation	Private (Part 91)						
Location							
Place of Departure	Wonderboom Airport (FAWB), Gauteng Province		Place of Intended Landing		Lephalale (Ellisras) Airport (FAER), Limpopo Province		
Place of Occurrence	Lephalale (Ellisras) Airport (FAER), Limpopo Province						
GPS Co-ordinates	Latitude	23°43'36"S	Longitude	27°41'18"E	Elevation	2799 ft	
Aircraft Information							
Registration	ZS-MPR						
Make; Model; S/N	Cessna 402C (Serial Number 402C-1017)						
Damage to Aircraft	Substantial			Total Aircraft Hours		3519.3	
Pilot-in-command							
Licence Type	Commercial Pilot Licence (CPL)		Gender	Male		Age	37
Licence Valid	Yes	Total Hours	3678.6		Total Hours on Type	62.4	
Total Hours 30 Days		32.3		Total Flying on Type Past 90 Days			18.7
People On-board	1+5	Injuries	0	Fatalities	0	Other (on ground)	0

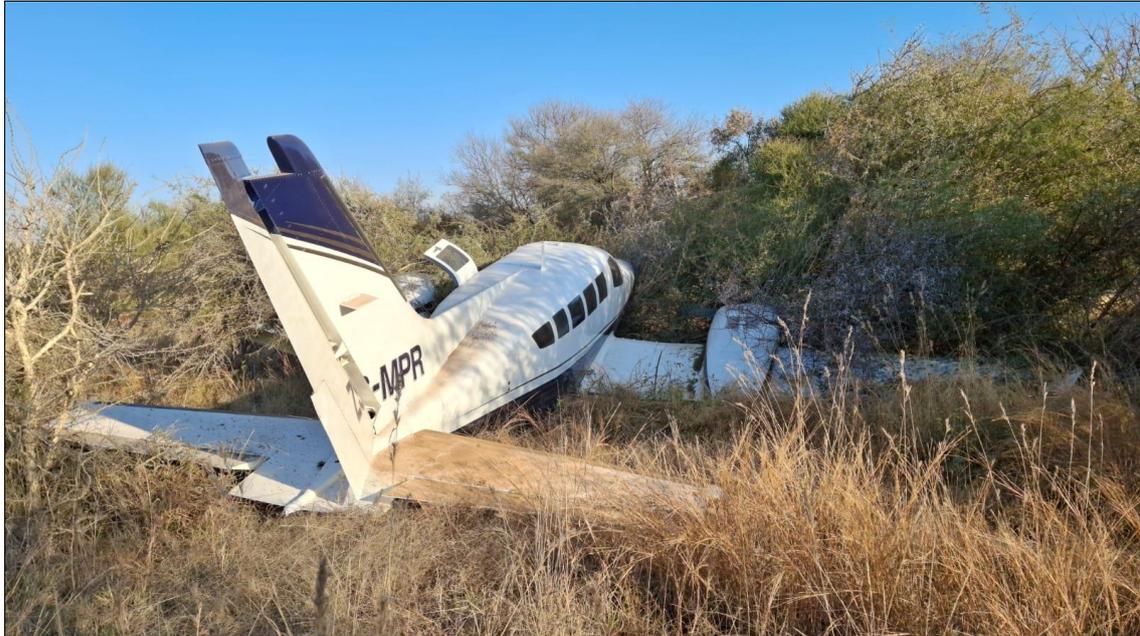
What Happened							
<p>On 14 August 2025, a pilot and five passengers on-board a Cessna 402C aircraft with registration ZS-MPR departed from Wonderboom Airport (FAWB), Gauteng province, to Lephalale (Ellisras) Airport (FAER), Limpopo province. The private flight was conducted under visual meteorological conditions (VMC) by day and under the provisions of Part 91 of the Civil Aviation Regulations (CAR) 2011 as amended.</p> <p>The pilot stated that upon arrival at FAER and whilst overhead the airport, he completed the unmanned joining procedures and aligned the aircraft for final approach on Runway 09. The aircraft touched down and rolled approximately 100 to 150 metres (m) during which he felt the aircraft yaw to the left of the runway centreline. He then applied the full right rudder and maintained the input for approximately 50m before the aircraft yawed farther to the left and departed the runway; it came to rest in a bushy terrain adjacent to the runway.</p> <p>The pilot and the passengers were unharmed during the accident sequence. The aircraft sustained substantial damage and was recovered to an approved aircraft maintenance facility after the accident.</p>

Figure 1: The aircraft at the accident scene.

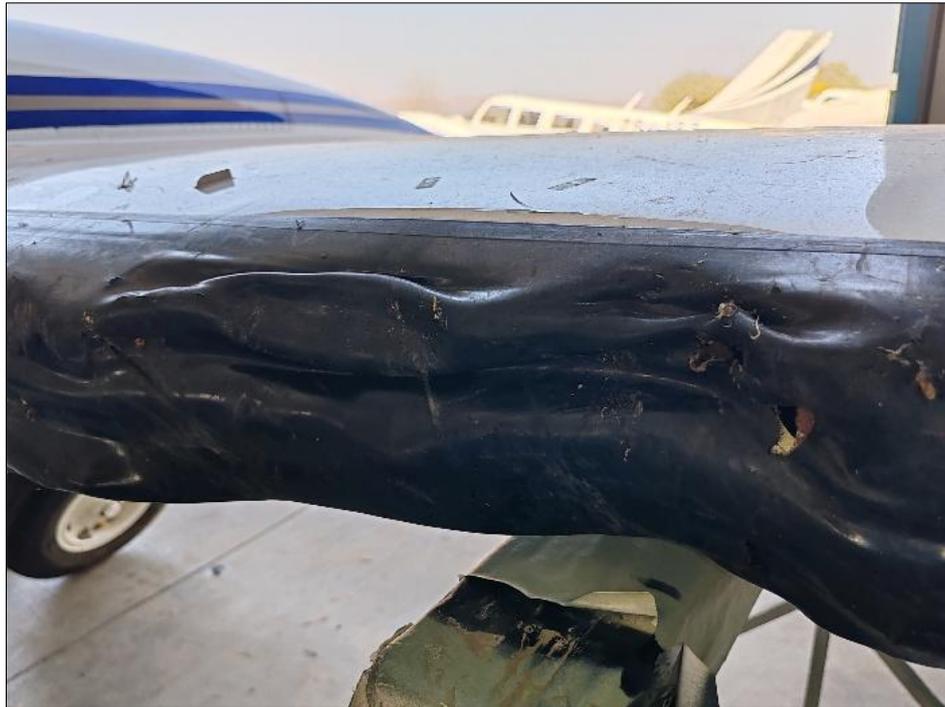
investigation found multiple impact marks on the left wing of the aircraft (see Figure 2); the wing tip and outboard section of the wing were found severed from the fuselage.

Figure 2: The leading edge of the left wing with impact damage.

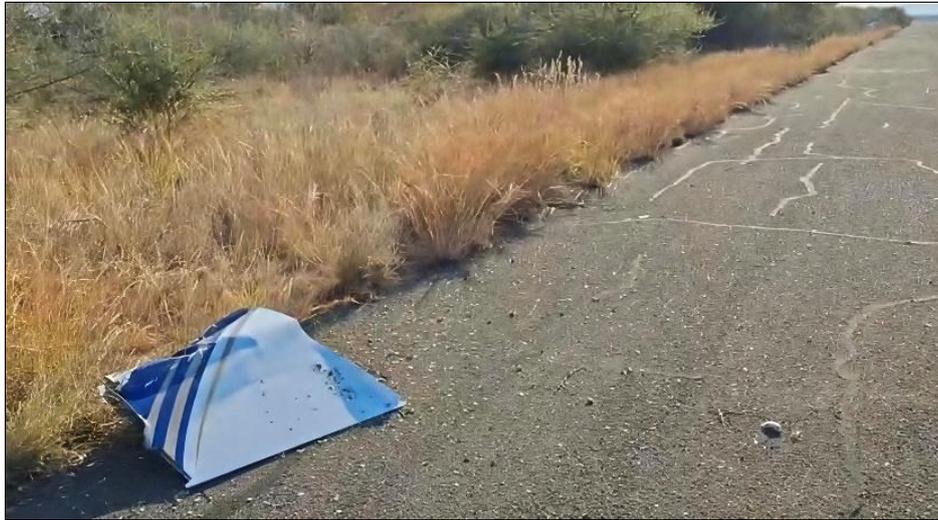
A video footage from the recovery team was shared with the investigators. It revealed that the aircraft's left wing had impacted vegetation on the left edge of Runway 09 over a distance of approximately 120m to 150m. The wing tip broke off and was found on the edge of the runway near the first tree that the aircraft had impacted. The outer part of the left wing was found approximately 60m down the runway, in the direction of landing. The final impact indications where the aircraft came to rest were 50m farther from where the outer part of the left wing was found (see Figures 3, 4, 5 and 6).

Figure 3: The left-wing tip on the edge of Runway 09. (Source: Video footage still image)

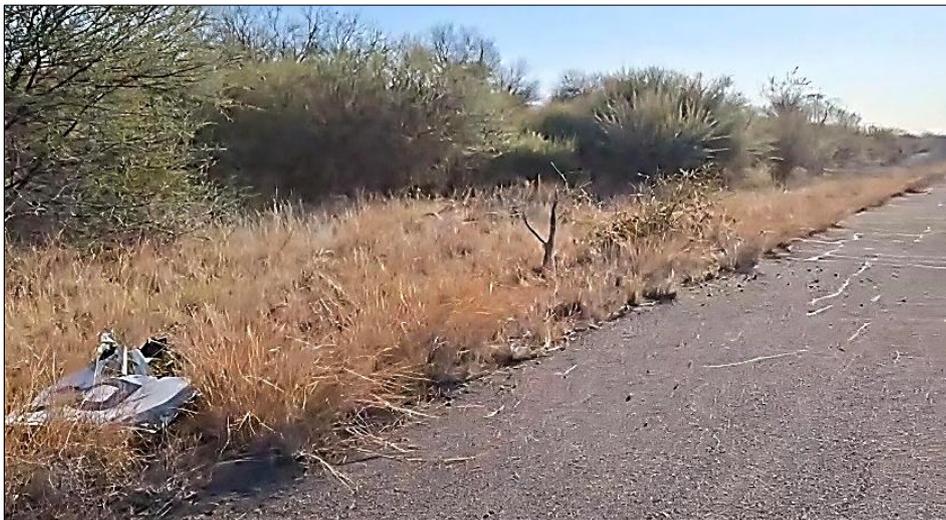
Figure 4: The left outer wing section found on Runway 09. (Source: Video footage still image)

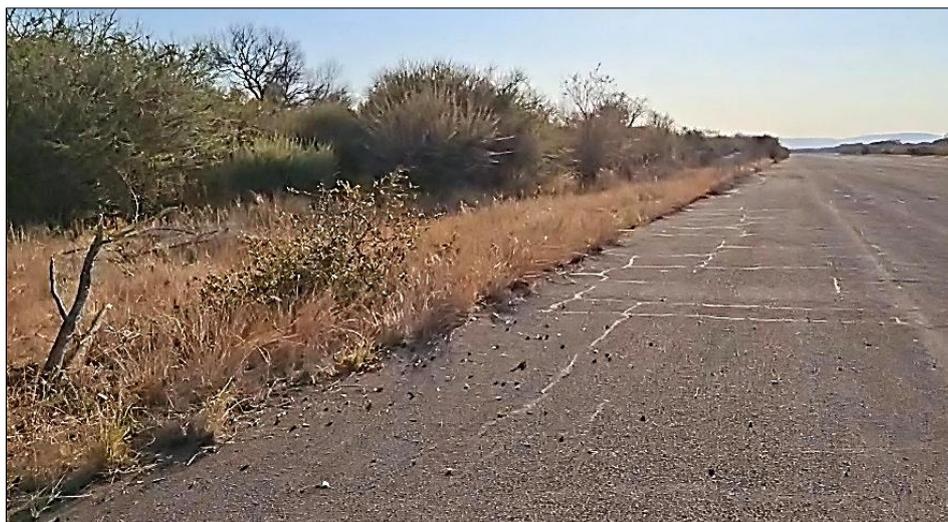
Figure 5: One of the severed trees impacted by the aircraft's left wing. (Source: Video footage still image)

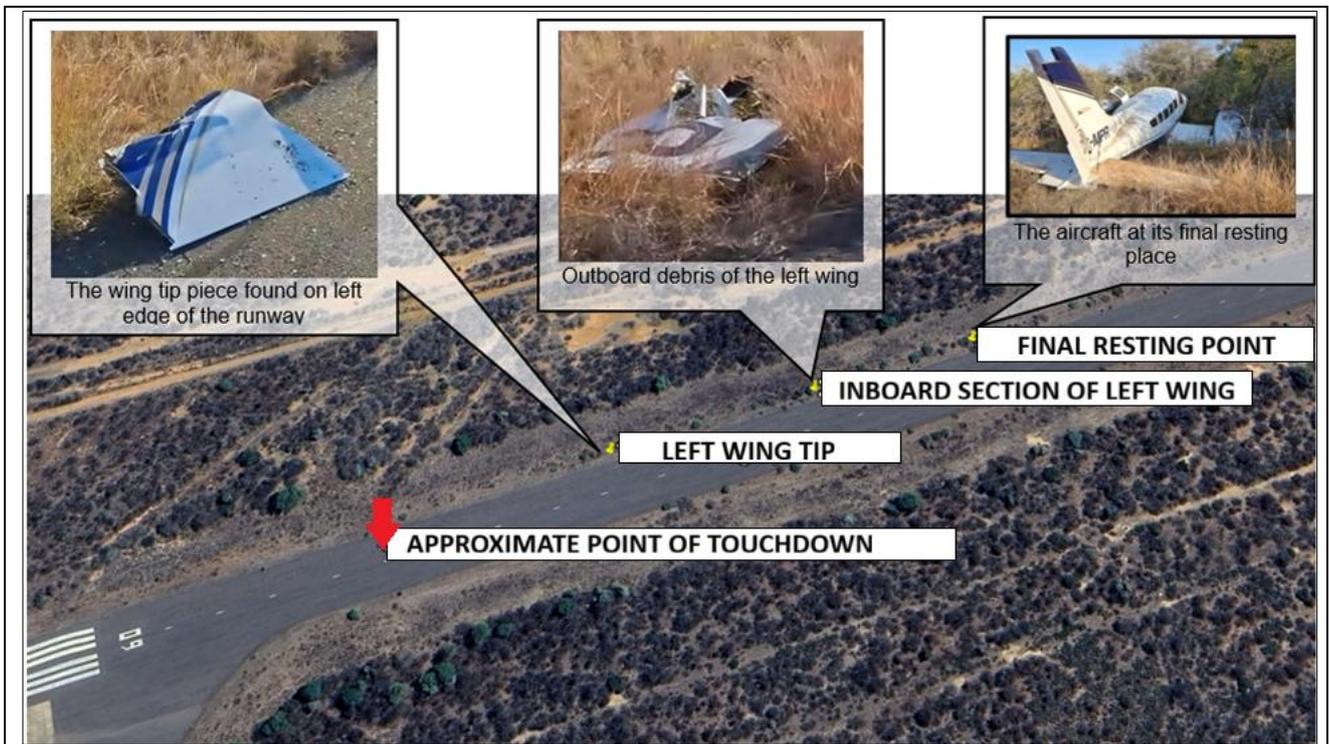
Figure 6: Approximate location of debris.

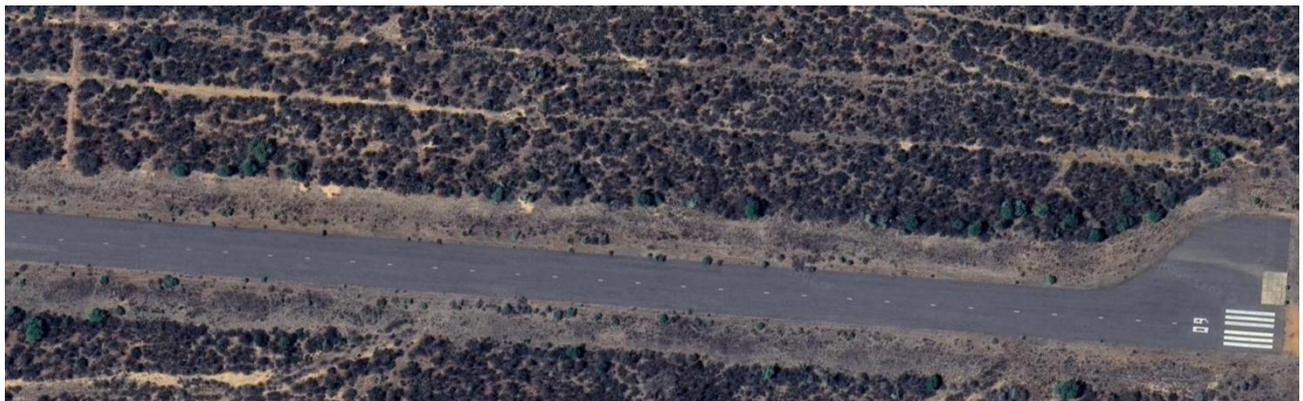
FAER is an old airport operated by the South African National Defence Force (SANDF) and is not subject to the requirements of the South African Civil Aviation Authority Regulations Part 139 Aerodromes and Heliports. The runway is 30m wide and 2194m long. Assessment of the runway condition revealed a substantial amount of vegetation alongside the left and right edges. This was also evident in the video footage that was supplied by the recovery team (see Figure 3, 4, 5, 6 and 7).

Figure 7: Partial aerial view of FAER showing vegetation near the left and right edges of Runway 09.

Lack of a runway safety area on the edges of the runway.
