LIMITED OCCURRENCE INVESTIGATION REPORT – FINAL

| Reference Number | CA18/2/3/10597 | | | | | | |
| Registration | ZU-MGB | | | | | | |
| Make; Model; S/N | Sling 2 (Serial Number: 101) | | | | | | |

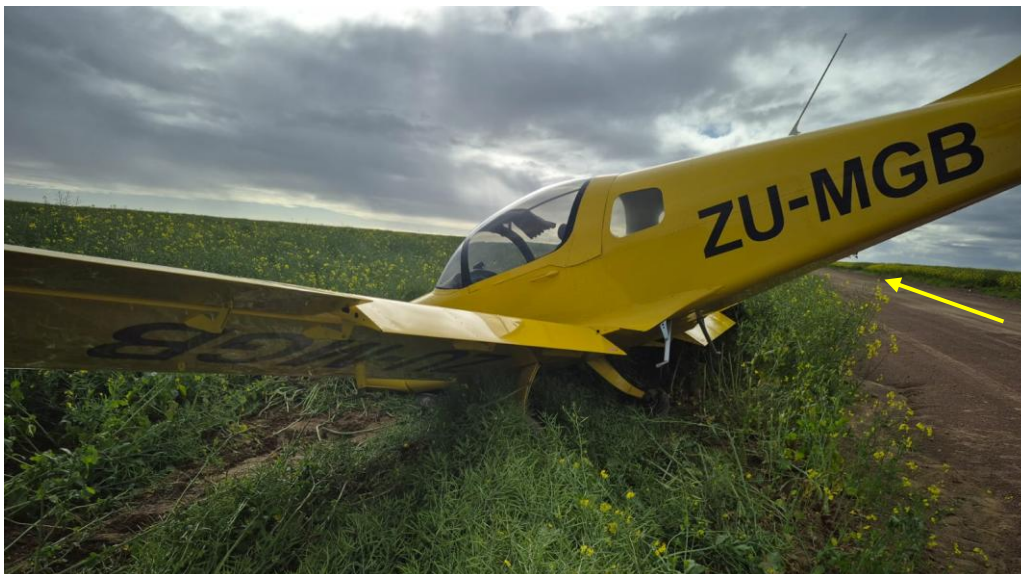
pitched down, and the propeller struck the soft ground. The aircraft stopped on the left side of the runway. After the accident, the FI turned off the fuel selector and master switch. The aircraft was substantially damaged; however, no person was injured.

Figure 1: The aircraft at the accident site; the yellow arrow indicates the direction of landing. (Source: Operator)

It is possible that the aircraft was unstable during approach for landing which resulted in the aircraft landing too fast; subsequently, the flight instructor lost directional control of the aircraft.
