**LIMITED OCCURRENCE INVESTIGATION REPORT – FINAL**

<b>Reference Number</b>	CA18/2/3/10598						
<b>Classification</b>	Accident		<b>Date</b>	23 August 2025		<b>Time</b>	0803Z
<b>Type of Operation</b>	Private (Part 91)						
<b>Location</b>							
Place of Departure	Vereeniging Airport (FAVV), Gauteng Province		Place of Intended Landing	George Airport (FAGG), Western Cape Province			
Place of Occurrence	On a private farm, south of Thembaletu township in George, Western Cape Province						
GPS Co-ordinates	Latitude	34° 01' 05.30" S	Longitude	22° 29' 59.48" E	Elevation	484ft	
<b>Aircraft Information</b>							
Registration	ZS-IZN						
Make; Model; S/N	Rockwell 500S Shrike Commander (Serial Number: 500S-3132)						
Damage to Aircraft	Substantial		Total Aircraft Hours	277.2			
<b>Pilot-in-command</b>							
Licence Type	Private Pilot Licence (PPL)		Gender	Male		Age	41
Licence Valid	Yes	Total Hours	168		Total Hours on Type	22	
Total Hours 30 Days	10		Total Flying on Type Past 90 Days	22

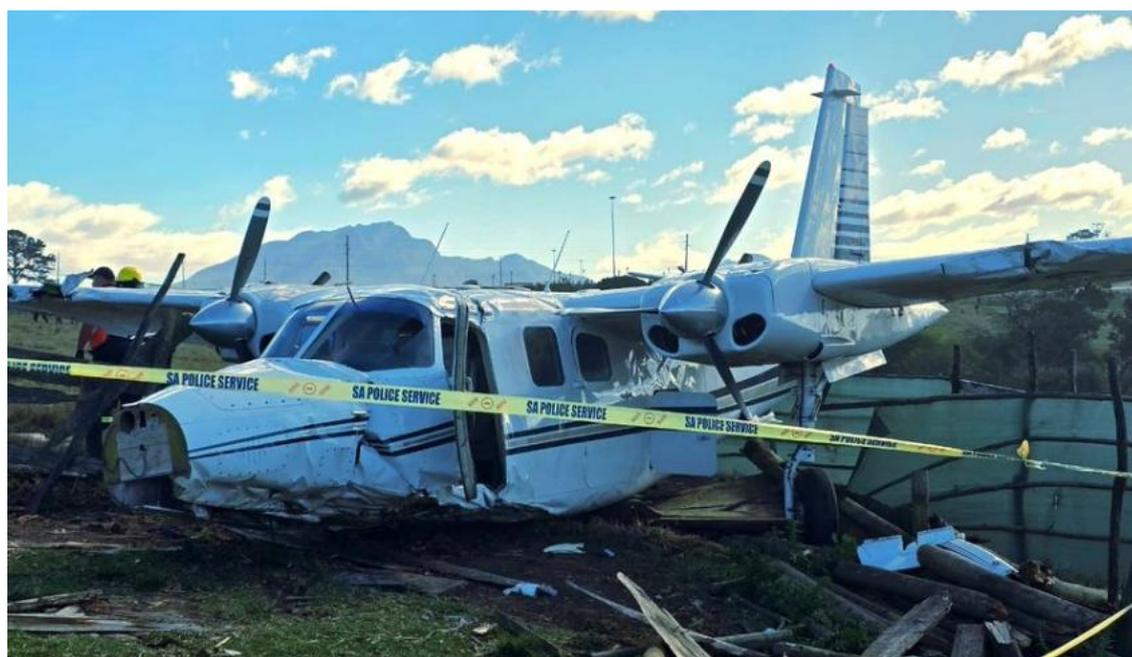
**Figure 2:** The aircraft at the accident site.

The investigating team conducted an on-site inspection. It was found that the aircraft had sustained severe damage to the outboard leading edges of both wings due to impact with a pole. The fuel tanks had remained intact with no sign of rupture or leakage. The cabin structure was largely intact; however, the underbelly sustained substantial damage. *The cockpit was equipped with multiple fuel-related indicators, including fuel quantity, fuel pressure and fuel flow gauges, as well as a low fuel warning light. These systems provided real-time fuel status to the flight crew throughout the flight.* The aircraft was powered, and the fuel quantity gauge was checked; it indicated empty. The fuel caps were found secure and locked; however, after they were removed for visual inspection, no fuel was found in both tanks (Figure 3). The fuel drain points were found closed; after they were opened, fuel did not discharge from the system. Both engines were manually rotated using the propellers, and no mechanical anomalies were noted.

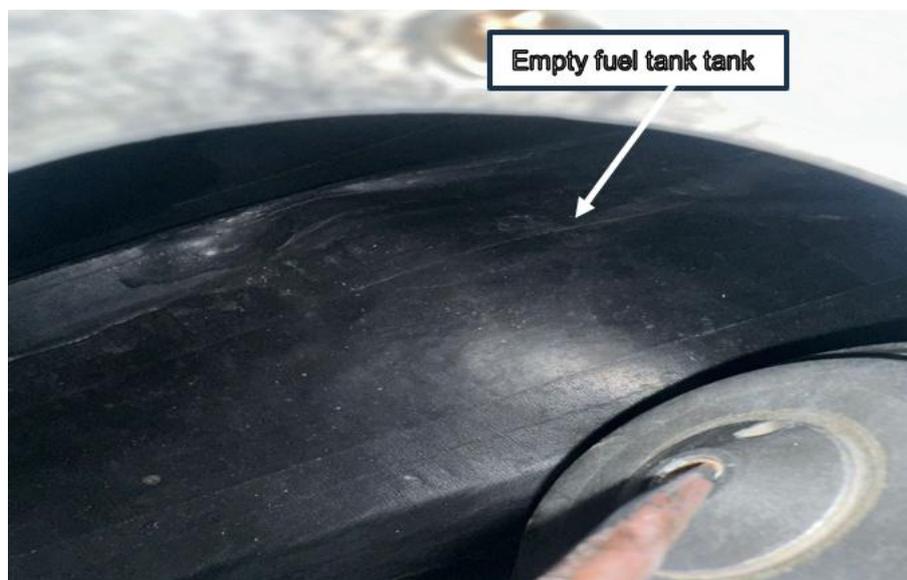
**Figure 3:** The empty fuel tank.

14. No fuel receipts were available as the fuel was uplifted directly from the drums in the hangar.
15. The fuel tanks were found empty after they were inspected at the accident site.

18. The aircraft was operated with insufficient fuel to complete the planned flight; this resulted in both engines ceasing operation in-flight. No evidence of fuel leakage or mechanical failure within the fuel system was identified during the post-accident inspection. The fuel tanks were intact, and the system components functioned normally.

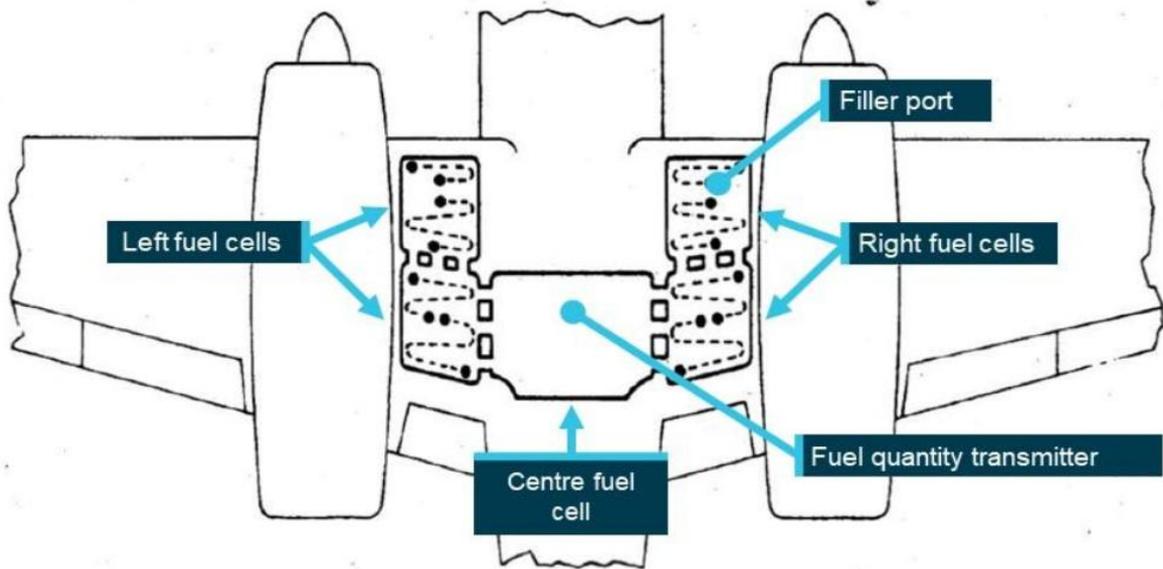
*This aircraft is equipped with multiple interconnected fuel tanks. To assure proper fuel level, it is necessary for fuelling personnel to allow extended fuelling time for fuel to flow and equalise level among the interconnected tanks.*

**Figure 5:** Fuel tank internal layout. (Source: Pilot's Operating Handbook)
