LIMITED OCCURRENCE INVESTIGATION REPORT – FINAL

Reference Number	CA18/2/3/10599						
Classification	Accident		Date	23 August 2025		Time	1235Z
Type of Operation	Aerial Works (Part 137)						
Location							
Place of Departure	Piet Retief Central Airstrip, Mpumalanga Province		Place of Intended Landing	Rusplaas Airstrip, Mpumalanga Province			
Place of Occurrence	Grass-covered runway at Rusplaas Airstrip, Mpumalanga Province						
GPS Co-ordinates	Latitude	26°53'.00"S	Longitude	030°46'.00" E	Elevation	4 048ft	
Aircraft Information							
Registration	ZS-NNZ						
Make; Model; S/N	Ayres Thrush; S2R-T34 (Serial Number: T34-122DC)						
Damage to Aircraft	Substantial			Total Aircraft Hours	10 937.6		
Pilot-in-command							
Licence Type	Commercial Pilot Licence (CPL)		Gender	Male		Age	41
Licence Valid	Yes	Total Hours	7 144.7		Total Hours on Type	1 486.2	
Total Hours 30 Days	7.2		Total Flying on Type Past 90 Days	7.2			
People On-board	1 + 0	Injuries	0	Fatalities	0	Other (on ground)	0

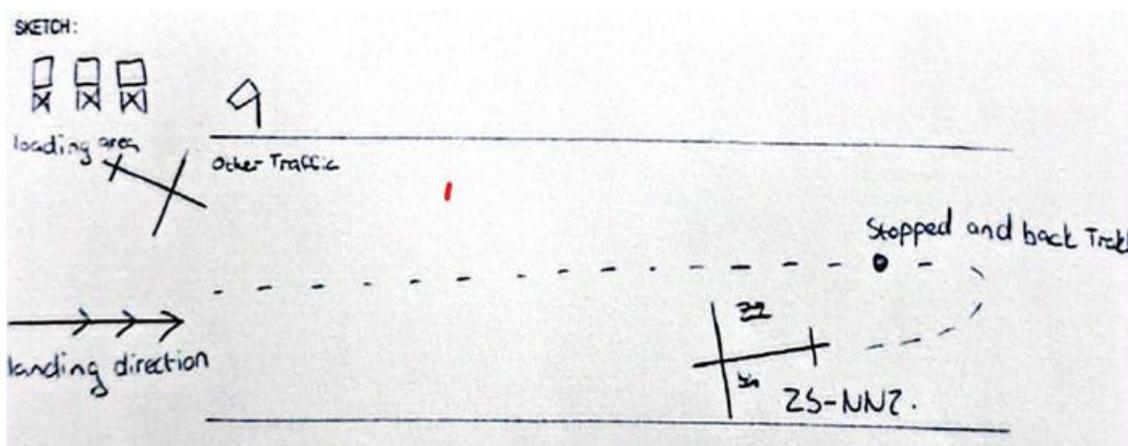
Figure 1: A sketch showing the direction of landing, the backtrack position and the accident site (shown in black dots). (Source: Pilot)

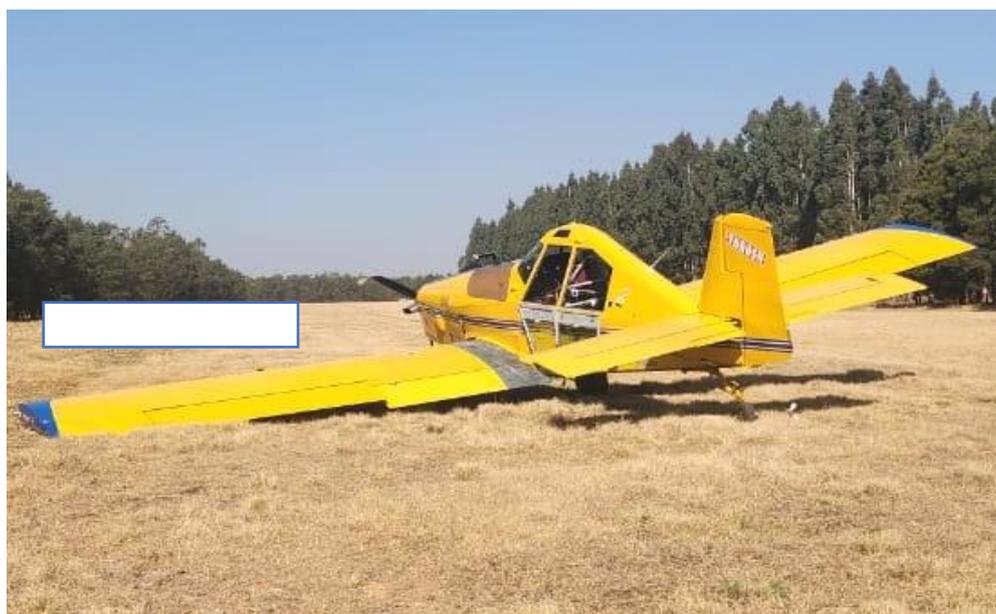
The aircraft came to a stop in the middle of the runway after sustaining substantial damage. The pilot turned off the master switch and fuel selector before he vacated the aircraft; he was unharmed.

Figure 2: A view of the runway and the final resting position of the aircraft. (Source: Pilot)

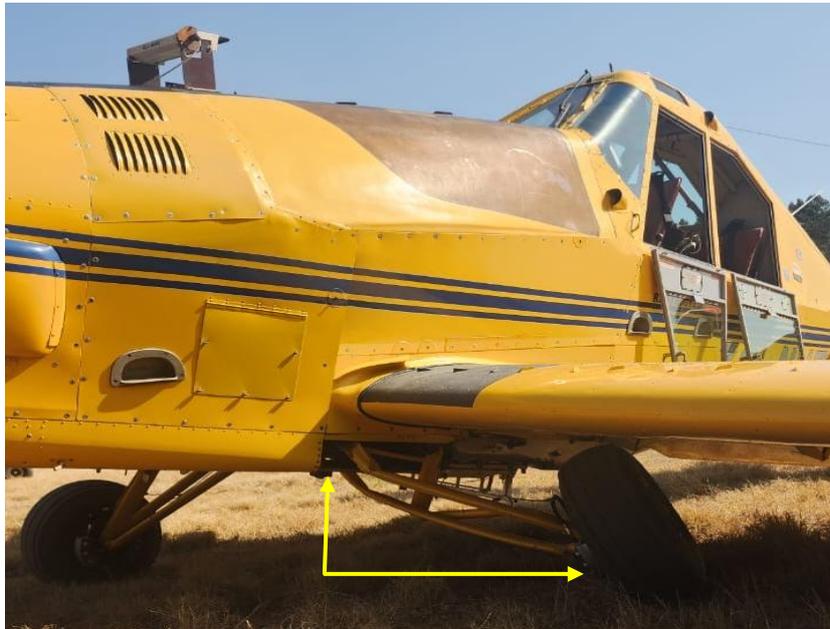
Figure 3: The damaged left main landing gear. (Source: Pilot)

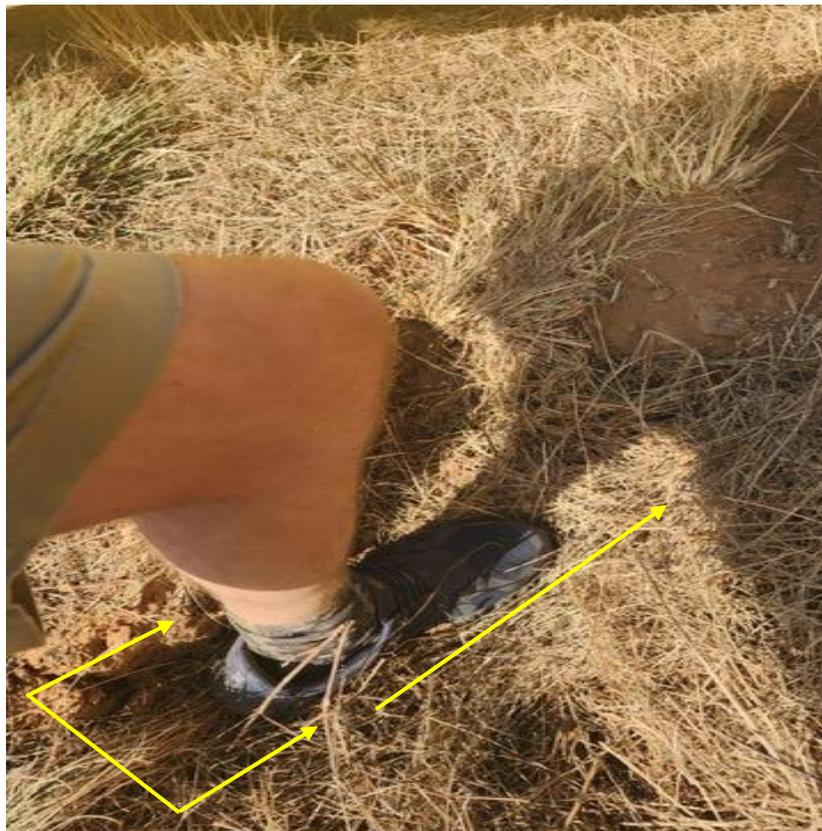
Figure 4: The pilot's leg positioned on the hole that was concealed by grass on the runway, and the direction of taxi (yellow arrow).

Post-accident investigation revealed that the pilot was informed by one of the workers at Rusplaas Airstrip in Ermelo that the runway was inspected for condition and that it (the runway) was safe for operation. The pilot reported that the airstrip was activated on Saturday morning, 23 August 2025, at approximately 0529Z.
