LIMITED OCCURRENCE INVESTIGATION REPORT – FINAL

Reference Number		CA18/2/3/10600											
Classification	Accident			Date	27 August 2025		Time	1145Z					
Type of Operation	Training (Part 141)												
Location													
Place of Departure		Brakpan Airfield (FABB), Gauteng Province		Place of Intended Landing		Brakpan Airfield (FABB), Gauteng Province							
Place of Occurrence		Secunda Airport (FASC), outside the barrier fence between two roads											
GPS Co-ordinates		Latitude	26°31'24.3" S	Longitude	029°10'47.1" E	Elevation	5 250 ft						
Aircraft Information													
Registration		ZS-EKI											
Make; Model; S/N		Piper Cherokee; PA-28-140 (Serial Number: 28-21124)											
Damage to Aircraft		Substantial			Total Aircraft Hours		6338.09						
Pilot-in-command													
Licence Type		Student Pilot Licence (SPL)		Gender		Female		Age	18				
Licence Valid		Yes		Total Hours		56.2		Total Hours on Type		14.1			
Total Hours 30 Days		14.1		Total Flying on Type Past 90 Days		14.1

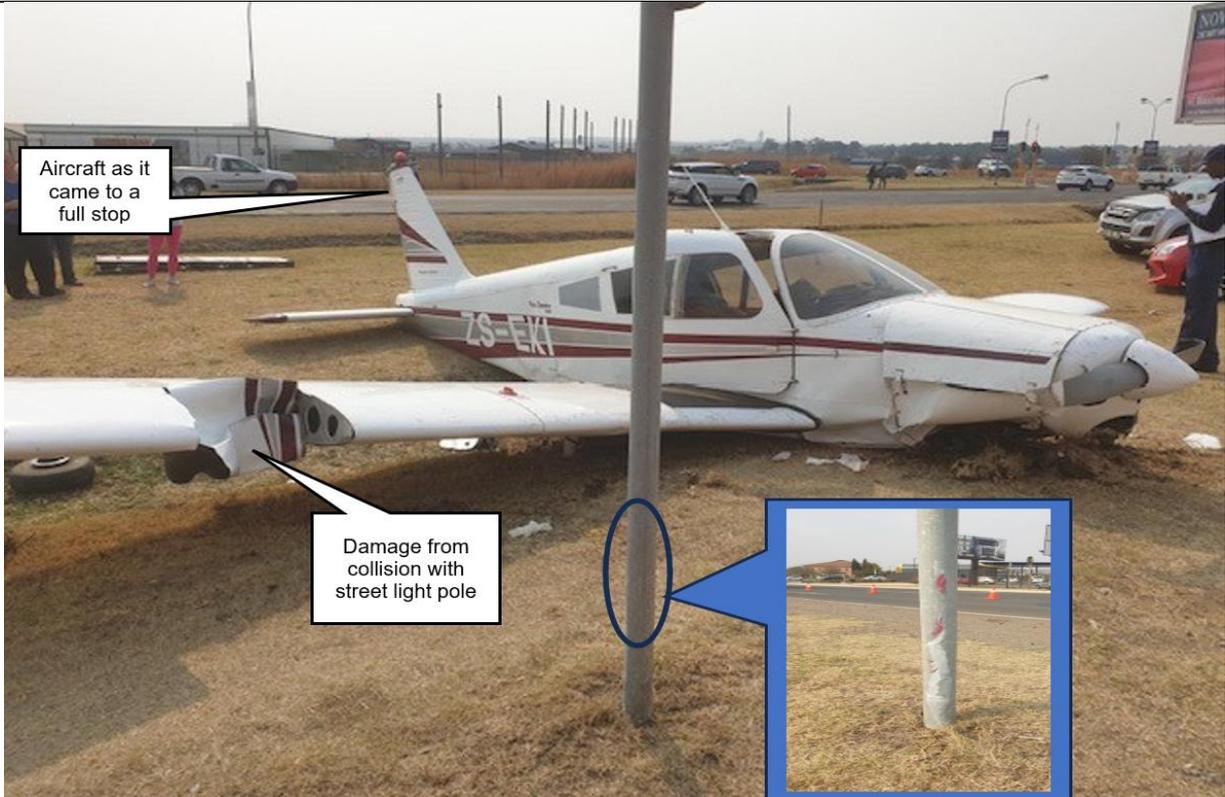
The eyewitness reported hearing a high-pitched engine sound which was consistent with a high-power setting. The aircraft rotated but failed to establish a positive rate of climb. It subsequently impacted the perimeter fence on the eastern boundary of the airfield before it struck the ground hard, which resulted in the landing gear detaching from the fuselage. The aircraft slid on its belly over one of the dual lanes on PDP Kruger Street and came to rest on an open area between the two lanes.

The SP sustained serious head injuries whilst the aircraft was substantially damaged. Emergency services, including the South African Police Service (SAPS), Mpumalanga Traffic Police Service, and Mpumalanga Fire and Rescue Service promptly responded to the accident scene. The paramedics administered first aid to the SP before transporting her by ambulance to a nearby hospital. Third-party damage was caused to the airfield perimeter fence (see Figure 4).

Figure 2: The aircraft as it came to a full stop after the accident.

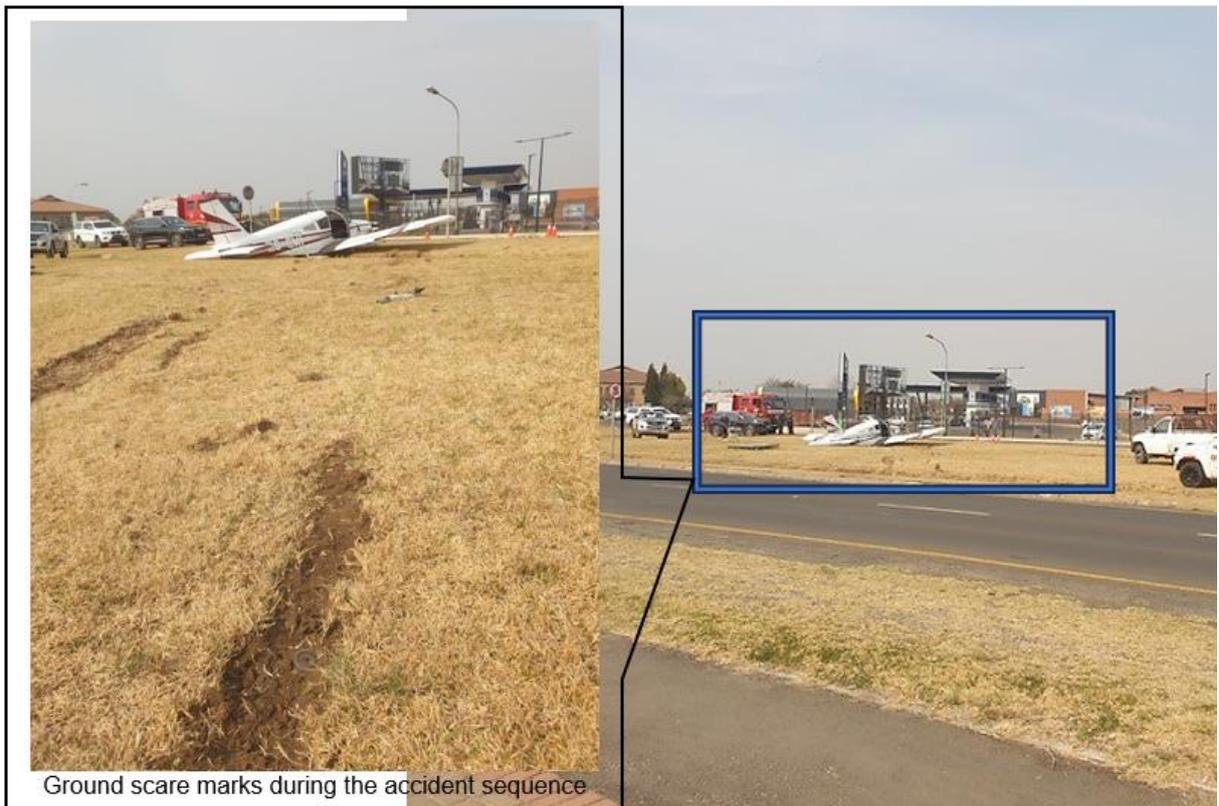
Figure 3: The scrape marks after ground impact.

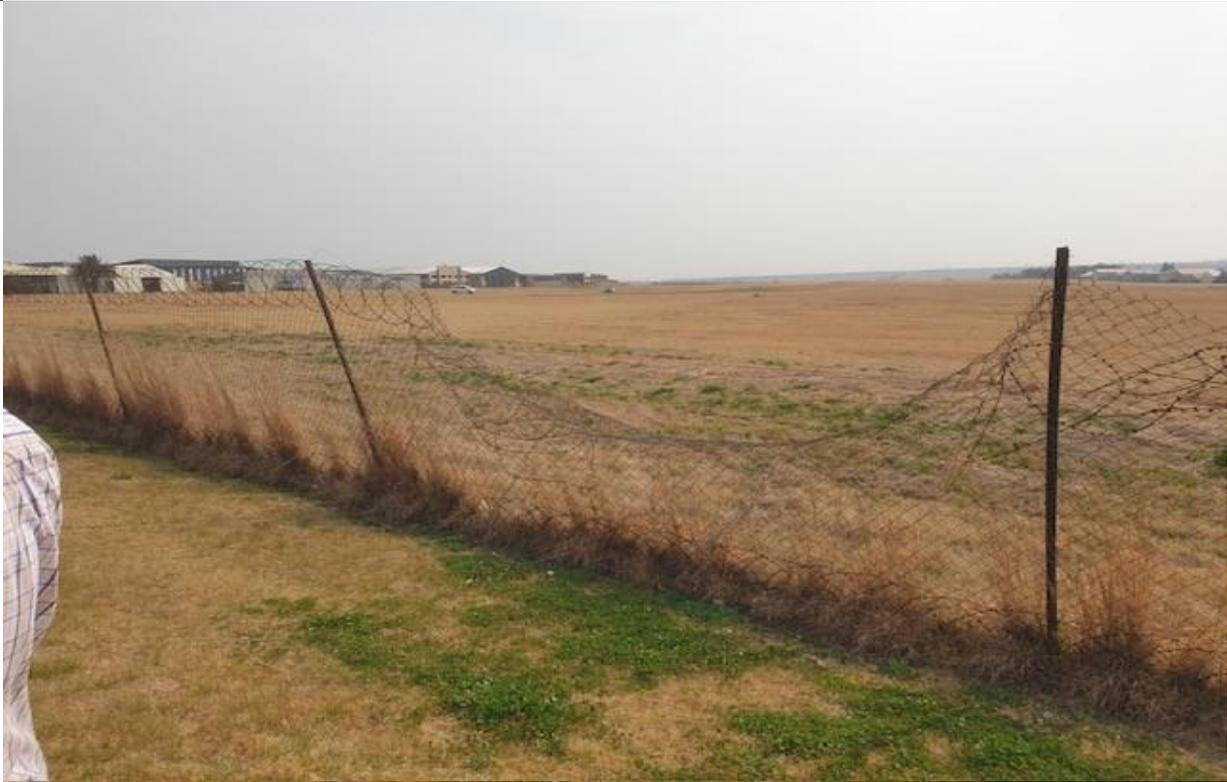
Figure 4: The damaged FASC fence.

The student pilot landed the aircraft on Runway 11 with a tailwind and, thereafter, attempted to take-off. However, as the aircraft landed deep, there was insufficient runway remaining; the aircraft failed to achieve a positive rate of climb, and it impacted the airfield's barrier fence.
