LIMITED OCCURRENCE INVESTIGATION REPORT – FINAL

Reference Number		CA18/2/3/10601					
Classification	Accident	Date	20 August 2025			Time	0745Z
Type of Operation	Private (Part 94)						
Location							
Place of Departure	Mankwe Game Farm Private Airstrip, North West Province			Place of Intended Landing	Mankwe Game Farm Private Airstrip, North West Province		
Place of Occurrence	Mankwe Game Farm Private Airstrip runway						
GPS Co-ordinates	Latitude	025°14'12.13" S	Longitude	027°14'34.64" E	Elevation	3,637 ft	
Aircraft Information							
Registration	ZU-IZR						
Make; Model; S/N	Bat Hawk R (Serial Number: 0123)						
Damage to Aircraft	Substantial			Total Aircraft Hours	75.9		
Pilot-in-command							
Licence Type	Commercial Pilot Licence (CPL)		Gender	Female		Age	48
Licence Valid	Valid	Total Hours	348.1		Total Hours on Type	221.6	
Total Hours 30 Days	15		Total Flying on Type Past 90 Days			37.8	
People On-board	1+1	Injuries	0	Fatalities	0	Other (on ground)	0

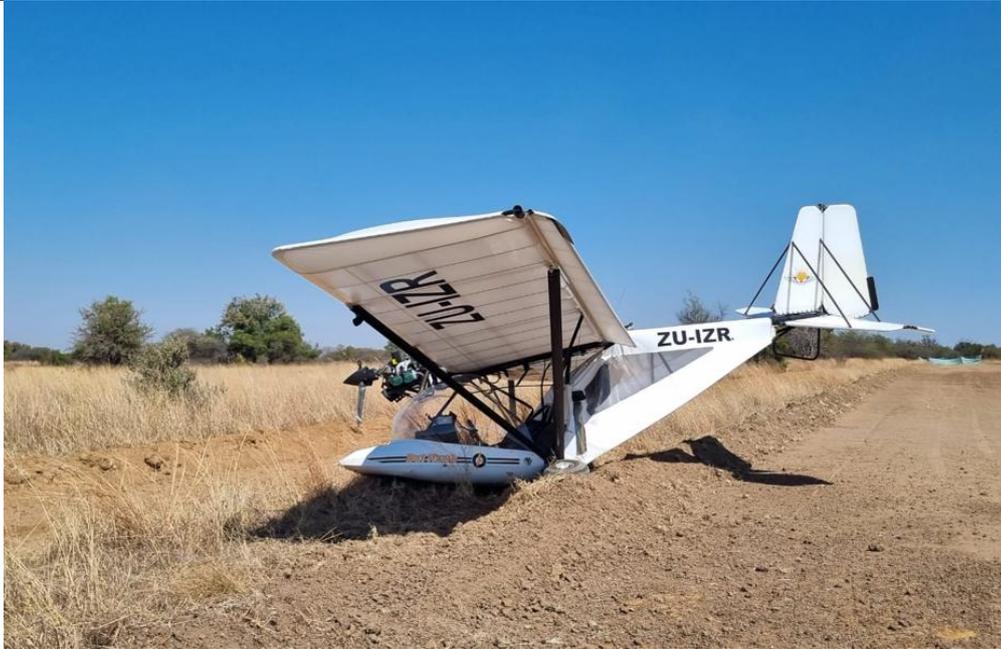
Figure 1: The aircraft after the accident. (Source: Pilot)

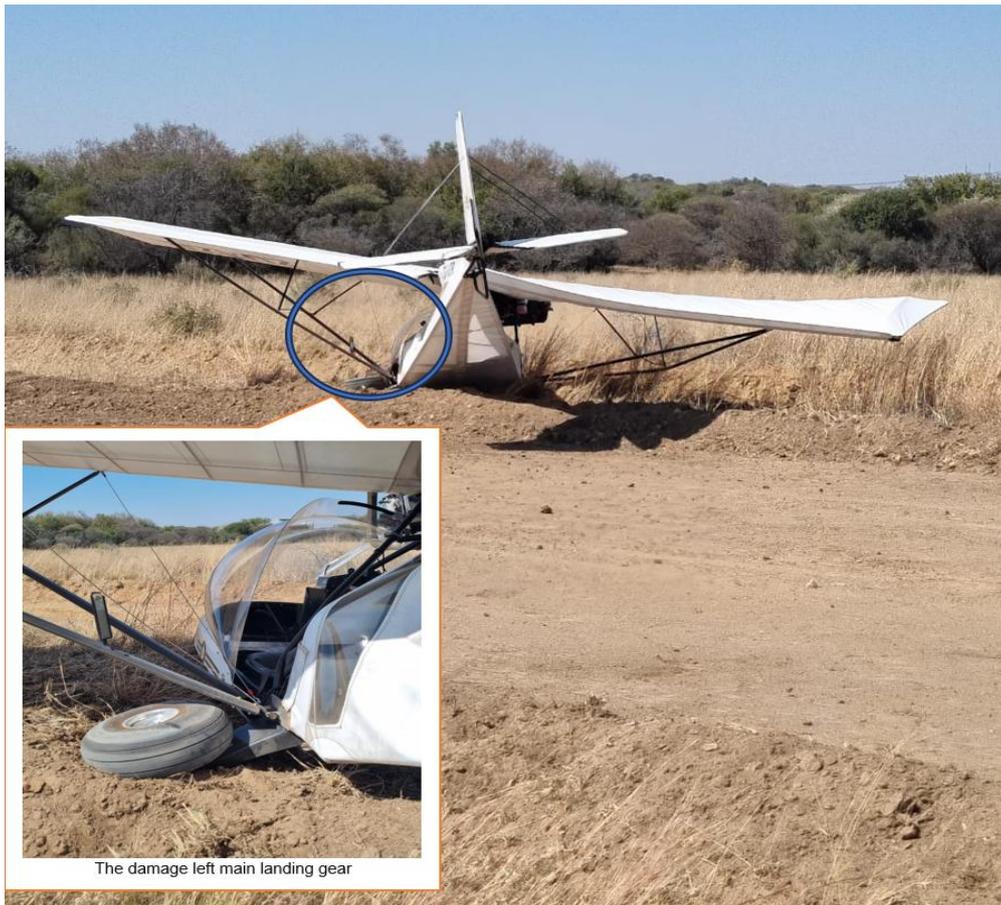
Figure 2: Damage on the left-side main landing gear and windshield. (Source: Pilot).

<p>13. The aircraft was flared too high at 6 feet (ft) above ground level (AGL) just above the threshold as the pilot was mindful of the short field. This resulted in a high sink rate and the subsequent hard landing.</p> <p>14. The hard impact momentarily caused the left wheel to pivot, and the pilot lost directional control. The aircraft departed the runway and impacted the sand barrier before it came to a full stop.</p>
<p>Probable Cause(s)</p>
<p>The aircraft landed hard after an early flare that led to a high sink rate. This resulted in a loss of directional control and the aircraft veered off to the left of the runway.</p>
<p>Contributing Factor(s)</p>
<ul style="list-style-type: none"> • Early flare initiation. • Incorrect flap selection as per the POH. • Incorrect technique for short field landing.
<p>Safety Action(s)</p>
<p>None.</p>
<p>Safety Message and/or Safety Recommendation/s</p>
<p>Pilots operating on short fields must follow the manufacturer's recommended procedures by maintaining the correct approach speed and flaring at the proper height. Using the correct technique reduces the risk of hard landings which could cause a loss of control, runway excursions or aircraft damage.</p>

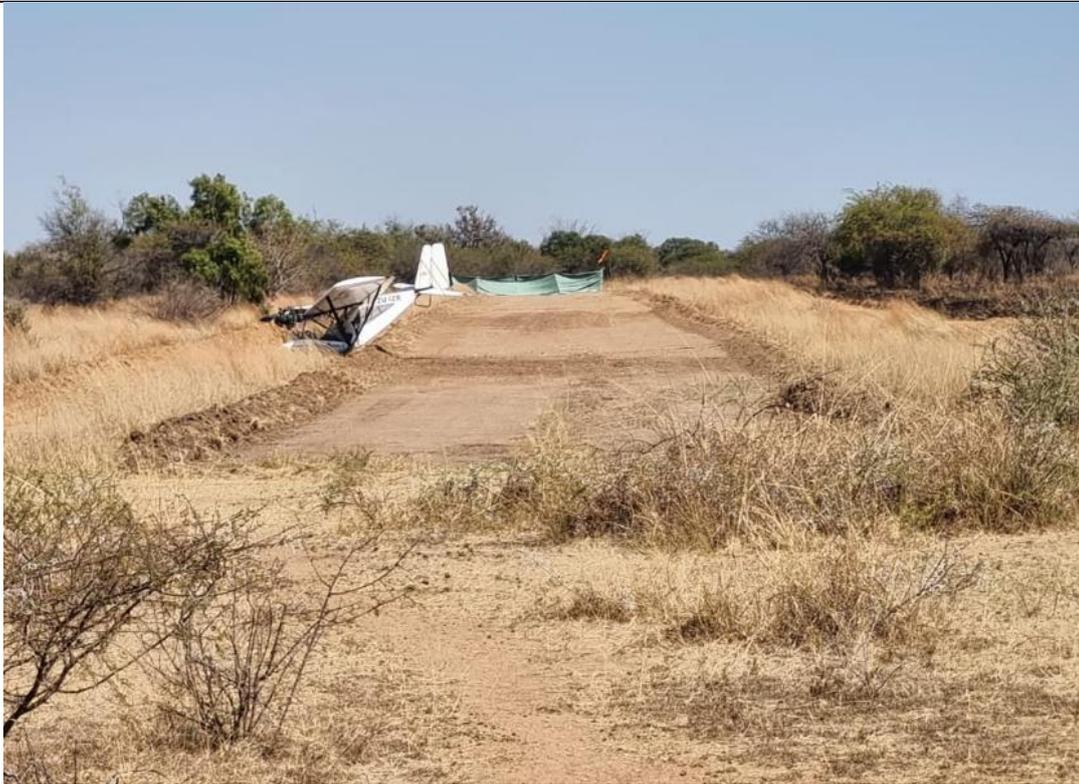
Figure 3: The airstrip and its surrounds. (Source: Pilot)

10. Good weather conditions prevailed at the time of the flight.
11. The airstrip is a short field runway surrounded by obstacles (trees); this therefore, provided limited overrun area.
