LIMITED OCCURRENCE INVESTIGATION REPORT – FINAL

Reference Number		CA18/2/3/10602						
Classification	Accident			Date	3 September 2025		Time	0655Z
Type of Operation	Private (Part 94)							
Location								
Place of Departure		Rand Airport (FAGM), Gauteng Province		Place of Intended Landing		Tedderfield Airfield (Airpark) (FATA), Gauteng Province		
Place of Occurrence		Rand Airport (FAGM), Gauteng Province						
GPS Co-ordinates		Latitude	26° 14' 31" S	Longitude	28° 09' 05" E	Elevation	5 483 ft	
Aircraft Information								
Registration		ZS-WTA						
Make; Model; S/N		Morovan; Z-526F (Serial Number: 1275)						
Damage to Aircraft		Substantial			Total Aircraft Hours		4244.9	
Pilot-in-command								
Licence Type		Private Pilot Licence (PPL)		Gender		Male	Age	50
Licence Valid		Yes	Total Hours		134.6	Total Hours on Type		12.6
Total Hours 30 Days		3		Total Flying on Type Past 90 Days			3	
People On-board		1+1	Injuries		0	Fatalities		0
						Other (on ground)		0

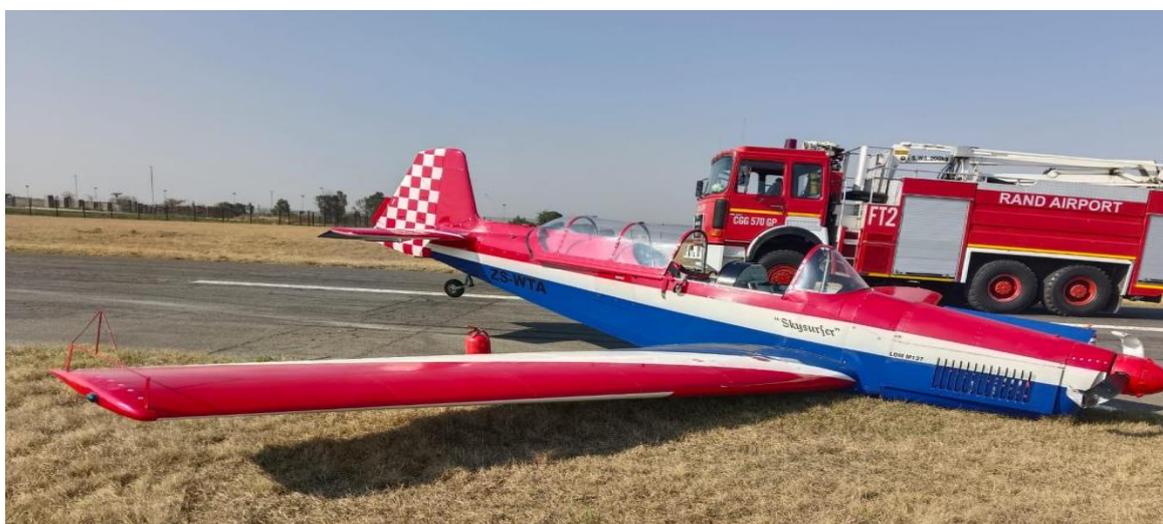
The pilot and the passenger evacuated the aircraft; they were not injured. The aircraft sustained substantial damage to the propeller blades and the underbelly. The airport fire and rescue personnel were dispatched to the accident scene.

Figure 2: The aircraft at the accident. (Source: Pilot)

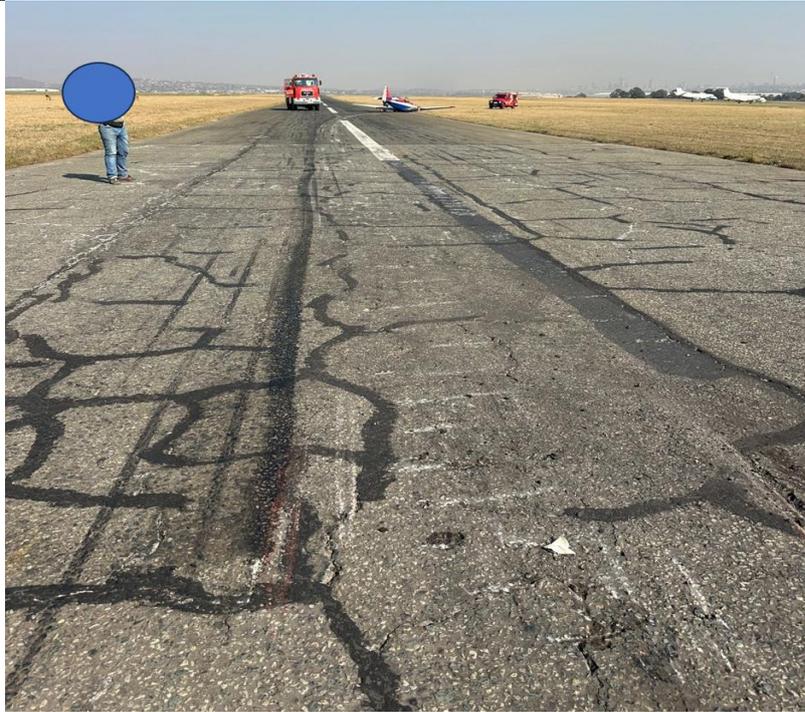
Figure 3: Scrape and propeller blades marks on the runway surface. (Source: Pilot)

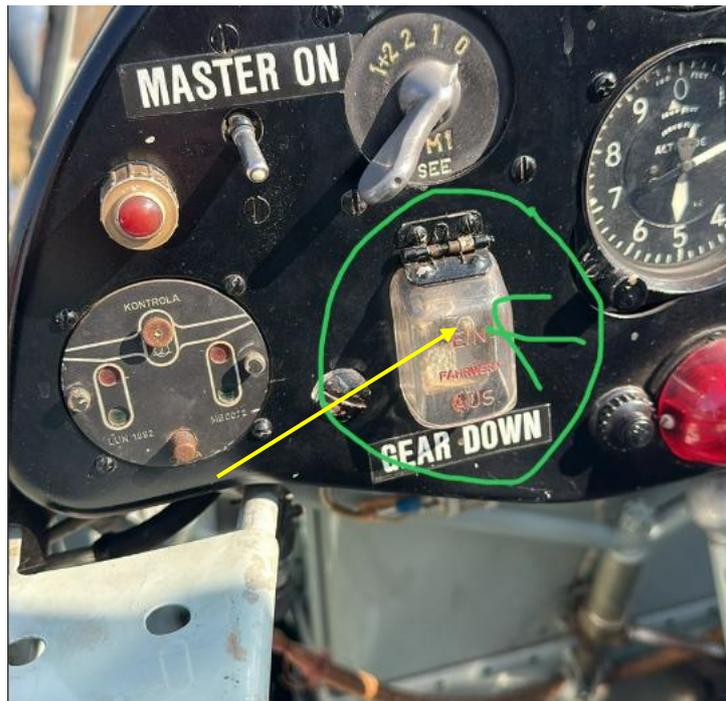
Post-accident examination of the aircraft revealed that the engine was producing maximum power at the time of the accident. The landing gear switch was found in the retracted position which suggested that the landing gear switch was selected up. The position of the gear switch during the pre-flight inspection was not confirmed by the pilot, which resulted in the downlocks releasing (unlocking) as the aircraft gained momentum and rotated during take-off.

Figure 4: The cockpit instrument panel showing the gear switch in “up” position under the guard cover (yellow arrow). (Source: Operator)

Figure 4 (picture) was taken immediately after the accident by the passenger as he disembarked from the aircraft; the operator shared the picture with the investigating team post-accident.
