LIMITED OCCURRENCE INVESTIGATION REPORT – FINAL

Reference Number	CA18/2/3/10603						
Classification	Accident		Date	3 September 2025		Time	0825Z
Type of Operation	Training (Part 141)						
Location							
Place of Departure	Lanseria International Airport (FALA), Gauteng Province		Place of Intended Landing	Lanseria International Airport (FALA), Gauteng Province			
Place of Occurrence	On the left side of Runway 07, Lanseria International Airport (FALA), Gauteng Province						
GPS Co-ordinates	Latitude	25°56'23"S	Longitude	027°55'32"E	Elevation	4 521 ft	
Aircraft Information							
Registration	ZS-FHH						
Make; Model; S/N	Piper; PA-28-140 Cherokee (Serial Number: 28-24010)						
Damage to Aircraft	Substantial			Total Aircraft Hours	7 677.55		
Pilot-in-command							
Licence Type	Student Pilot Licence (SPL)		Gender	Male		Age	25
Licence Valid	Yes	Total Hours	28.6		Total Hours on Type	28.6	
Total Hours 30 Days	7.8		Total Flying on Type Past 90 Days	28.6

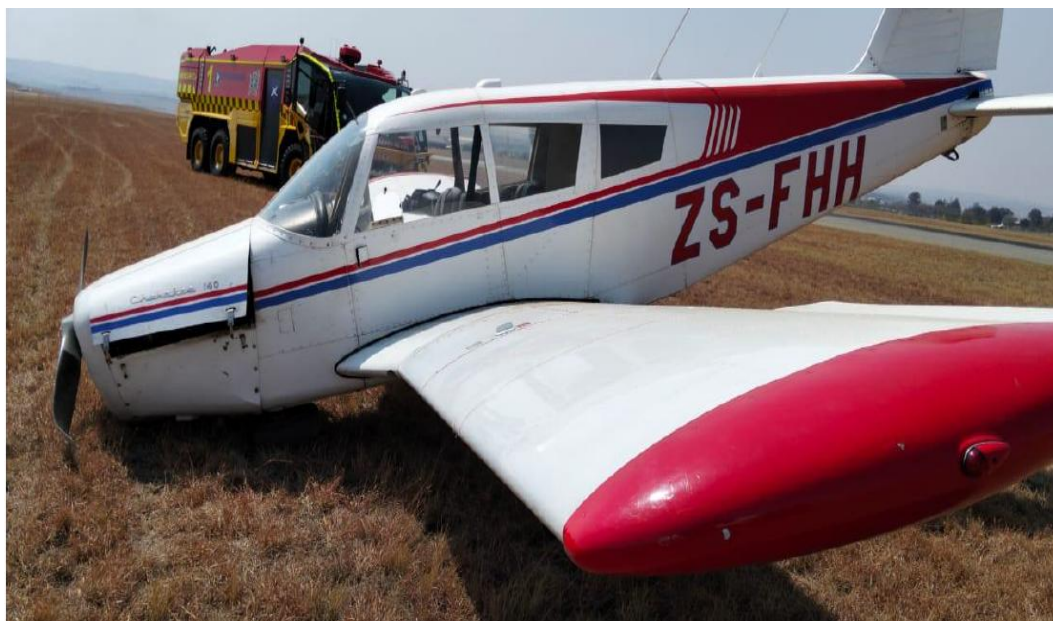
The ATCO instructed the SP to report when ready for base leg, which the SP acknowledged. Later, the SP communicated to the ATCO that he was ready for base leg. A few minutes later, the ATCO cleared the SP for final Runway 07. Whilst on base leg, the SP selected the flaps to two notches and maintained a speed of 75 kts. After turning final for Runway 07, the SP was cleared to execute the first touch-and-go landing. During final approach, the SP selected the flaps to three notches and maintained a speed of 70 kts. The aircraft touched down normally on Runway 07; however, during the landing roll, the aircraft veered off to the left of the centre line. The SP tried to recover by applying the right rudder but was unsuccessful. The aircraft continued to veer off to the left and, subsequently, exited the runway surface during which the nose landing gear strut collapsed. The propeller struck the ground, and aircraft came to a stop on the grass area approximately 15 metres (m) to the left of the runway edge. The ATCO alerted the airport Aircraft Rescue and Firefighting (ARFF) team who swiftly responded to the scene. The aircraft was substantially damaged. The SP was not injured; he disembarked from the aircraft without assistance.

Figure 1: The aircraft after it had come to rest. (Source: FALA ARFF)
