**LIMITED OCCURRENCE INVESTIGATION REPORT – FINAL**

<b>Reference Number</b>	CA18/2/3/10604						
<b>Classification</b>	Accident		<b>Date</b>	11 September 2025		<b>Time</b>	0704Z
<b>Type of Operation</b>	Agriculture (Part 137)						
<b>Location</b>							
Place of Departure	Eenboom Farm Airstrip, Swartland, Western Cape Province		Place of Intended Landing		Eenboom Farm Airstrip, Swartland, Western Cape Province		
Place of Occurrence	Eenboom Farm Airstrip, Swartland, Western Cape Province						
GPS Co-ordinates	Latitude	33°09'36.4" S	Longitude	18°35'28.6" E	Elevation	2 473.8 ft	
<b>Aircraft Information</b>							
Registration	ZS-OGP						
Make; Model; S/N	Air Tractor; AT-402A (Serial Number: 402A-1057)						
Damage to Aircraft	Substantial			Total Aircraft Hours	13 006,5		
<b>Pilot-in-command</b>							
Licence Type	Commercial Pilot Licence (CPL)		Gender	Male		Age	42
Licence Valid	Yes	Total Hours	1 838		Total Hours on Type	113.5	
Total Hours 30 Days	44.60		Total Flying on Type Past 90 Days		113.5

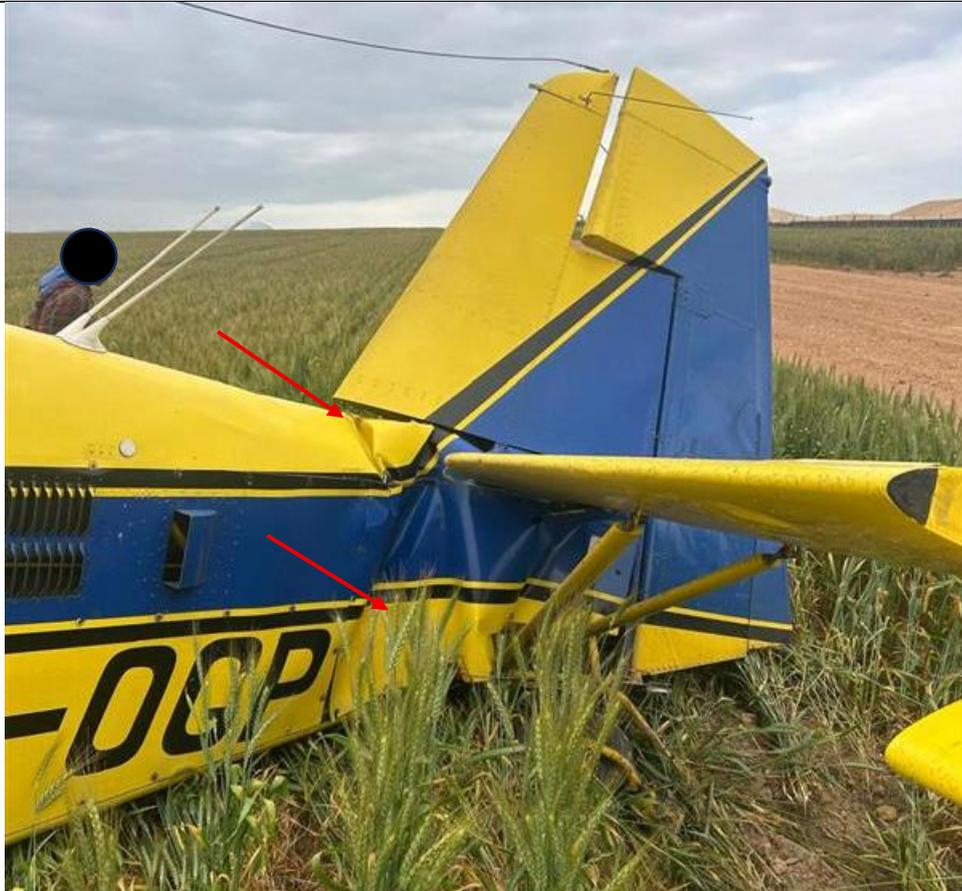
**Figure 2:** The damaged empennage (red arrows on the left side) and tailwheel. (Source: Pilot)

Post-accident, the aircraft flight controls, including the brakes, were examined and nothing abnormal was detected. Good weather conditions prevailed at the time of the flight. Damage observed on the empennage, tailwheel and the right main gear was consistent with overcontrolling of the aircraft.

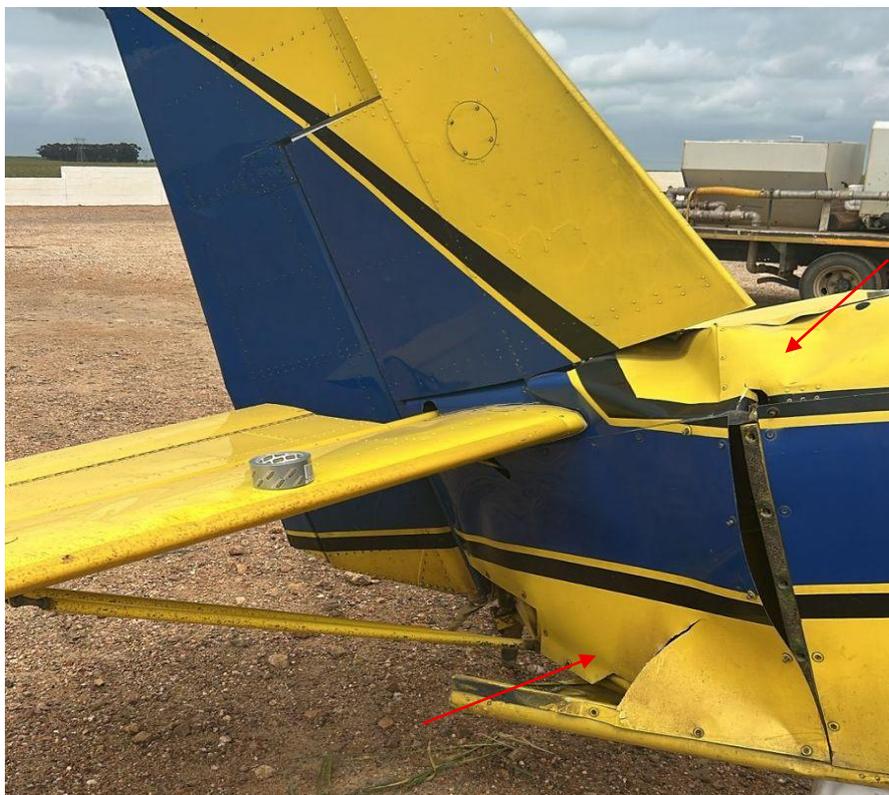
**Figure 3:** Damage on the right side of the empennage. (Source: Pilot)

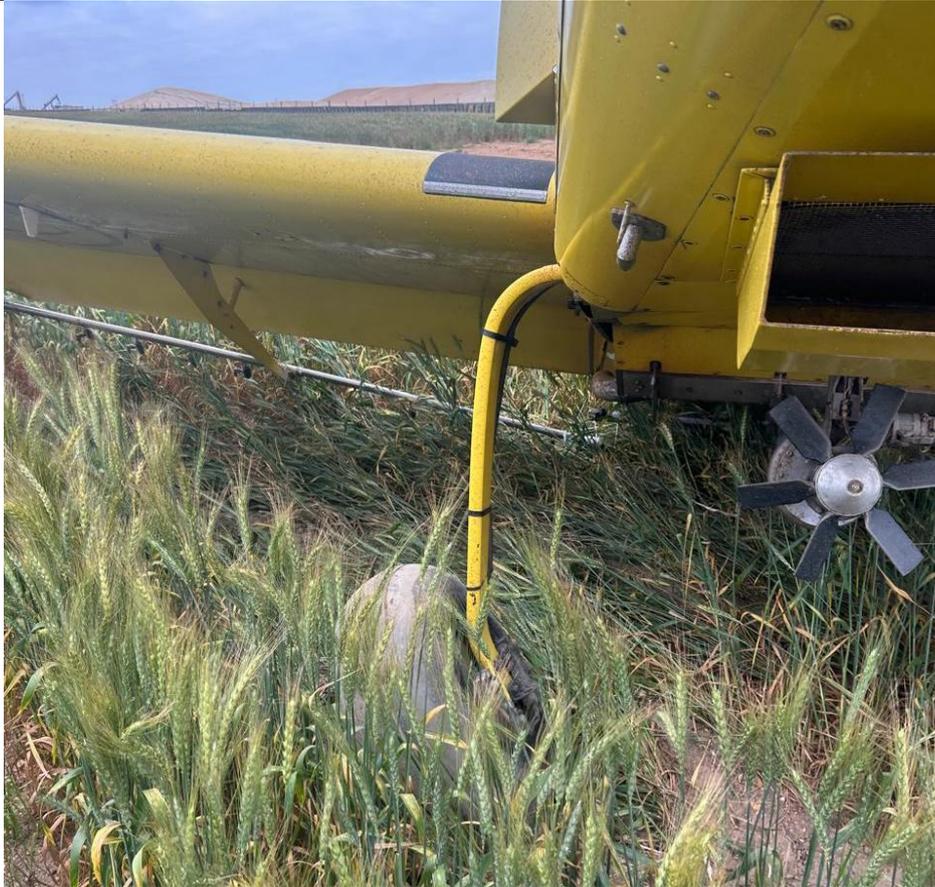
**Figure 4:** The bent right main gear. (Source: Pilot)
