LIMITED OCCURRENCE INVESTIGATION REPORT – FINAL

Reference Number		CA18/2/3/10605					
Classification	Accident	Date	4 October 2025			Time	1200Z
Type of Operation	Private (Part 94)						
Location							
Place of Departure	Vleesbank Private Farm Airstrip, Western Cape Province			Place of Intended Landing	Vleesbank Private Farm Airstrip, Western Cape Province		
Place of Occurrence	On a grass-covered runway at Vleesbank Private Farm Airstrip, Western Cape Province						
GPS Co-ordinates	Latitude	33° 29' 35.39" S	Longitude	018° 59' 3.69" E	Elevation	264 ft	
Aircraft Information							
Registration	ZU-EMD						
Make; Model; S/N	Magni; Gyroplane-M22 (Serial Number: 22063904)						
Damage to Aircraft	Substantial			Total Aircraft Hours	705.5		
Pilot-in-command							
Licence Type	National Pilot Licence (NPL)		Gender	Male	Age	47	
Licence Valid	Yes	Total Hours	46.4		Total Hours on Type	18.8	
Total Hours 30 Days	5.6		Total Flying on Type Past 90 Days			13.8	
People On-board	1+1	Injuries	0	Fatalities	0	Other (on ground)	0

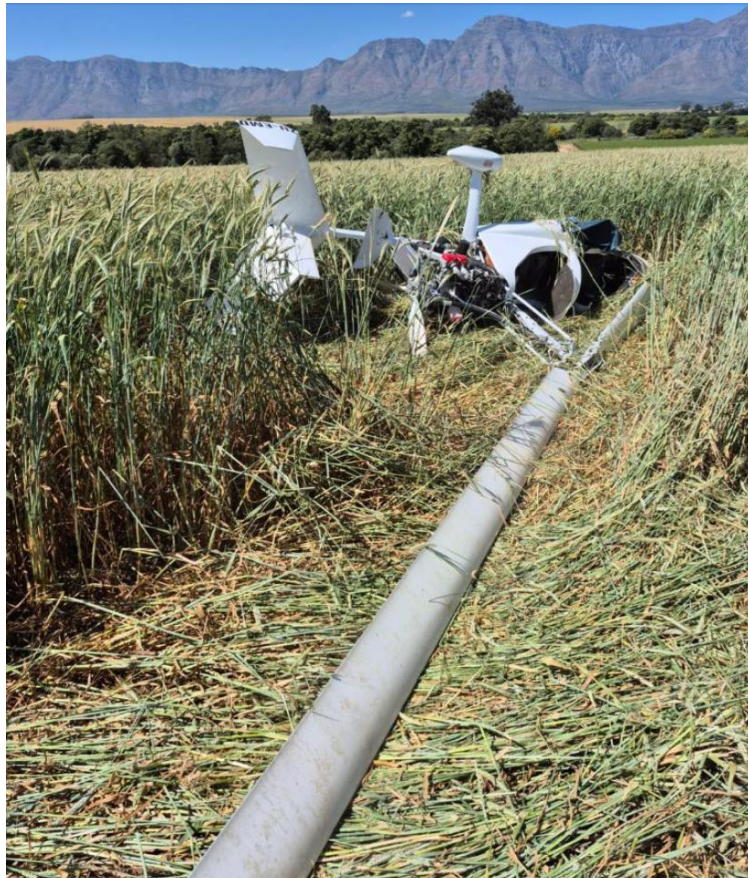
Figure 2: The Gyroplane at the accident site and the wheat crops cut by the rotor blades. (Source: Operator)

Loss of directional control during the landing roll on a grass runway after encountering a sudden low-level wind shear from the left; consequently, the Gyroplane exited the runway and rolled onto the tall wheat crops during which the rotor blades struck the wheat and flipped over to the right.
