**LIMITED OCCURRENCE INVESTIGATION REPORT – FINAL**

<b>Reference Number</b>	CA18/2/3/10610						
<b>Classification</b>	Accident	<b>Date</b>	26 October 2025		<b>Time</b>	0920Z	
<b>Type of Operation</b>	Training (Part 141)						
<b>Location</b>							
Place of Departure	Rand Aerodrome (FAGM), Gauteng Province		Place of Intended Landing	Rand Aerodrome (FAGM), Gauteng Province			
Place of Occurrence	Hoërskool Alberton, Gauteng Province						
GPS Co-ordinates	Latitude	26°16'01.49" S	Longitude	28°07'55.42" E	Elevation	5 184 ft	
<b>Aircraft Information</b>							
Registration	ZU-BJX						
Make; Model; S/N	Tecnam; P92 Echo (Serial Number: 247)						
Damage to Aircraft	Destroyed		Total Aircraft Hours	491			
<b>Pilot-in-command</b>							
Licence Type	Commercial Pilot Licence (CPL)		Gender	Male		Age	30
Licence Valid	Yes	Total Hours	1 250		Total Hours on Type	600	
Total Hours 30 Days	38.6		Total Flying on Type Past 90 Days	41.6			
<b>People On-board</b>	2+0	<b>Injuries</b>	0	<b>Fatalities</b>	0	<b>Other (on the ground)</b>	0

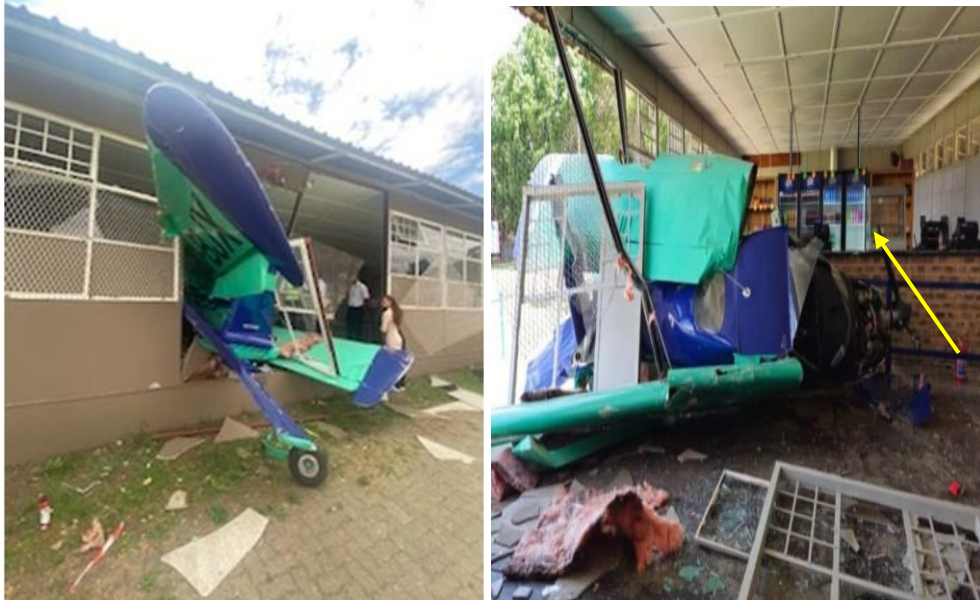
approach for Runway (RWY) 35. The air traffic control officer (ATCO) granted the request, and the aircraft joined the circuit pattern for RWY35. Whilst overhead Alberton residential area, the engine stopped. The FI took control of the aircraft and attempted to restart the engine several times but to no avail. He then scanned the area and spotted Hoërskool Alberton sports field. Thereafter, the FI glided the aircraft to the sports field to conduct a forced landing; the aircraft touched down in the middle of the sports field but could not bring the aircraft to a stop; consequently, it impacted the school's building (cafeteria) where it came to a stop about halfway through it. Third party damage was limited to the school building. The aircraft was destroyed during the accident sequence; no person was injured.

**Figures 2 and 3:** The images depict the damaged school cafeteria with the aircraft halfway through.
