**LIMITED OCCURRENCE INVESTIGATION REPORT – FINAL**

<b>Reference Number</b>	CA18/2/3/10612						
<b>Classification</b>	Accident	<b>Date</b>	5 November 2025		<b>Time</b>	1332Z	
<b>Type of Operation</b>	Private (Part 94)						
<b>Location</b>							
Place of Departure	Mapungubwe National Park Airstrip, Limpopo Province			Place of Intended Landing	Mapungubwe National Park Airstrip, Limpopo Province		
Place of Occurrence	On a field approximately 150 metres (m) from the threshold of Runway 36 at Mapungubwe National Park, Limpopo Province						
GPS Co-ordinates	Latitude	22°12'30.26" S	Longitude	029°18'0.76" E	Elevation	1 699 feet	
<b>Aircraft Information</b>							
Registration	ZU-IZD						
Make; Model; S/N	Bat Hawk R (Serial Number: 0118)						
Damage to Aircraft	Substantial			Total Aircraft Hours	78.5		
<b>Pilot-in-command</b>							
Licence Type	Private Pilot Licence (PPL)		Gender	Male		Age	62
Licence Valid	Yes	Total Hours	1 090.05		Total Hours on Type	18.2

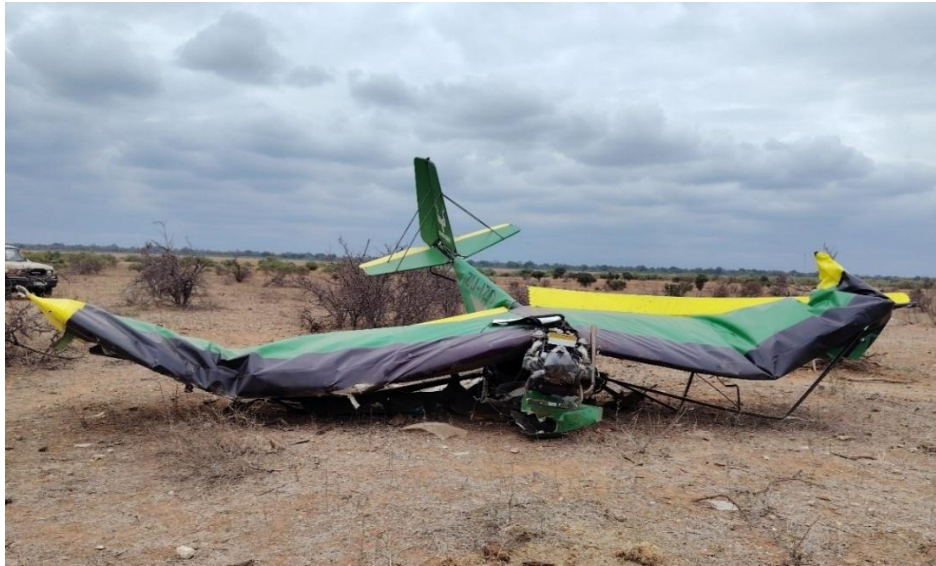
During final approach for landing and whilst approximately 100 feet (ft) above ground level (AGL), the pilot noticed a drop in the aircraft's left-wing, and he recovered the aircraft to the wing-level position. Shortly afterwards, the left-wing dropped again. He then applied full power, pulled aft on the control column, as well as applied full right rudder. Subsequently, the aircraft stalled and impacted the ground approximately 150 metres (m) from the threshold of Runway 36. The aircraft was substantially damaged. Both occupants sustained serious injuries and were airlifted to a nearby hospital for medical attention.

**Figure 2:** The aircraft at the accident site.

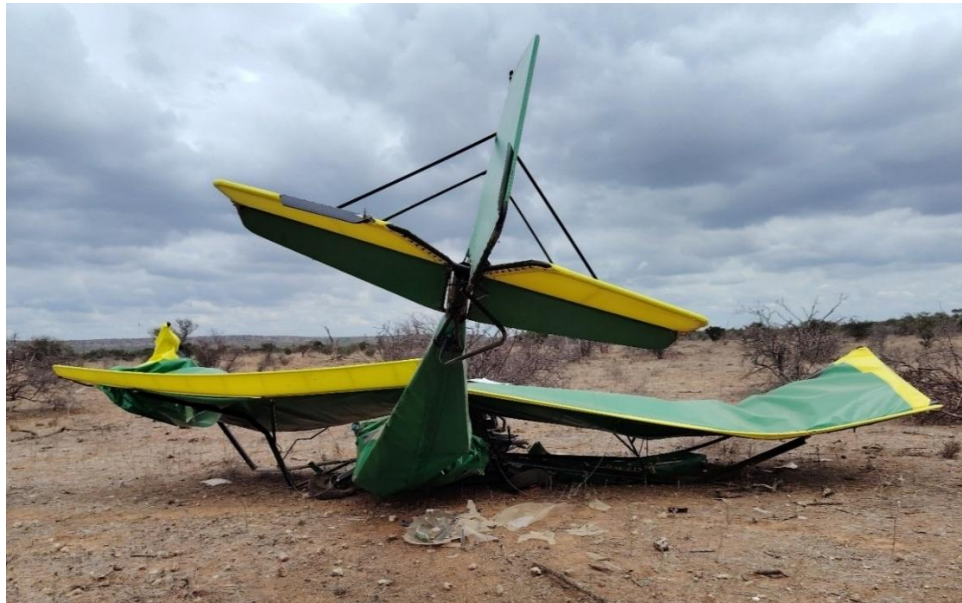
**Figure 3:** Rear view of the aircraft.

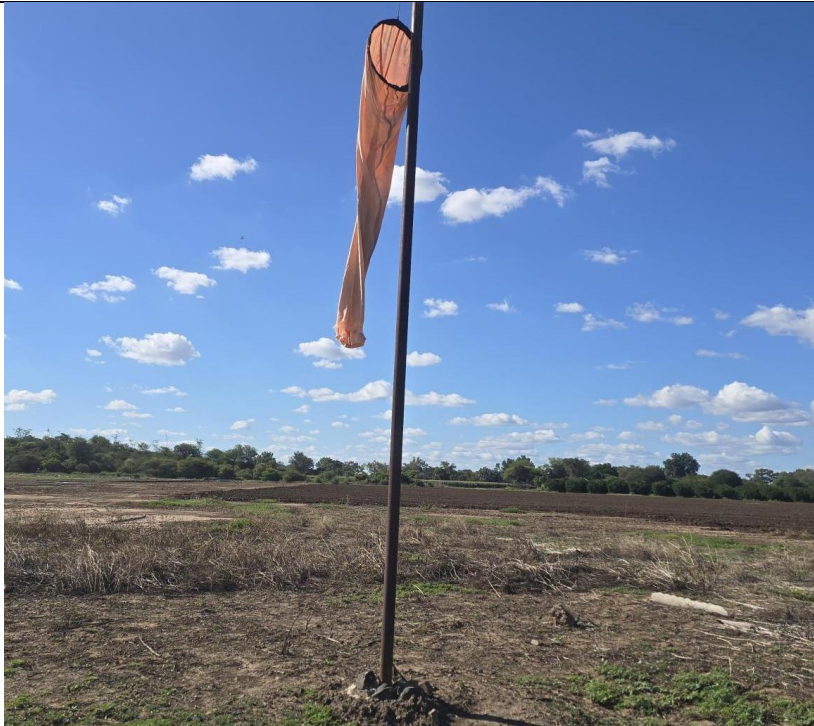
**Figure 4:** The windssock around the time of the accident; it indicated the absence of wind.

- 2.5 The windsock at the airstrip indicated that there was no wind around the time of the accident.
