**LIMITED OCCURRENCE INVESTIGATION REPORT – FINAL**

<b>Reference Number</b>	CA18/2/3/10615						
<b>Classification</b>	Accident		<b>Date</b>	11 November 2025		<b>Time</b>	1245Z
<b>Type of Operation</b>	Training (Part 141)						
<b>Location</b>							
Place of Departure	Springs Airfield (FASI), Gauteng Province		Place of Intended Landing	Springs Airfield (FASI), Gauteng Province			
Place of Occurrence	Runway 03 at Springs Airfield (FASI), Gauteng Province						
GPS Co-ordinates	Latitude	26° 14' 58" S	Longitude	28° 23' 54" E	Elevation	5 340ft	
<b>Aircraft Information</b>							
Registration	ZS-ISI						
Make; Model; S/N	Piper; PA-28-180 (Serial Number: 28-474)						
Damage to Aircraft	Substantial			Total Aircraft Hours	8 291.8		
<b>Pilot-in-command</b>							
Licence Type	Student Pilot Licence (SPL)		Gender	Female		Age	20
Licence Valid	Yes	Total Hours	42.3		Total Hours on Type	42.3	
Total Hours 30 Days	9.7		Total Flying on Type Past 90 Days	10.6			
<b>People On-board</b>	1+0	<b>Injuries</b>	0	<b>Fatalities</b>	0	<b>Other (on ground)</b>	0

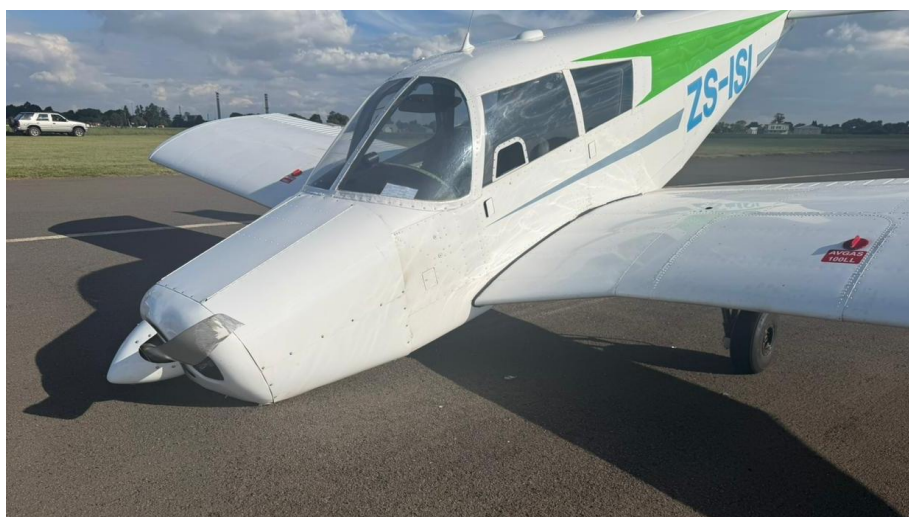
During landing on Runway 03, the aircraft bounced and the SP lost control of the aircraft; it landed hard with the nosewheel first which resulted in the collapse of the nose gear strut. Consequently, the nose pitched down and the propeller struck the runway surface.

The aircraft came to a stop in the middle of the runway after which the SP switched off the fuel and master switch. The aircraft sustained damage to the nose gear strut, engine cowl (bottom section) and the propeller. The SP was not injured.

**Figure 2:** The aircraft on the runway after the accident. (Source: Operator)
