LIMITED OCCURRENCE INVESTIGATION REPORT

Reference Number	CA18/2/3/10618						
Classification	Accident		Date	22 November 2025		Time	0655Z
Type of Operation	Part 94						
Location							
Place of Departure	Margate Airport (FAMG), KwaZulu-Natal Province		Place of Intended Landing	Margate Airport (FAMG), KwaZulu-Natal Province			
Place of Occurrence	Mawatsheni, 10 nautical miles (nm) south of Port St. Johns						
GPS Co-ordinates	Latitude	31°43' 49.49" S	Longitude	029°23' 46.02" E	Elevation	770 ft	
Aircraft Information							
Registration	ZU-FNM						
Make; Model; S/N	Sling LSA (Serial Number: 023)						
Damage to Aircraft	Substantial			Total Aircraft Hours	2 790.25		
Pilot-in-command							
Licence Type	Private Pilot Licence (PPL)		Gender	Male		Age	49
Licence Valid	Yes	Total Hours	5621.9		Total Hours on Type	3554.1	
Total Hours 30 Days	7.5		Total Flying on Type Past 90 Days	9.3			
People On-board	1 + 1	Injuries	0	Fatalities	0	Other (on ground)	0

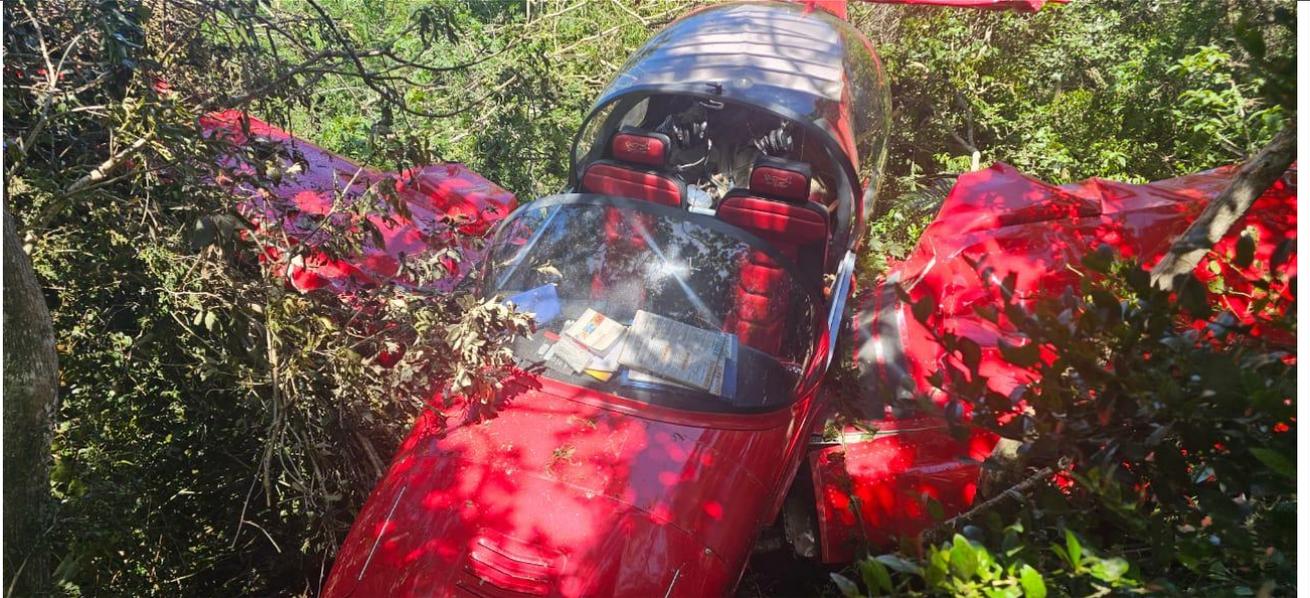
forced landing on a bushy terrain in Mawatsheni, about 10 nautical miles (nm) south of Port St. Johns. The aircraft rested on top of the trees with full flaps. Both occupants were not injured. The aircraft sustained substantial damage to the propeller, empennage, engine, wings and fuselage.

Figure 2: Aircraft in its resting position after the accident. (Source: Pilot)

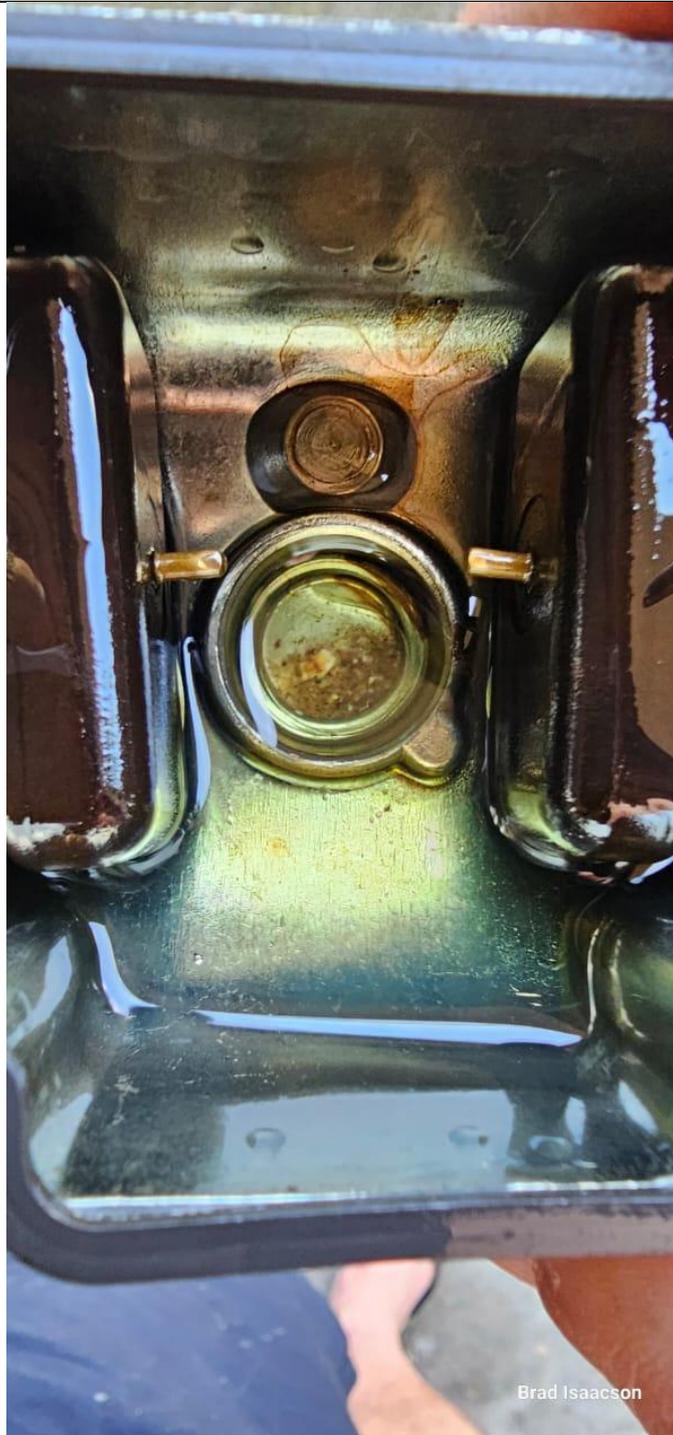
Figure 3: Fuel contamination.

Post-accident, the aircraft was examined by an approved person (AP). The examination revealed that both wing fuel tank caps were properly secured. There was an oil leak from the oil filter which was attributed to damage sustained during the impact sequence. The carburetor bowls were removed, and water and dirt contamination was found in them.

7. Fuel that was used to refuel the aircraft was stored in the jerry cans.
8. After the accident, the carburettor bowl was dismantled, and water and sediment were found in them.

Fuel contamination.
