## LIMITED OCCURRENCE INVESTIGATION REPORT

<b>Reference Number</b>	CA18/2/3/10619						
<b>Classification</b>	Accident		<b>Date</b>	22 November 2025		<b>Time</b>	1115Z
<b>Type of Operation</b>	Private (Part 94)						
<b>Location</b>							
Place of Departure	Umkomaas Airfield, KwaZulu-Natal Province		Place of Intended Landing		Umkomaas Airfield, KwaZulu-Natal Province		
Place of Occurrence	On Runway 04 at Umkomaas Airfield, KwaZulu-Natal Province						
GPS Co-ordinates	Latitude	30°12' 19.103" S	Longitude	30°44' 23.37" E	Elevation	689 ft	
<b>Aircraft Information</b>							
Registration	ZU-FYX						
Make; Model; S/N	Savannah S (Serial Number: 13-0154-0241)						
Damage to Aircraft	Substantial			Total Aircraft Hours	672.8		
<b>Pilot-in-command</b>							
Licence Type	National Pilot Licence (NPL)		Gender	Male		Age	65
Licence Valid	Yes	Total Hours	672.8		Total Hours on Type	251.4	
Total Hours 30 Days	9.2		Total Flying on Type Past 90 Days		33		
<b>People On-board</b>	1 + 1	<b>Injuries</b>	0	<b>Fatalities</b>	0	<b>Other (on ground)</b>	0

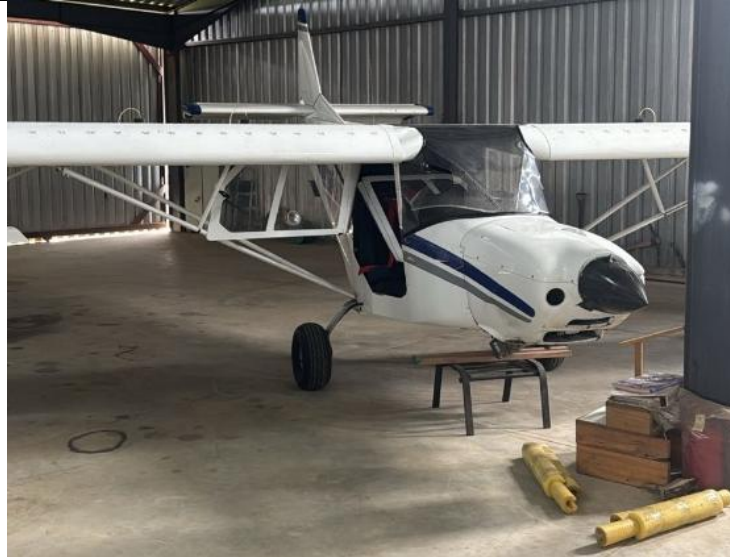
**Figure 2:** The aircraft parked in a hangar after it was recovered from the accident site. (Source: Pilot)

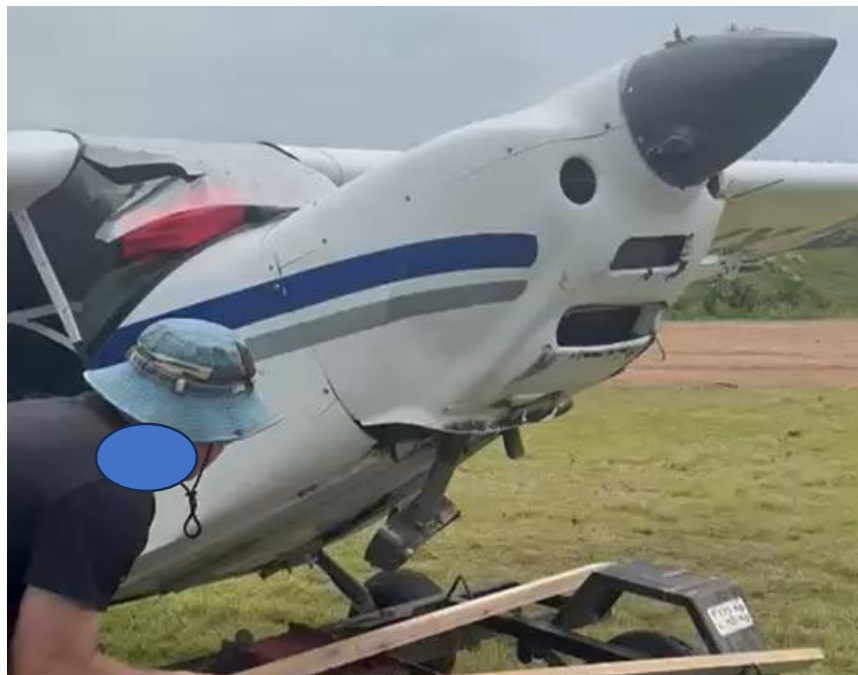
<b>What Happened</b>							
<p>On Saturday, 22 November 2025, a pilot and a passenger on-board a Savannah S aircraft with registration ZU-FYX took off on a private flight from Umkomaas Airfield, KwaZulu-Natal province, with the intention to land back at the same airfield. The flight was conducted under visual meteorological conditions (VMC) by day and under the provisions of Part 94 of the Civil Aviation Regulations (CAR) 2011, as amended.</p> <p>The pilot stated that he performed the pre-flight inspection of the aircraft and did not identify anomalies. The aircraft had a total of 100 litres (L) of Avgas LL100 in the tanks. The aircraft took off at approximately 1015Z and climbed to 1 000 feet (ft), routing north towards Durban harbour whilst travelling at a speed of approximately 85 miles per hour (mph). After 30 minutes of flight time, the aircraft returned to Umkomaas Airfield. Upon reaching the airfield, the pilot followed the traffic pattern for landing on Runway 04. During final approach (landing) into the wind, the pilot selected second notch flaps whilst maintaining a speed of 55 mph. He reported that just before touchdown, approximately 3 feet (ft) above the runway, he encountered a windshear which resulted in the aircraft losing air speed. As the pilot flared the aircraft, it stalled due to a loss of lift. The aircraft descended and landed hard with the nosewheel first; it sustained substantial damage to the nose gear strut, windshield and propeller blades. The pilot was not injured.</p>

**Figure 3:** The damaged propeller blades and nose gear strut. (Source: Pilot)

The aircraft encountered a windshear just before touchdown on Runway 04, approximately 3m above the runway; consequently, it stalled due to a loss of lift and landed hard with the nosewheel first.
