LIMITED OCCURRENCE INVESTIGATION REPORT – FINAL

Reference Number	CA18/2/3/10622						
Classification	Accident		Date	6 December 2025		Time	0710Z
Type of Operation	Private (Part 94)						
Location							
Place of Departure	Musina Airfield (FAMH), Limpopo Province		Place of Intended Landing	Polokwane Civil Airport (FAPI), Limpopo Province			
Place of Occurrence	Field covered with thorn bushes near Kalkspruit in Limpopo Province						
GPS Co-ordinates	Latitude	23°44'22" S	Longitude	028°55'34 E	Elevation	3 604ft	
Aircraft Information							
Registration	ZS-WJE						
Make; Model; S/N	Raptor Trike (Serial Number: ARW044)						
Damage to Aircraft	Substantial		Total Aircraft Hours	681.7			
Pilot-in-command							
Licence Type	National Pilot Licence (NPL)		Gender	Male		Age	29
Licence Valid	Yes	Total Hours	155		Total Hours on Type	2	
Total Hours 30 Days	1		Total Flying on Type Past 90 Days	2			
People On-board	1+0	Injuries	1	Fatalities	0	Other (on ground)	0
What Happened

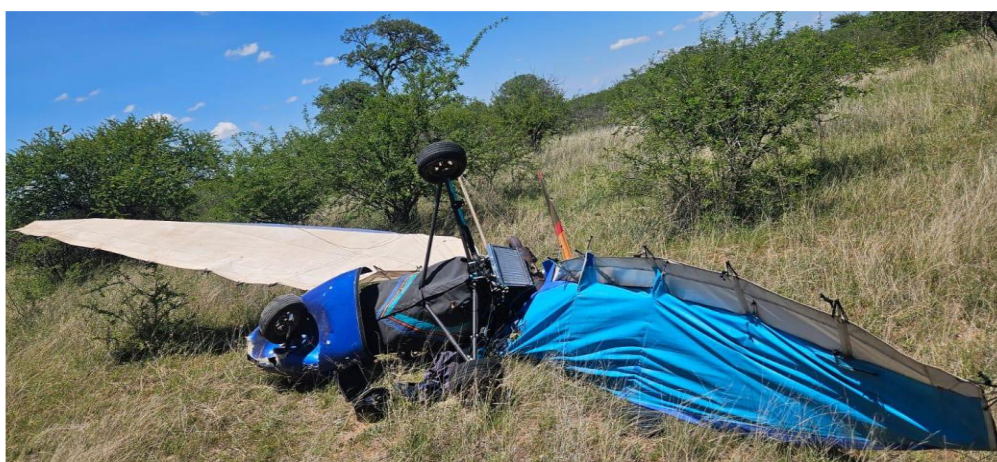
Figure 2: The aircraft at the accident site. (Source: Emergency Medical Services)

Post-accident examination of the aircraft by an approved person (AP) revealed that the structure of the aircraft was still intact. Damage to the aircraft was due to impact with the ground in a right-bank slip and steep nose-down attitude. The impact forces caused the front of the main frame to bend left and upward. The AP's inspection of the engine found no evidence of mechanical failure. The aircraft's fuel tank and associated lines were also intact. Upon examination of the fuel system, the AP noticed that the fuel filter and the carburettor bowls did not contain fuel, an indication that the engine had stopped due to fuel exhaustion.
