AIRCRAFT ACCIDENT REPORT AND EXECUTIVE SUMMARY

Reference:		CA18/2/3/10623	
Aircraft Registration	ZS-LUG	Date of Accident		12 December 2025		Time of Accident	0500Z
Type of Aircraft	Piper PA-36-285 Pawnee Brave			Type of Operation		Aerial works (Part 137)	
Pilot-in-command Licence Type		Commercial Pilot Licence (CPL)		Age	29	Licence Valid	Yes
Pilot-in-command Flying Experience			Total Flying Hours		1008.4	Hours on Type	398
Last Point of Departure		Kroonstad Airfield (FAKS), Free State Province					
Next Point of Intended Landing		Kroonstad Airfield (FAKS), Free State Province					
Damage to Aircraft		Destroyed					
Location of the accident site with reference to easily defined geographical points (GPS readings if possible)							
At Eden Farm, approximately 5.11 nautical miles (nm) north-east of FAKS at GPS co-ordinates determined as South 27°38'30" East 27°24'23"							
Meteorological Information		Wind direction: 110°C; Wind speed: 16 knots; Temperature: 21°C; Visibility: 5 kilometres

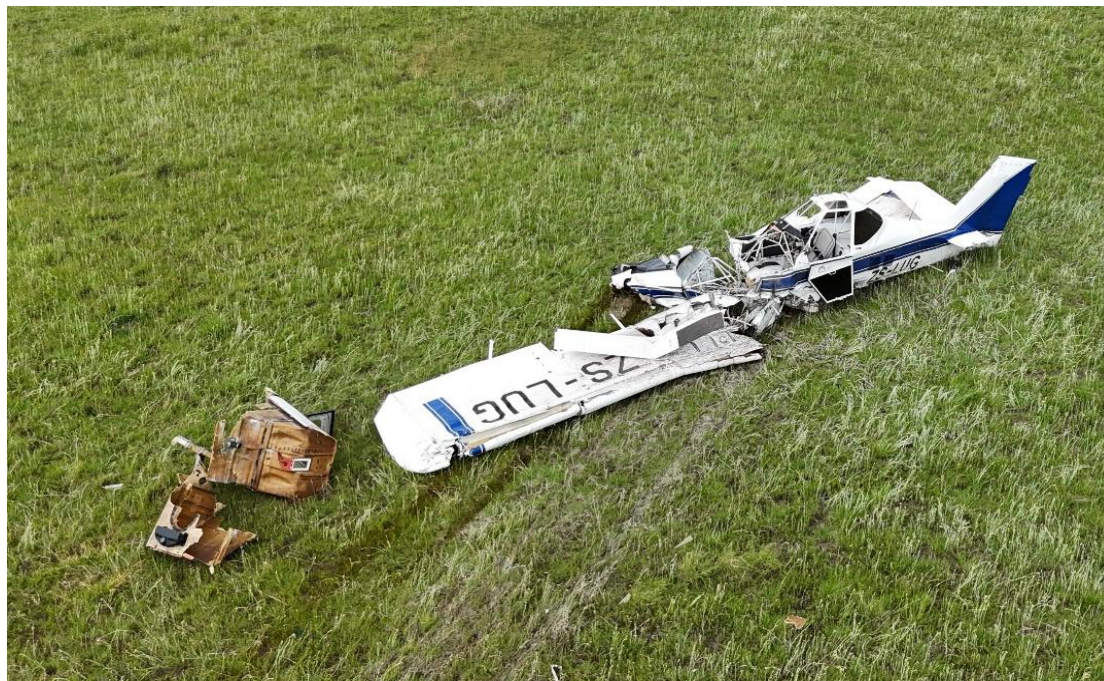
1.3.1 The aircraft was substantially damaged during the accident sequence.

Figure 2: The wreckage at the accident site.

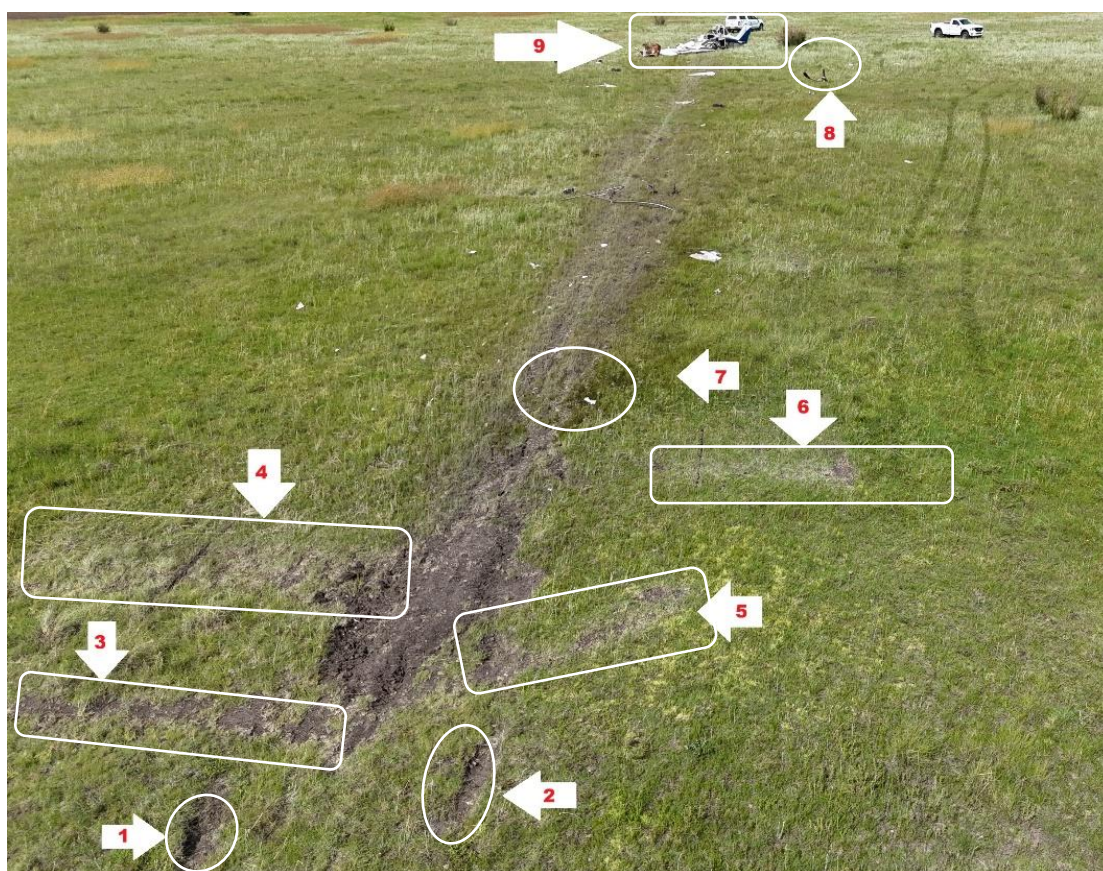
1.12.1 The aircraft impacted the ground with the left-wing which broke off and the aircraft slid on its belly for approximately 102m before it rested on the field.

Figure 3: Ground scars made by ZS-LUG during the accident.

Item	Description
1.	Initial impact ground scar from the left main wheel
2.	Impact ground scar from the right main wheel
3.	Initial impact ground scar from the left wing
4.	Second impact ground scar from left wing
5.	Initial impact ground scar from the right wing
6.	Second impact ground scar from the right wing
7.	Significant spill of engine oil
8.	Location of propeller
9.	Where the aircraft, engine and hopper came to rest

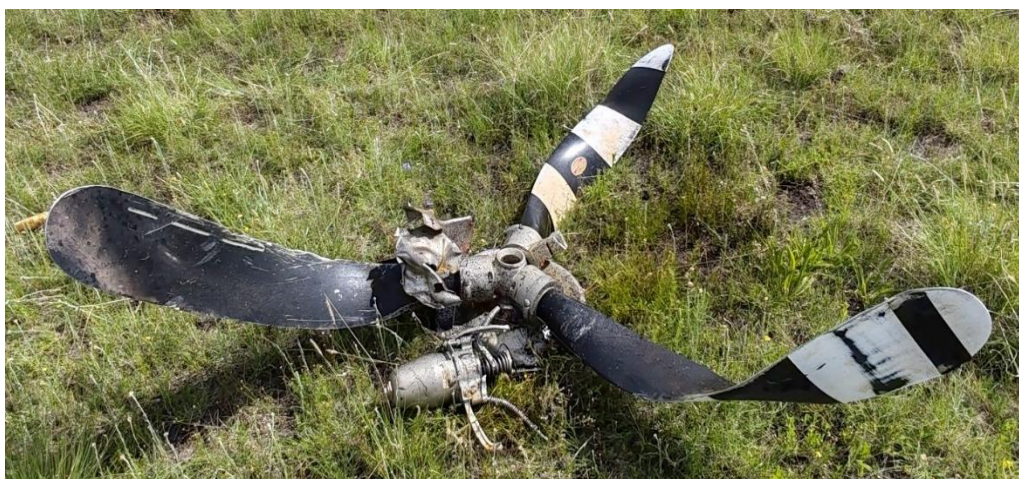
1.16.1 The propeller separated from the crankshaft flange, and the blades indicated that the engine was producing a substantial amount of power at the time of the accident.

Figure 4: The propeller at the accident site.

2.2.4 A post-accident examination of the airframe and engine revealed no evidence of any pre-impact mechanical malfunctions or failure that would have precluded normal operation. The signatures on the propeller blades were consistent with the engine delivering power at the time of the accident. The investigation determined that the accident was due to loss of situational awareness that resulted in loss of control of the aircraft whilst it was operated at low level.
