LIMITED OCCURRENCE INVESTIGATION REPORT – FINAL

Reference Number	CA18/2/3/10624						
Classification	Accident		Date	13 December 2025		Time	1615Z
Type of Operation	Private (Part 94)						
Location							
Place of Departure	Plettenberg Bay Airport (FAPG), Western Cape Province		Place of Intended Landing		Plettenberg Bay Airport (FAPG), Western Cape Province		
Place of Occurrence	On Runway 30, Plettenberg Bay Airport (FAPG), Western Cape Province						
GPS Co-ordinates	Latitude	34° 5'19.54"S	Longitude	23°20'4.19"E	Elevation	446 feet	
Aircraft Information							
Registration	ZU-BZC						
Make; Model; S/N	Windlass Aquilla (Serial Number: WA 812)						
Damage to Aircraft	Substantial		Total Aircraft Hours	1684			
Pilot-in-command							
Licence Type	National Pilot Licence (NPL)		Gender	Male		Age	70
Licence Valid	Yes	Total Hours	680		Total Hours on Type	17	
Total Hours 30 Days	6.4		Total Flying on Type Past 90 Days	17			
People on board	1+0	Injuries	1	Fatalities	0	Other (on ground)	0

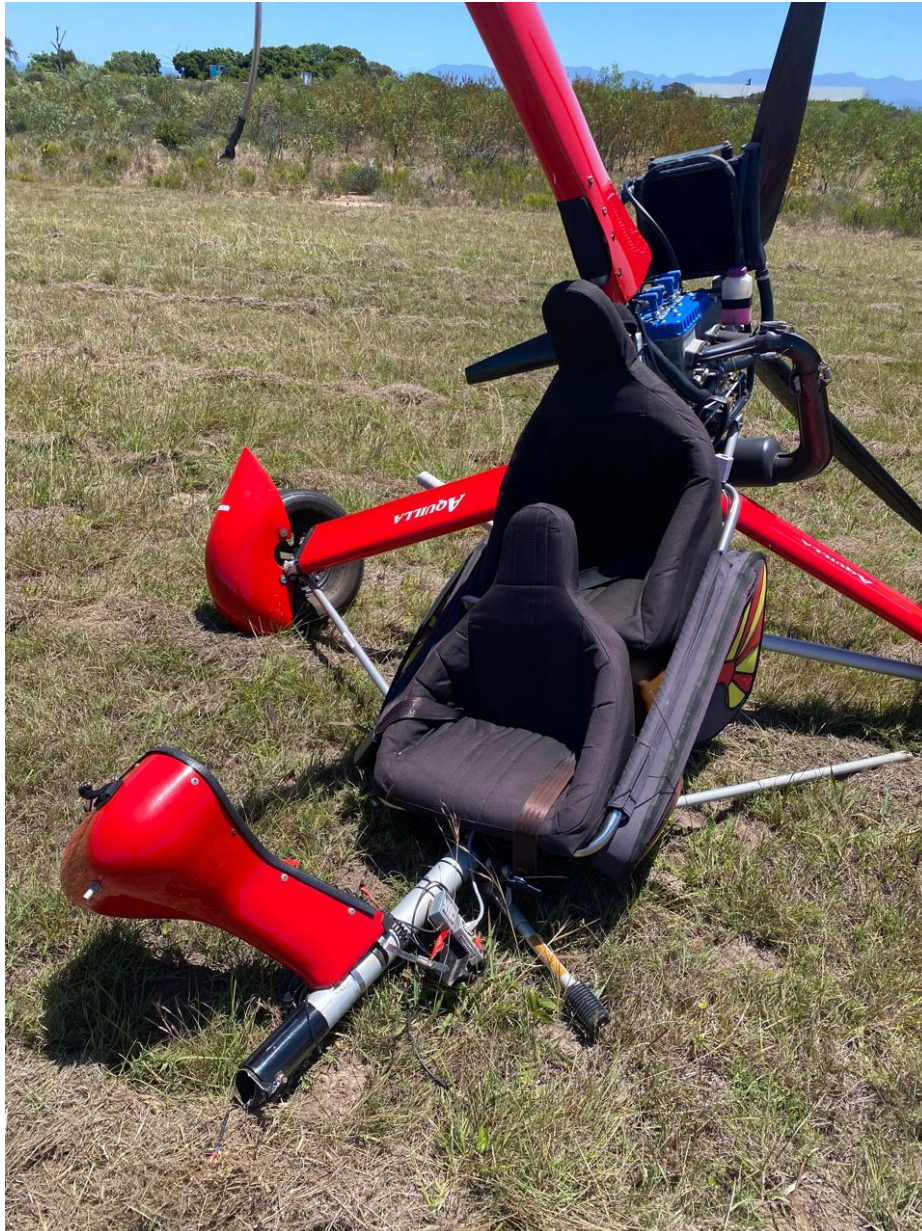
Figure 2: The aircraft on the left side of the runway after the accident. (Source: Pilot)

<p>2.3 The Certificate of Registration (C of R) was issued to the present owner on 8 August 2025.</p> <p>3. <u>Conclusion</u></p> <p>3.1 An increase in wind speed (gust) from a south-westerly direction during the landing flare contributed to the pilot losing control of the aircraft.</p>
<p>Probable Cause(s)</p> <p>A wind gust caused the pilot to lose control of the aircraft during the landing phase which led to a hard landing on the runway.</p>
<p>Contributing Factor(s)</p> <ul style="list-style-type: none"> • Poor airmanship. • The pilot's disregard of the Civil Aviation Regulations, 2011 Part 62.01.2.
<p>Safety Action(s)</p> <p>None.</p>
<p>Safety Message and/or Safety Recommendation/s</p> <p>None.</p>
<p>About this Report</p> <p><i>The decision to conduct a limited investigation is based on factors including whether the cause is known and the evidence supporting the cause is clear, the level of safety benefit likely to be obtained from an investigation and that will determine the scope of an investigation. For this occurrence, a limited investigation has been conducted, and the Accident and Incident Investigations Division (AIID) has relied on the information submitted by the affected person/s and organisation/s to compile this limited report. The report has been compiled using information supplied in the initial notification, as well as from follow-up desk top enquiries to bring awareness of potential safety issues to the industry in respect of this occurrence, as well as possible safety action/s that the industry might want to consider in preventing a recurrence of a similar occurrence.</i></p> <p><i>All times given in this report are Co-ordinated Universal Time (UTC) and will be denoted by (Z). South African Standard Time is UTC plus 2 hours.</i></p>

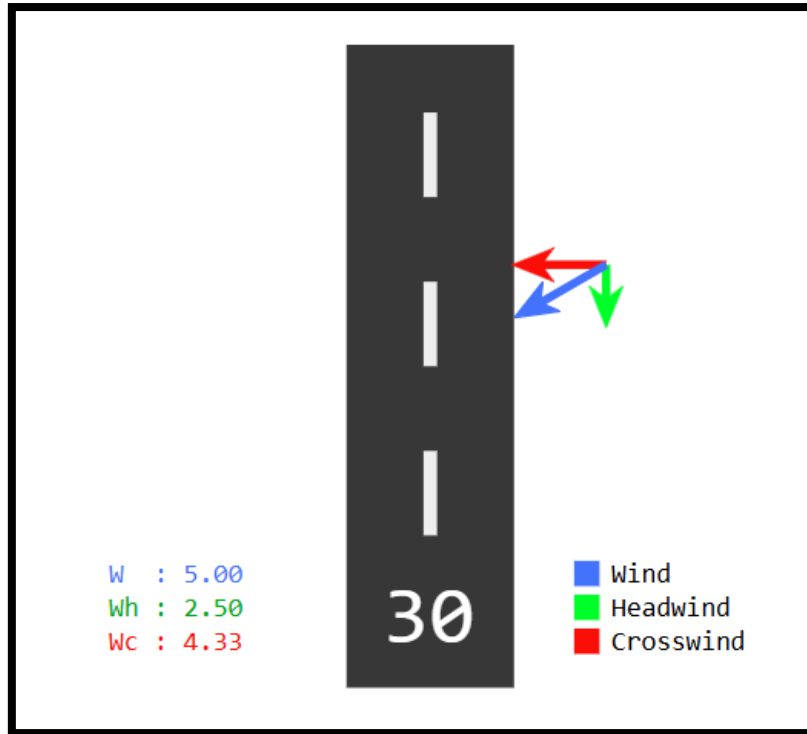
Figure 3: Crosswind component measured at 4.33 kts. (Source: <https://e6bx.com>)
