LIMITED OCCURRENCE INVESTIGATION REPORT – FINAL

Reference Number		CA18/2/3/10625						
Classification	Accident	Date	12 December 2025			Time	0930Z	
Type of Operation	Private (Part 94)							
Location								
Place of Departure	Bapsfontein Aerodrome (FABA), Gauteng Province			Place of Intended Landing	Bapsfontein Aerodrome (FABA), Gauteng Province			
Place of Occurrence	On Runway 02 at Bapsfontein Aerodrome (FABA), Gauteng Province							
GPS Co-ordinates	Latitude	25° 59' 15.75" S	Longitude	28° 24' 59.71" E	Elevation	5267 ft		
Aircraft Information								
Registration	ZU-RLS							
Make; Model; S/N	Magni Gyro; SRL-24C (Serial Number: 24159274)							
Damage to Aircraft	Substantial			Total Aircraft Hours	693.2			
Pilot-in-command								
Licence Type	National Pilot Licence (NPL)			Gender	Male		Age	59
Licence Valid	Yes	Total Hours	82.3		Total Hours on Type	0		
Total Hours 30 Days	4.6			Total Flying on Type Past 90 Days	0			
People On-board	1 + 0	Injuries	0	Fatalities	0	Other (on ground)	0

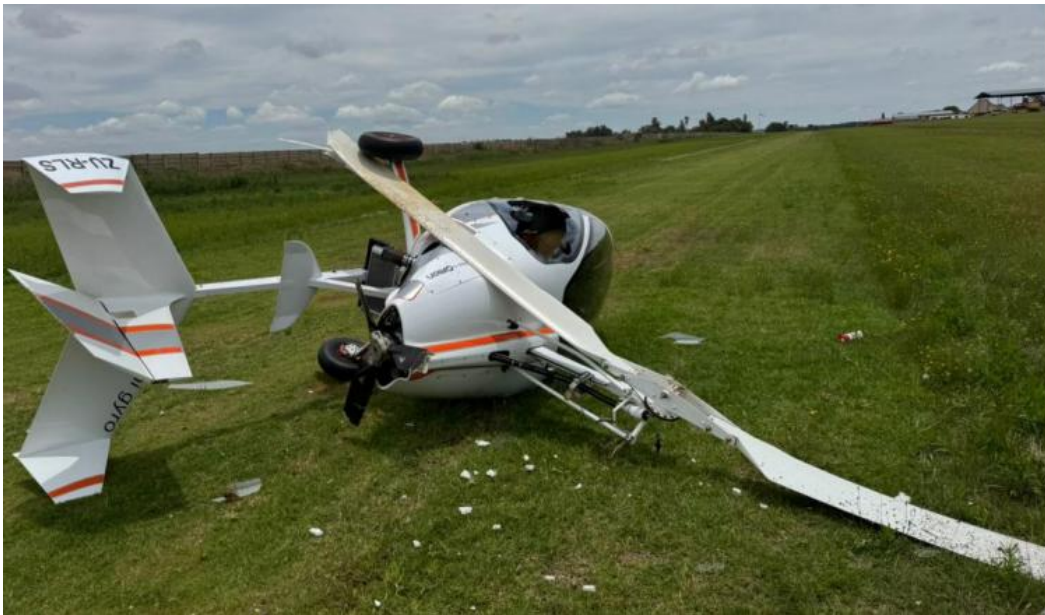
What Happened								
<p>On Friday morning, 12 December 2025, a pilot on-board a Magni Gyro SRL-24C gyroplane registered ZU-RLS was conducting a private flight from Bapsfontein Aerodrome (FABA) in Gauteng province with the intention to land at the same aerodrome when the accident occurred. The flight was conducted under visual meteorological conditions (VMC) by day and under the provisions of Part 94 of the Civil Aviation Regulations (CAR) 2011 as amended.</p> <p>The pilot reported that he conducted a pre-flight inspection of the gyroplane with no anomalies noted. The gyroplane had a total of 45 litres (L) of Avgas 100LL fuel in the tank. After the pilot had started the engine, he allowed it to run for a few minutes until all the indications were within the green arch. At approximately 0820Z, he opened the throttle to 5 300 revolutions per minute (RPM) and commenced with the take-off run on Runway 02. The gyroplane rotated and climbed to 6 300 feet (ft), headed to the general flying area (GFA). After about 35 minutes, the pilot routed back to FABA. Upon reaching FABA, the pilot assessed the windsock on the side of the runway and it favoured Runway 02 for landing. The gyroplane's approach speed was approximately 65 knots (kts). After landing and during the landing roll, the pilot felt a crosswind blowing from the left and the gyroplane drifted to the right. The pilot applied the left rudder to recover and back pressure to absorb the rotor energy to bring the gyroplane to a halt, but he was unsuccessful. Consequently, he lost control and the gyroplane rolled to the right during which the main rotor blades struck the ground. The gyroplane was substantially damaged. The pilot was not injured.</p>

Figure 2: The gyroplane after the accident. (Source: Pilot)

Loss of directional control during the landing roll in crosswind conditions resulted in the gyroplane veering off to the right and entering a dynamic rollover to the right.

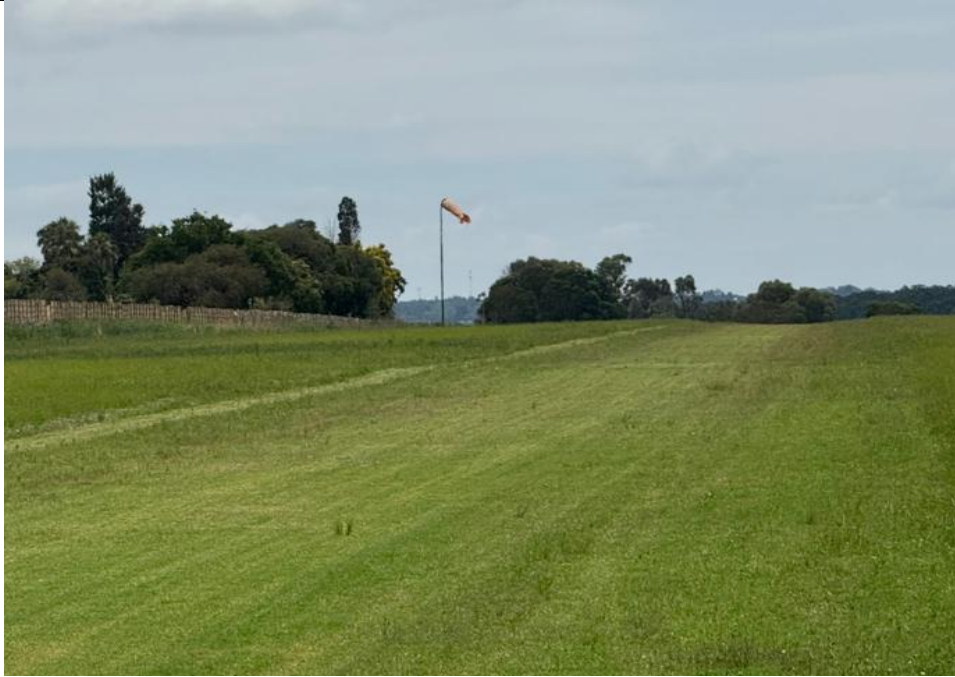
Figure 3: The grass-covered runway that was used and the windsock in the background. (Source: Pilot)

The weather conditions indicated a crosswind at 10 kts that was blowing north-west (left side) on the day and time of the accident. According to the Gyroplane Pilot's Operating Handbook (POH), it has a maximum of 25 kts demonstrated crosswind component during landing.
