LIMITED OCCURRENCE INVESTIGATION REPORT – FINAL

Reference Number	CA18/2/3/10626						
Classification	Accident	Date	29 December 2025		Time	0330Z	
Type of Operation	Aerial Work Operations (Part 137)						
Location							
Place of Departure	Spitsbak Citrus Farm near Hankey, Eastern Cape Province		Place of Intended Landing	Spitsbak Citrus Farm near Hankey, Eastern Cape Province			
Place of Occurrence	Spitsbak Citrus Farm near Hankey, Eastern Cape Province						
GPS Co-ordinates	Latitude	33°53'54.21" S	Longitude	024°55'12.38" E	Elevation	82 feet	
Aircraft Information							
Registration	ZS-ROM						
Make; Model; S/N	Robinson, R44 Raven II (Serial Number 10093)						
Damage to Aircraft	Substantial		Total Aircraft Hours	1 217.8			
Pilot-in-command							
Licence Type	Commercial Pilot Licence		Gender	Male		Age	50
Licence Valid	Yes	Total Hours	6 068.3		Total Hours on Type	2 403.2	
Total Hours 30 Days	23.6		Total Flying on Type Past 90 Days	23.6			
People On-board	1 + 0	Injuries	1	Fatalities	0	Other (on ground)	0

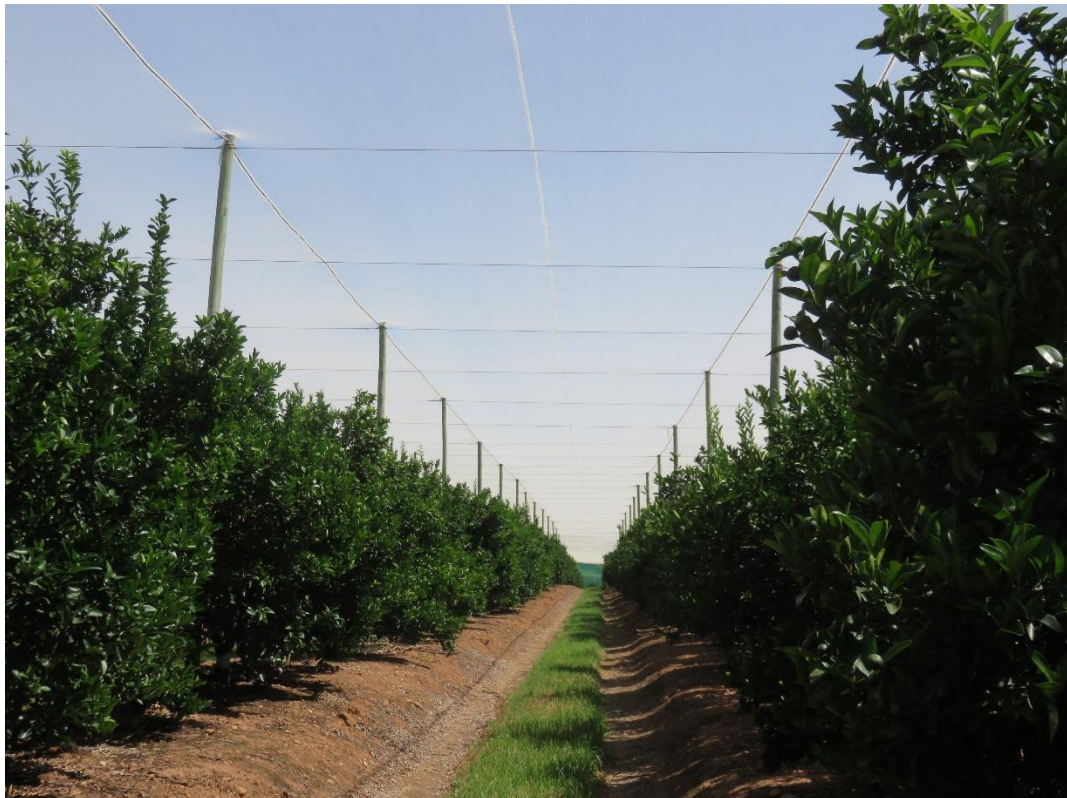
The pilot stated that he was aware of the wires as he had flown six times to spray the orchard without incident. Due to the white colour of the netting and the time of day (early morning), as well as the topography (sloping terrain), it became difficult to see the powerlines, which were grey in colour, above the white netting. The flight was conducted low over the netted area as the spray solution (liquid formula) was meant to drip through the netting and onto the orange trees.

Figure 2: A view of the orchard with netting.

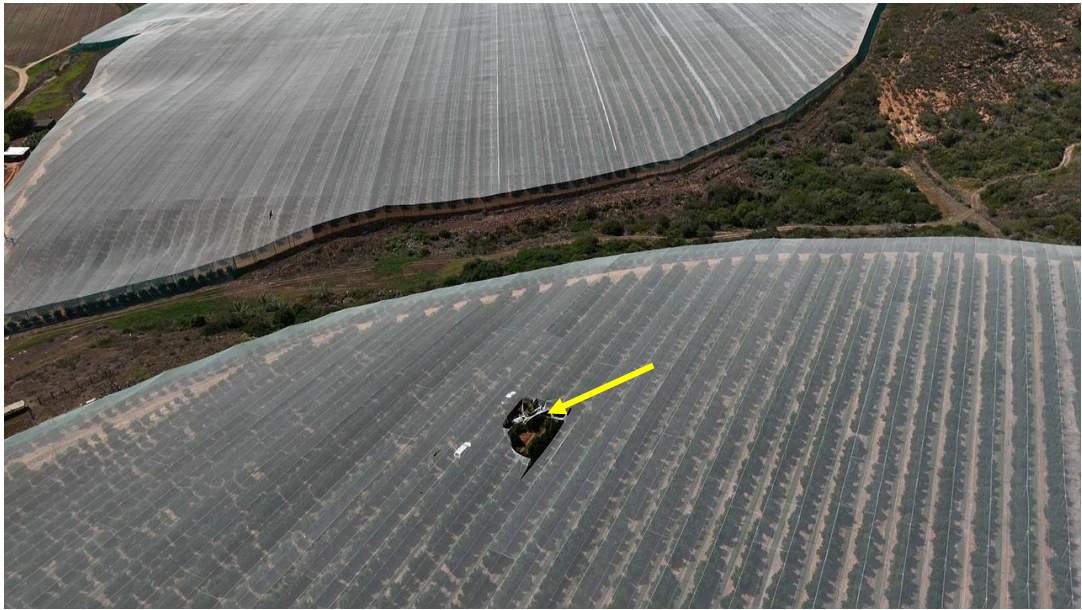
Third party damage was caused to a large area of the netting, as well as to some of the orange trees which were either in direct contact with the helicopter during impact or due to debris that was scattered during the impact sequence.

Figure 3: The damaged netting. The yellow arrow points to the helicopter under the netting.

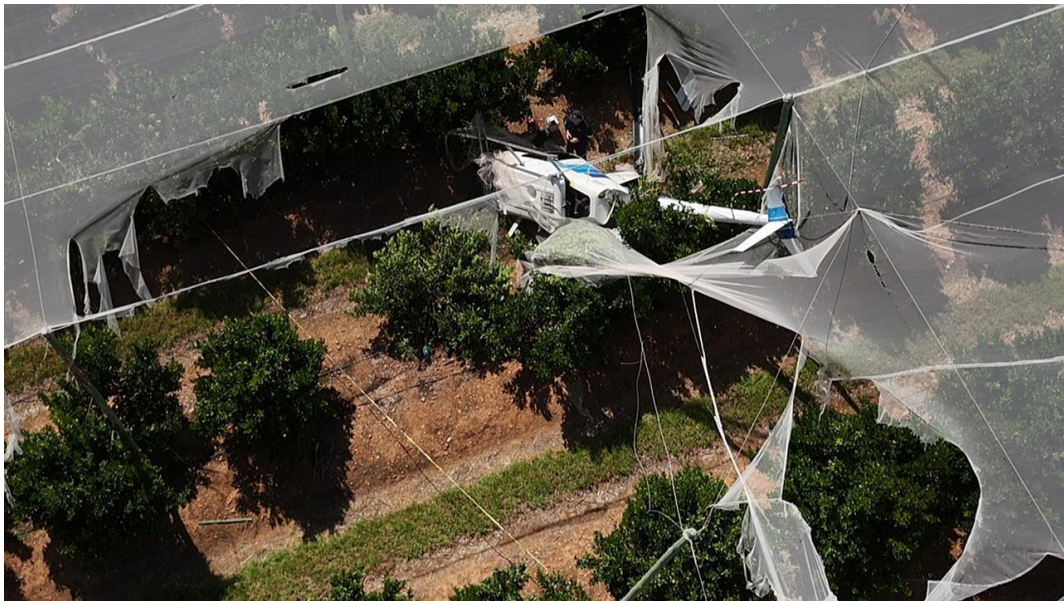
Figure 4: A closer view of the damaged netting and the helicopter.

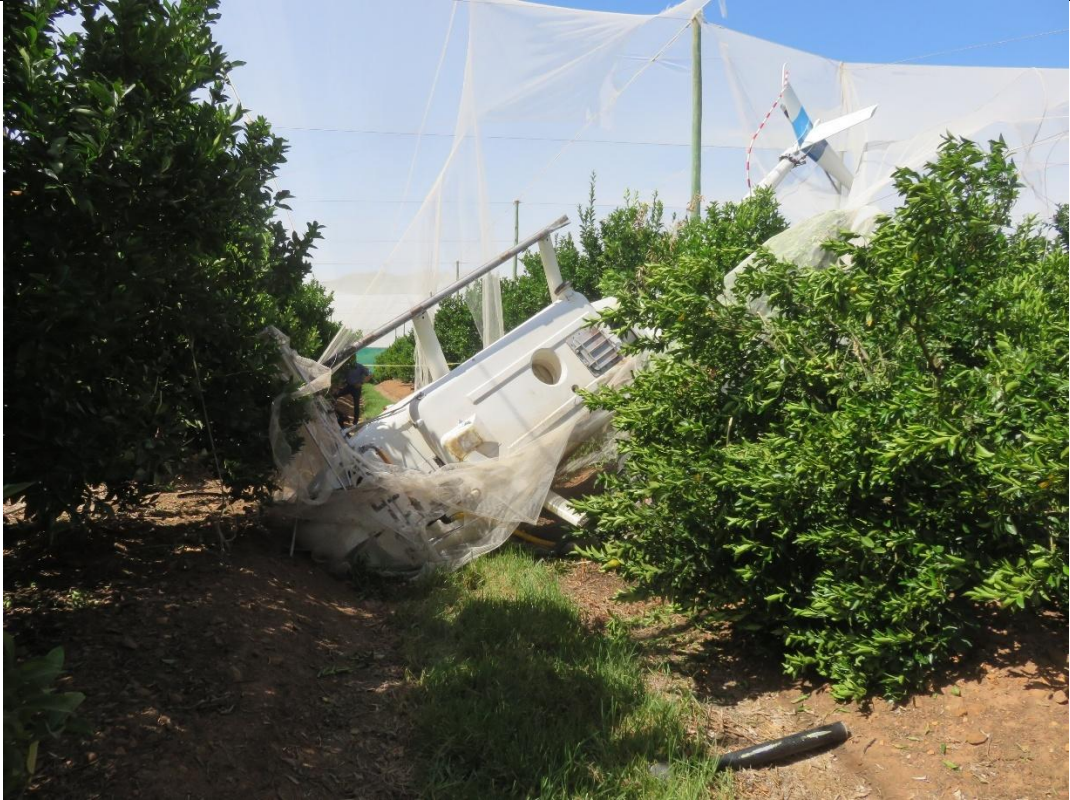
through the netting in a nose-down attitude. He then pulled his legs up into his stomach and braced for impact. The helicopter came to rest on its right side. The pilot (seated at the right side) was wearing a helmet which prevented him from sustaining head injuries. He sustained laceration to his lower left leg and some other minor cuts and bruises due to the broken Plexiglass windscreen. Farm personnel were quick to respond to the scene; they assisted the pilot who was later taken to a medical facility. The helicopter as well as the spray booms were substantially damaged.

Figure 5: The helicopter as it came to rest on its right side and nose down.

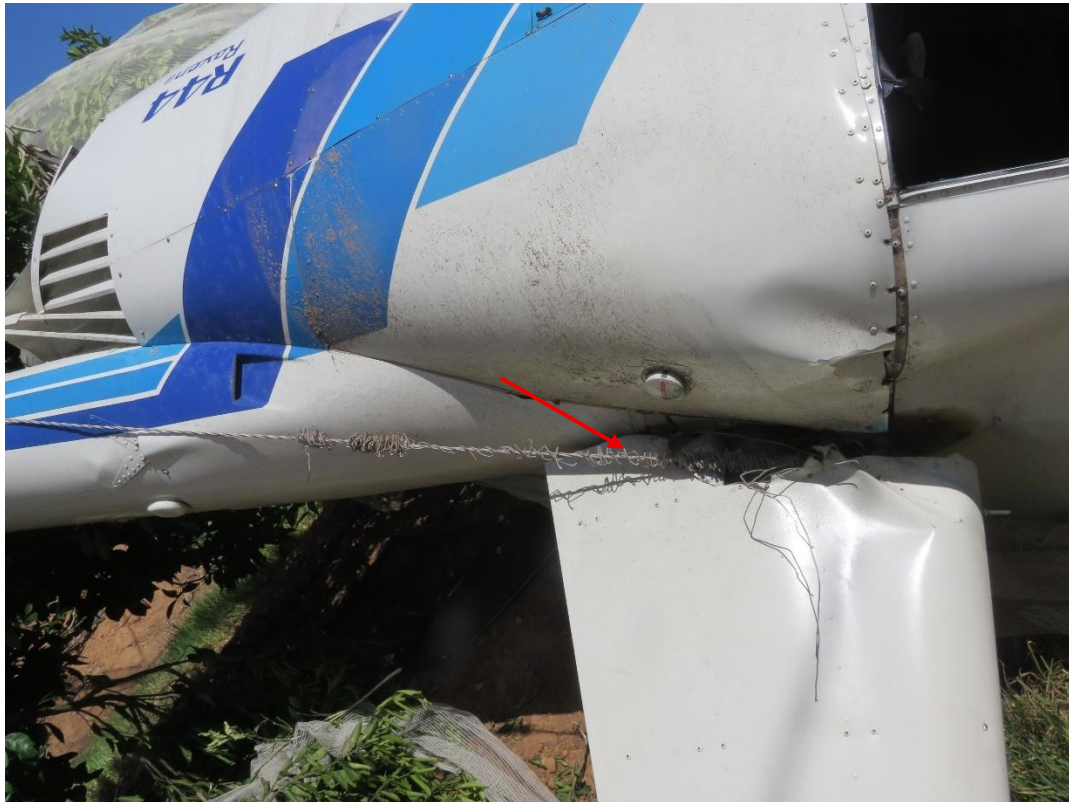
Figure 6: The cable entangled around the main rotor mast and control rods.

The pilot impacted the powerlines during an agricultural spraying operation over a net-covered orchard, which resulted in loss of control and the resultant ground impact.

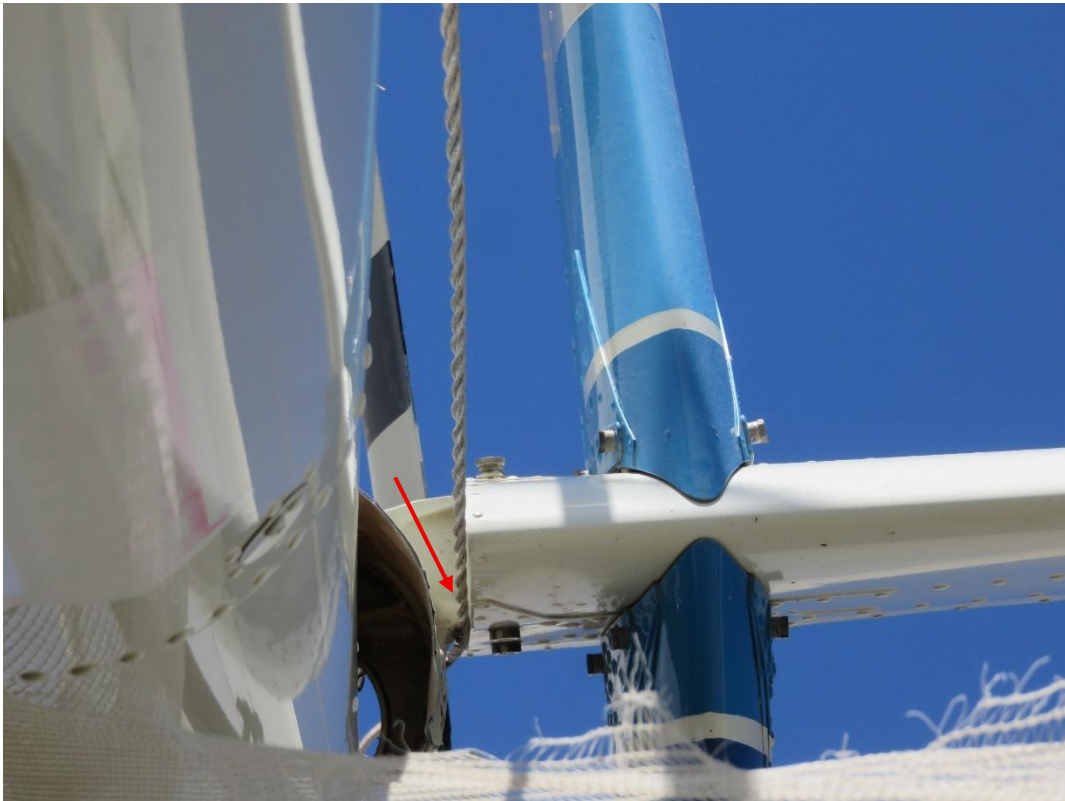
Figure 7: The cable was found hooked over the horizontal stabiliser.

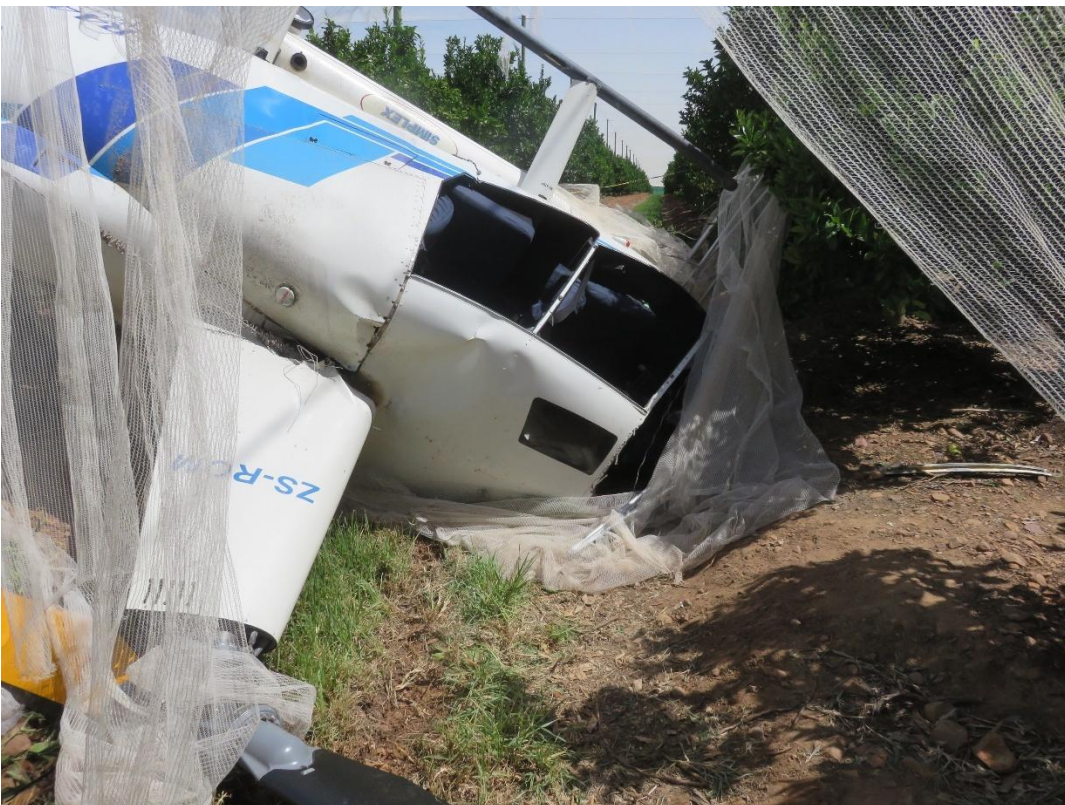
Figure 8: The helicopter resting on its right side.

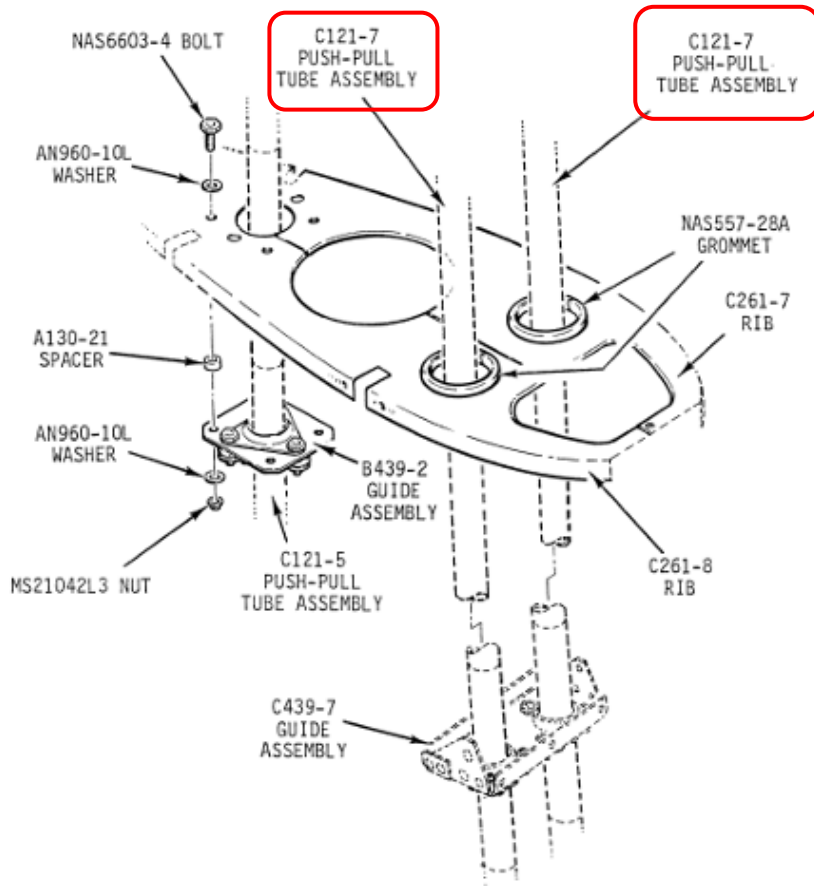
Diagram 1: Illustration of the three control rods (push-pull tubes) positioned next to the main rotor mast, where the cable was entangled (Figure 5). This caused limited (to no) movement of the two front control rods (push-pull tubes) highlighted in red.
